Channel response to Dam Removal, Clear Creek, California

Channel Response to Dam Removal, Clear Creek, California

Peter Miller and Pilar Vizcaino

January 9, 2004

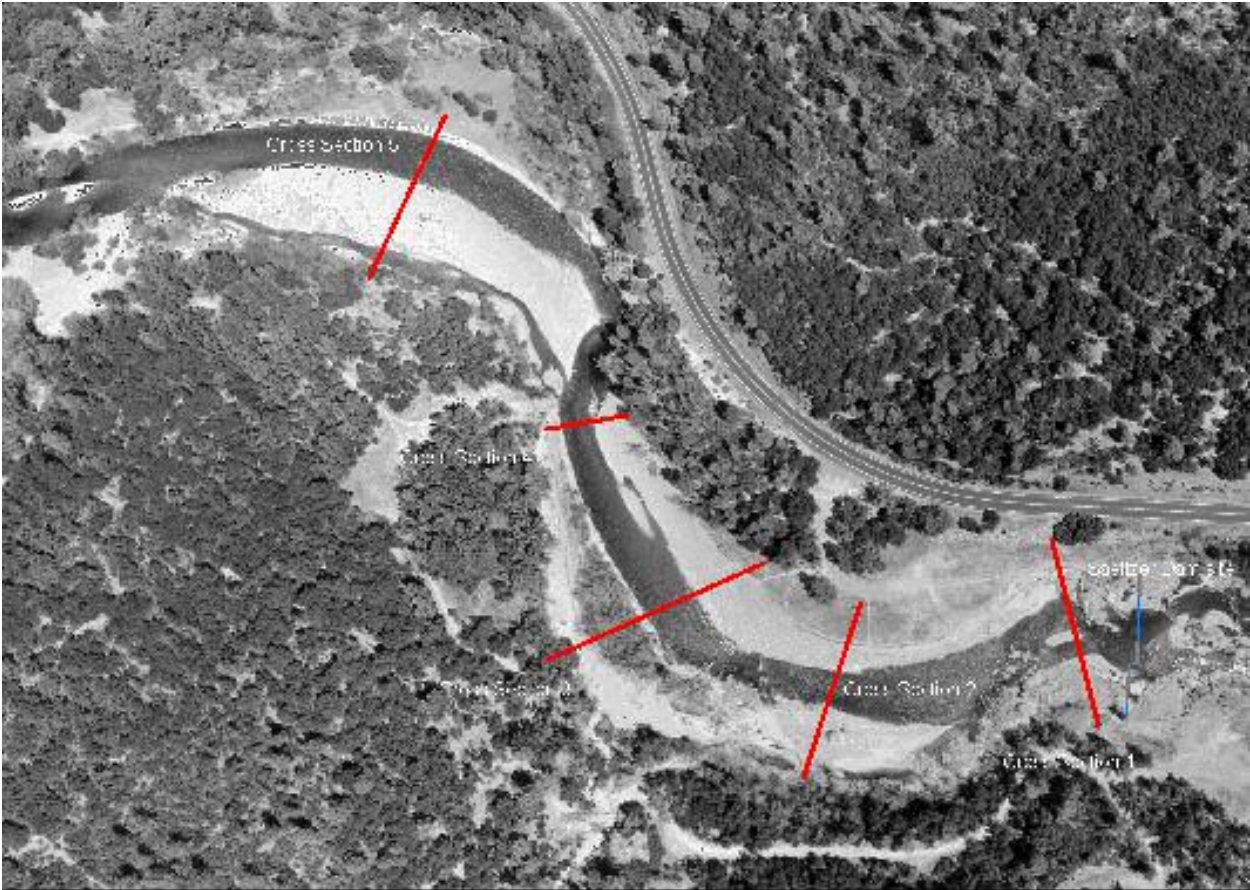
Figure 2: Site Map

In the upstream 285 meters of the former reservoir, the channel is a shallow channel with a broad gravel bar backed by a steep bank on the left and an abandoned high flow channel on the right (Figure 2). The high flow channel ends at 285 meters and from there to approximately 450

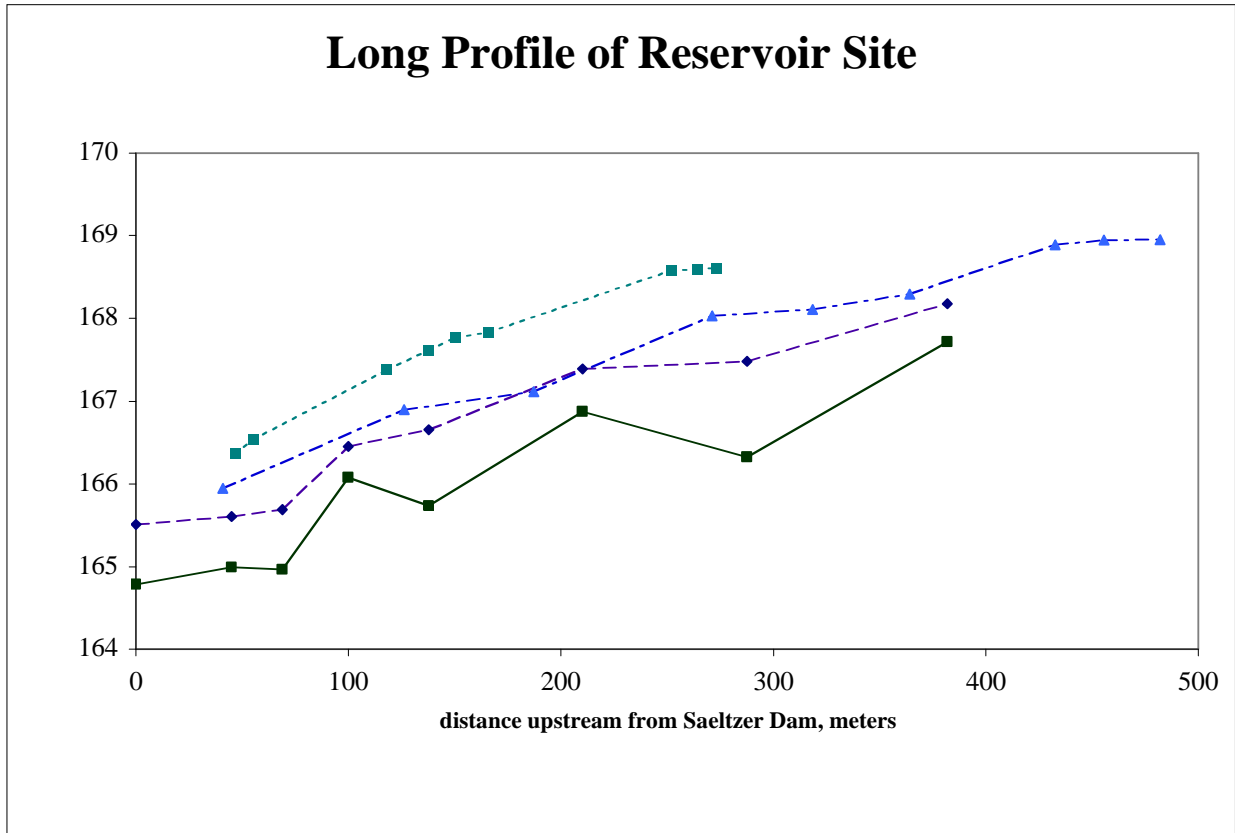
Figure 8: Long Profile

Comparison of long profiles and cross sections from May 2001 and April 2003³ show post-dam incision of up to 1.5 meters, decreasing as one moves upstream from the dam site. The lack of a bed profile immediately following dam removal makes it difficult to draw more specific conclusions.

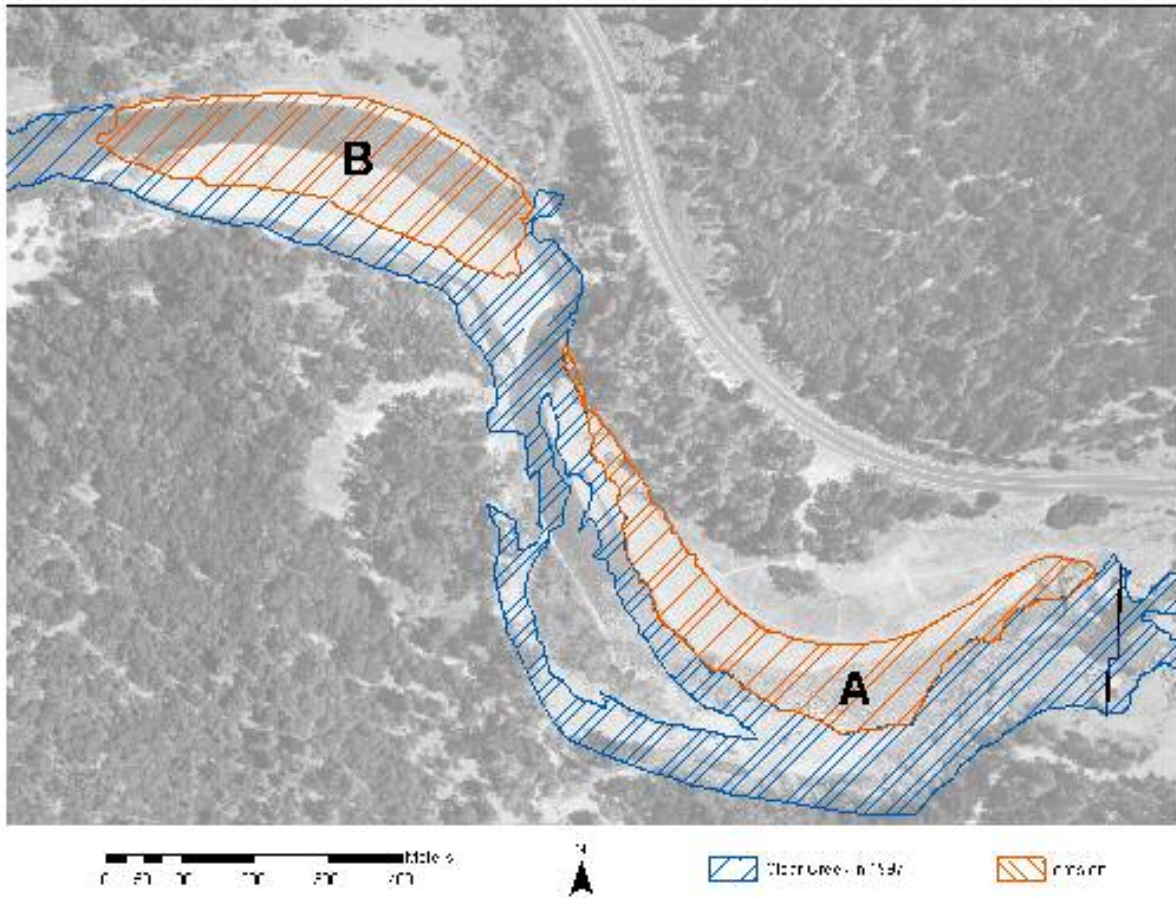
Figure 9: Aerial Photo of Reservoir Site with Areas of Erosion

Figure 9 is an aerial photograph of the site with the principal areas of erosion shaded to show their lateral extent. Area A is immediately upstream of the former dam site on the left bank. The spatial extent of Area A is 5,306 sq. meters. The bank height along the left (north) edge of Area A declines fairly linearly from 4.43 meters at cross section 1 to 1.98 meters at cross section 4. (Figure 10) Because slope is relatively smooth and the distribution of Area A is balanced over this distance, we assumed a linear slope between the endpoints and used the average of this range as an estimate of the average height of the eroded volume.⁴ This approach produces an average height of 3.2 meters. Simple multiplication of the area and the average height produces an estimate of eroded material of 17,006 m³.

The other principal area of erosion, Area B, is also on the left bank beginning approximately 300 meters upstream of the dam site. The spatial extent of Area B is 6,631 square meters. We surveyed a single cross section near the midpoint of Area B. Because the bank height along cross section 5 is near the midpoint and is close to the average of the two ends, we

used this height to estimate the volume of sediment underlying Area B. The bank height along cross section 5 is 3.43 meters, resulting in an estimated volume of 22,744 m³.

Based on these calculations, we estimate the total volume of sediment eroded to be 39,750 m³. This estimate is conservative because it excludes any eroded sediment outside the boundaries of these two areas. In particular, we have excluded any sediment from incision into the streambed.

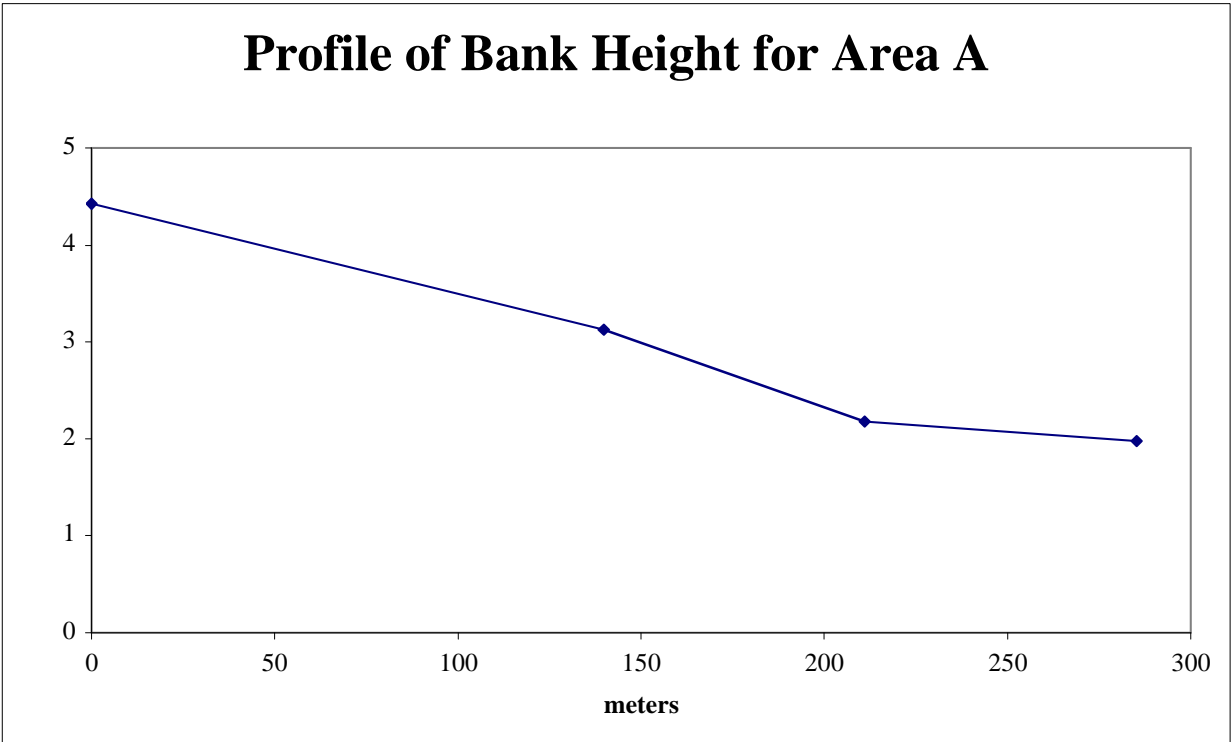
Figure 10: Bank Height for Area A

⁴ A simple average of the bank heights from cross sections 1-4, is slightly lower at 2.93 meters, but the cross sections are more heavily weighted to the smaller end of the eroded area.
