## Restoration of Rivers and Streams (LA 227)

Post-Project Appraisal of Crocker Creek Dam Removal Project, Sonoma Co., California

December 13, 2005

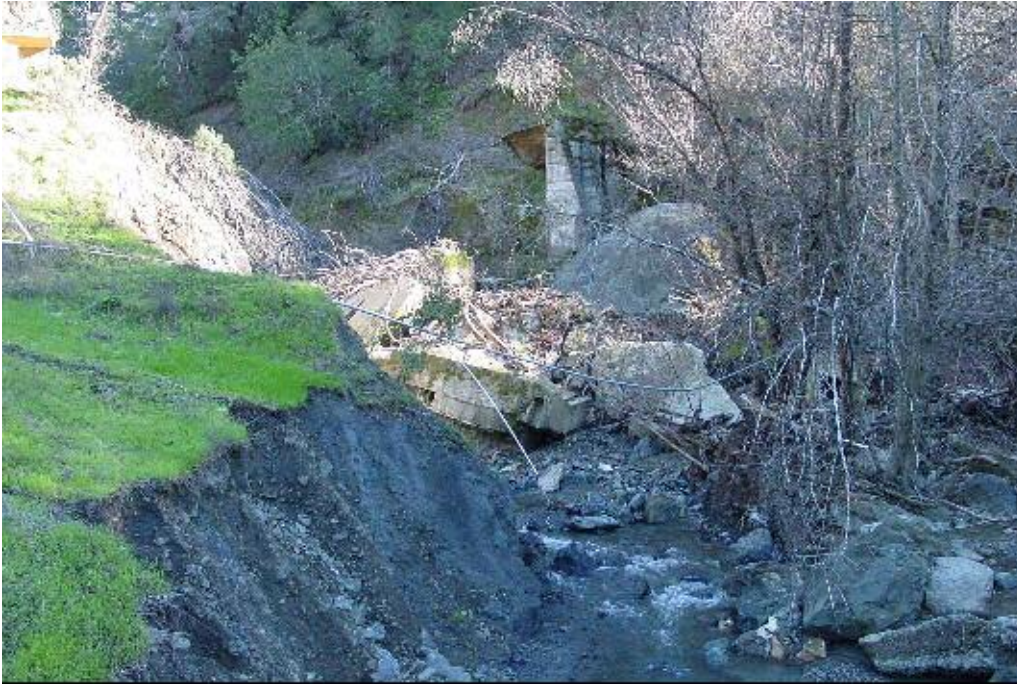
Crocker Creek Dam began to show signs of failure in 1974 (SCWA, 2005). In 1995, the entire northern portion of the dam with the exception of the original base failed, and further failure occurred in 1997 (Figure 1). The dam was nearly full of sediment at the times of failure (Scherzinger, personal communication, 8/26/05). These failures released sediment to the downstream areas and aggraded the bed (SCWA, 2005). Upstream areas experienced erosion

**FIGURE 1.** View upstream of failed Crocker Creek Dam in 2002. Unknown photographer, image courtesy of SCWA.

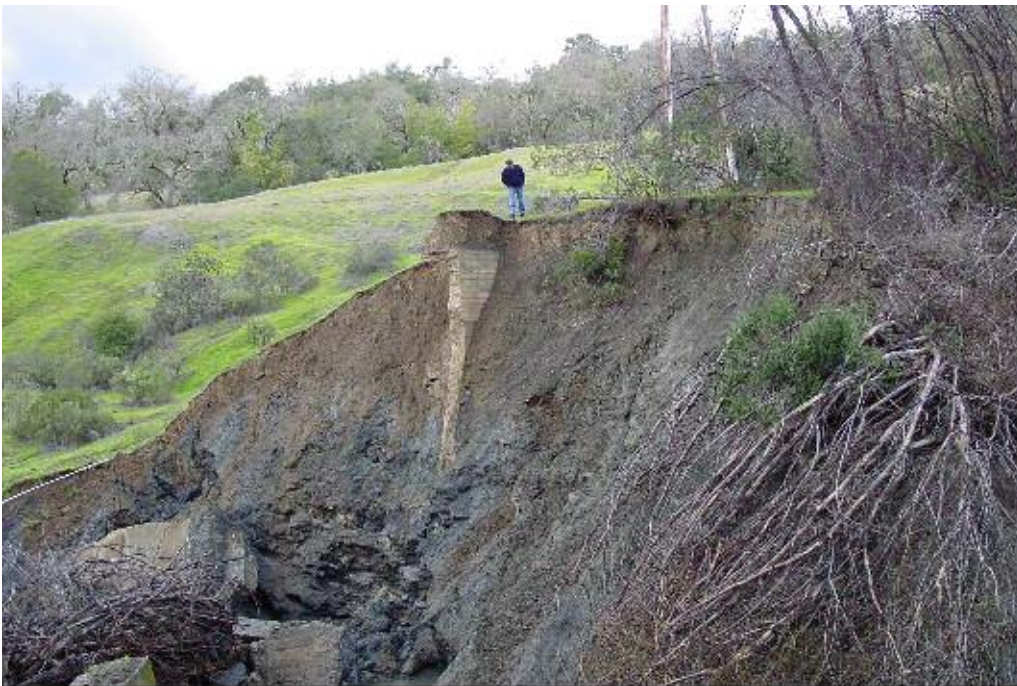
The project effort primarily focused on meeting the goal of stabilizing the adjacent stream banks. We are unsure whether these stream banks are the original stream banks or the banks of the remaining reservoir sediment. Restoration work occurred in 4 project areas. Areas I and II involved the right (north) and left (south) banks that held the dam abutments. In Area I, the stream bank had become unstable after the dam failures (Figure 2). To stabilize it, SCWA

**FIGURE 2.** View of the north abutment (Area I), after the '95 and '97 Crocker Creek dam failures in 2002, prior to restoration. Unknown photographer, image courtesy of SCWA.

regraded the steep bank at a 2:1 slope. In Area II, the south abutment and spillways were demolished and removed, and a small portion of the bank was recontoured at a 2:1 slope. (SCWA, 2005)

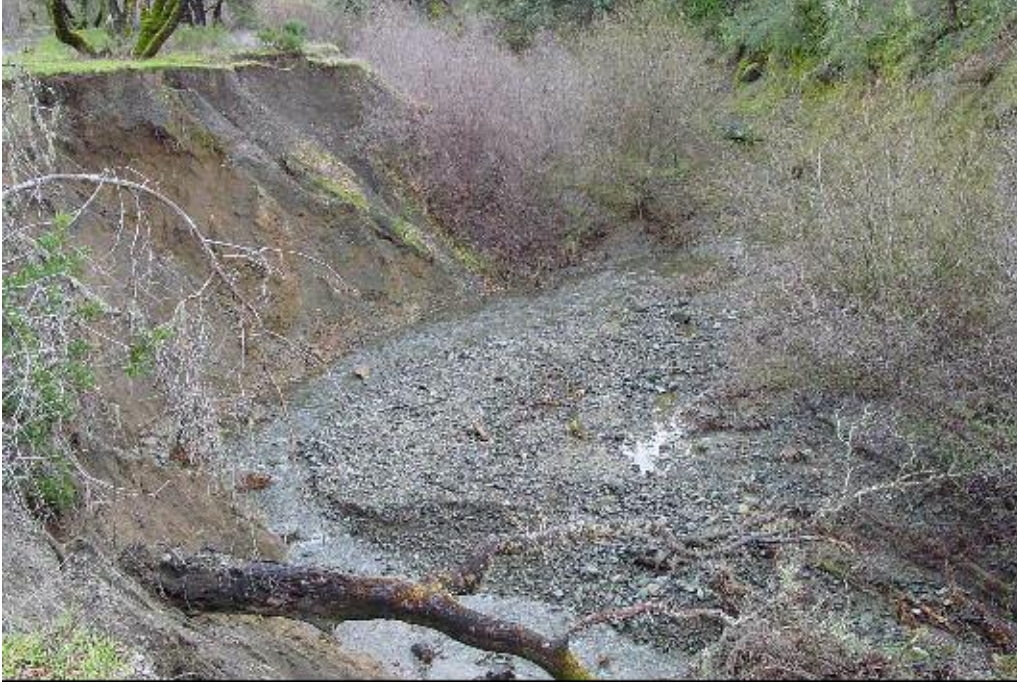
Area III, approximately 150 feet upstream of the dam site, was an erosional scarp 21 feet high and 170 feet long (Figure 3) (SCWA, 2005). The plan for this area was to regrade to a 2:1 slope using the surplus fill created from the Area I activities earlier described. However, during construction, the project manager quickly realized that the cost of transporting the sediment from Area I to Area III was not cost effective. Instead, an area of depression adjacent to Area I became the fill site for remains of the old dam, abutment, and spillway. These remains were buried using fill generated from the grading of Area I SCWA engineers controlled Area III's right bank erosion by placing riprap along the bank. (Scherzinger, personal communication, 11/3/05)

**FIGURE 3.** View upstream of Area III prior to restoration in 2002. The channel was eroding the right bank. Unknown photographer, image courtesy of SCWA.

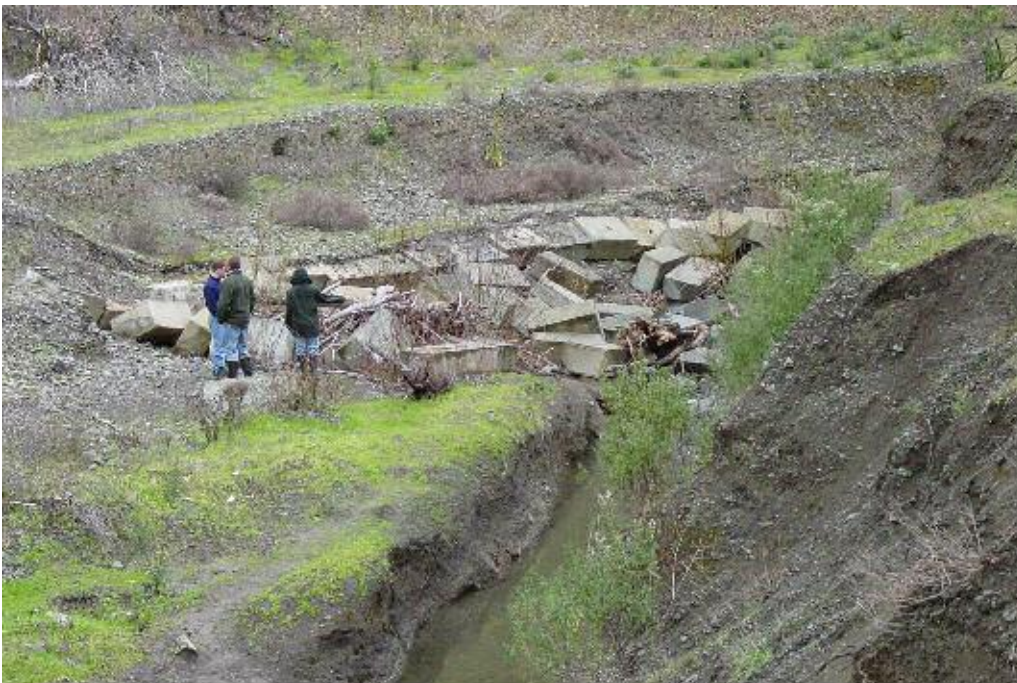
Area IV is located furthest upstream from the former dam site. Previously at this site, KOA owners attempted to stabilize erosion on the right bank through placement of concrete blocks (Figure 4). Though adequately preventing bank erosion, the blocks were in disarray and unnatural in appearance. To restore this area, SCWA recontoured the bank at a 2:1 slope, established willow revetment at the toe, and placed a series of 4 redwood log spurs to direct water away from eroding the right bank. (Scherzinger, personal communication, 11/3/05)

**FIGURE 4.** View upstream of Area IV prior to restoration in 2002. Concrete blocks were placed along the right bank to prevent bank erosion. Unknown photographer, image courtesy of SCWA.

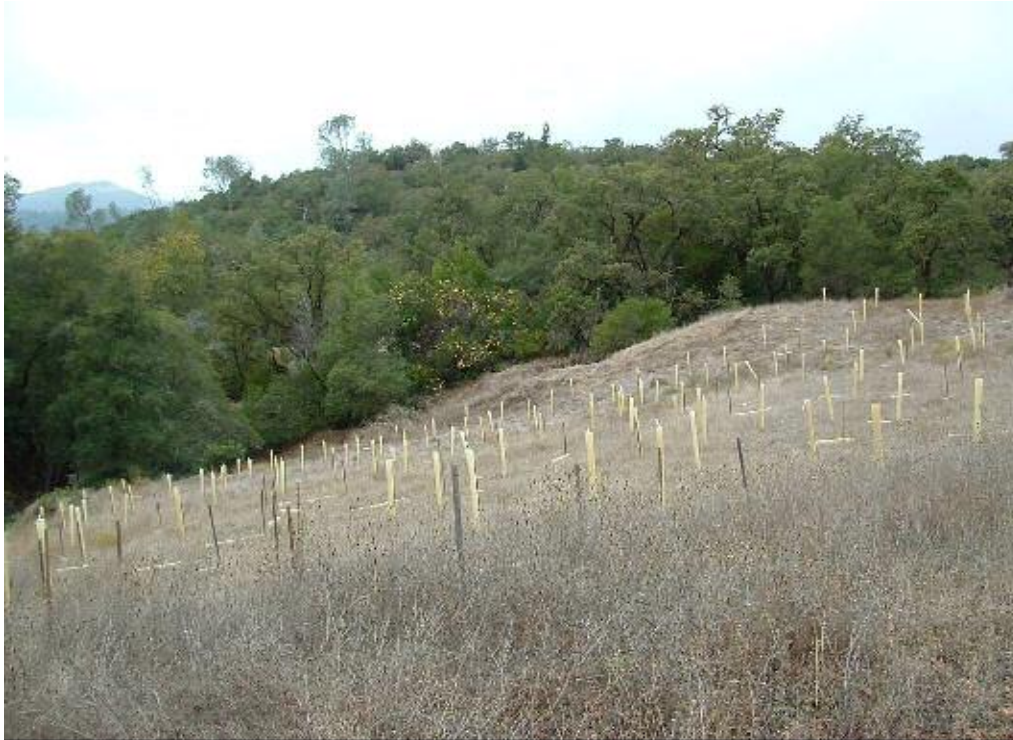
The regraded hillside north of the former dam location (Area I) was the target of a large revegetation planting which we found unsuccessful. A thick mattress of willows covers the eastern end of Area I (Appendix A); however the majority of the slope has few survivors from the initial planting. While willows may still eventually establish on the slope, to stabilize this slope, the root systems of trees or shrubs may be needed.

**FIGURE 5.** View of revegetation effort at Area 1 in 2005. Plantings were staked and protected by plastic tubing. Photo taken by Alicia Gilbreath on November 3, 2005.

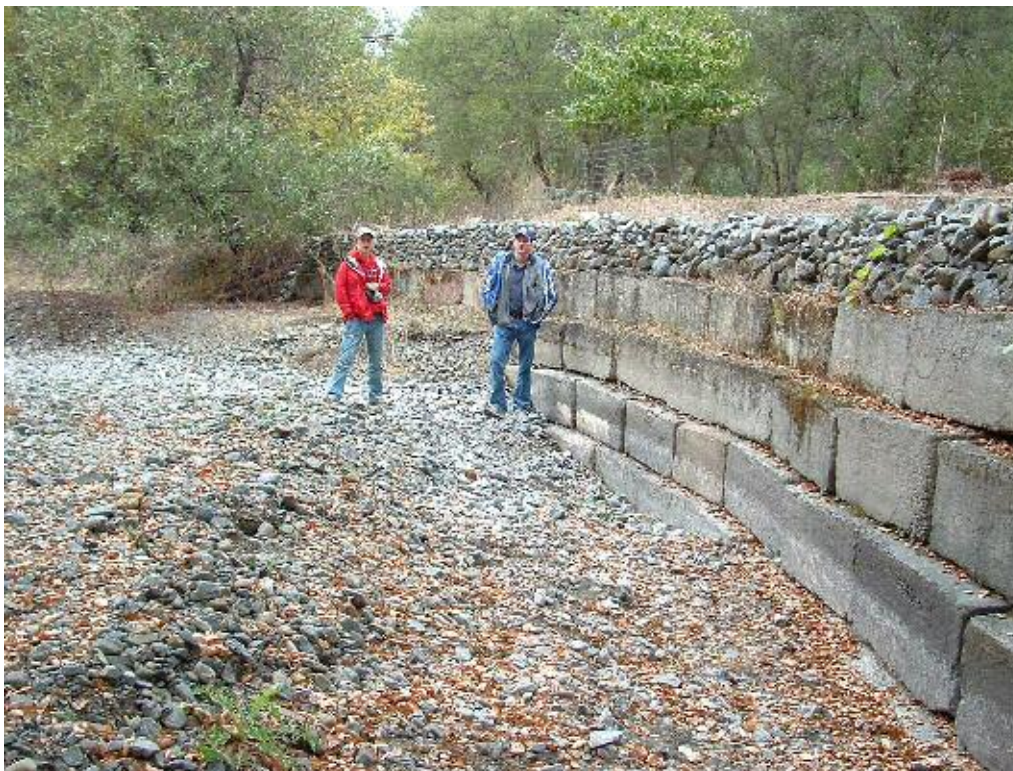
**FIGURE 6.** Concrete block wall on left bank of channel, downstream of Crocker Creek Dam removal site. Rocks on top of wall appear to be in place to raise effective height. Looking upstream. Photo taken by Alicia Gilbreath on November 3, 2005.

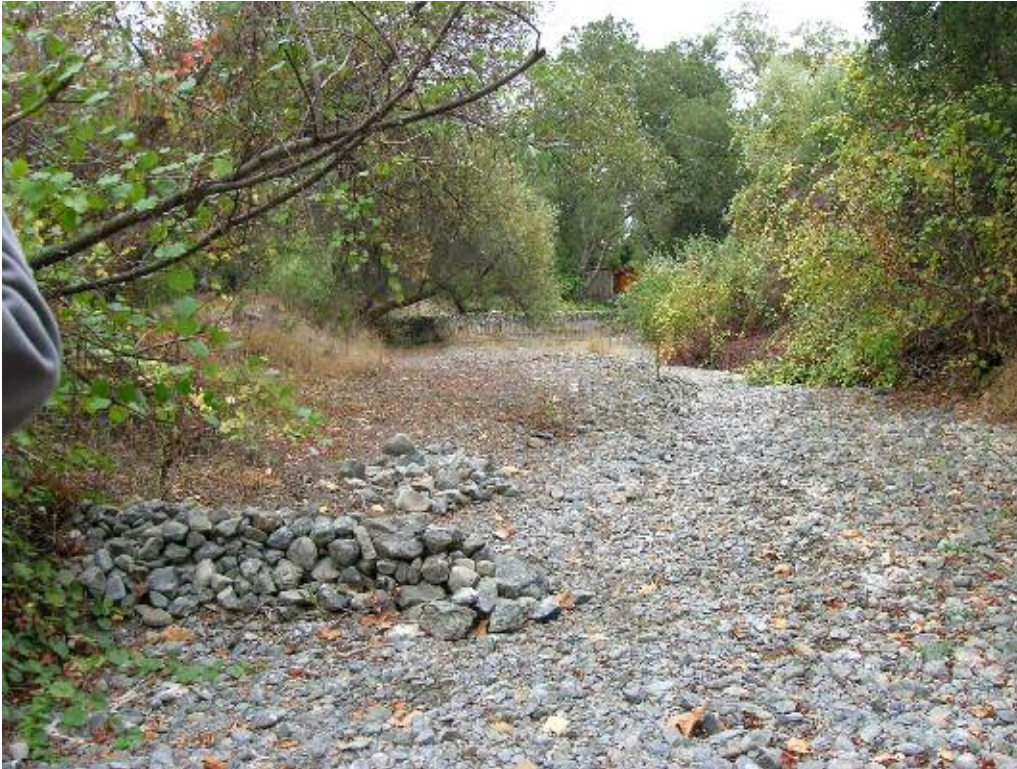
By observing the sediment terraces and walking upstream, we estimate the upstream extent of the former sediment field is several hundred feet upstream of Area IV. Additionally, walking downstream of the former dam site out to the confluence with the Russian River, we observed dam debris and evidence of bed aggradation. Some tree trunks appeared buried, and a concrete block wall along the left bank showed signs of partial burial (Figure 6). We observed rocks piled near the edge of the left bank, presumably to divert flows away from the stream bank (Figure 7).

**FIGURE 7.** Rocks piled near left bank downstream of Crocker Creek Dam removal site. Looking downstream. Photo taken by Maureen Downing-Kunz on November 3, 2005.

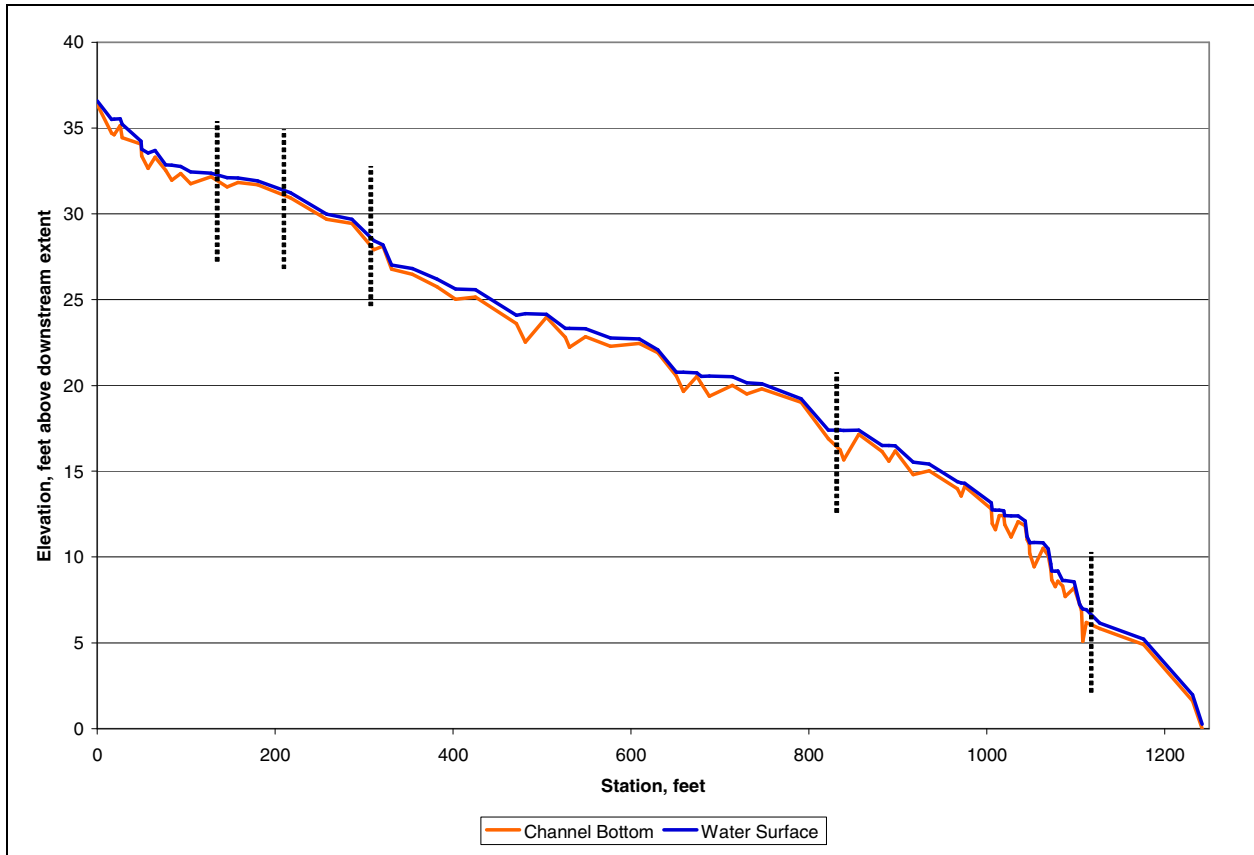
Therefore, as a result of the dam removal, we expect the long profile slope to level out from upstream to downstream. And that is the result we see from our long profile (Figure 9). The new slope is 2.7% from the former dam site moving upstream, while the slope from the former dam site going downstream is 5.1%. There are no major barriers shown in the profile, leading us to the conclusion that fish passage has been successfully restored. The former dam location is seen in Figure 15; no significant barriers to fish passage are visually evident.

Though it is beyond the scope of appraising the achievement of the objective, we note that our long profile also illustrates that there are several pools of one-to-two feet in depth just upstream of the former dam site, while the upstream portions of the long profile are dominated by runs and riffles (Figure 9).

**FIGURE 9.** Post-project longitudinal profile of stream along thalweg, beginning at upstream boundary of project area (Station 0). Elevation of channel bottom and water surface are plotted relative to downstream extent (feet). Channel cross-section locations are indicated by vertical, dashed lines.

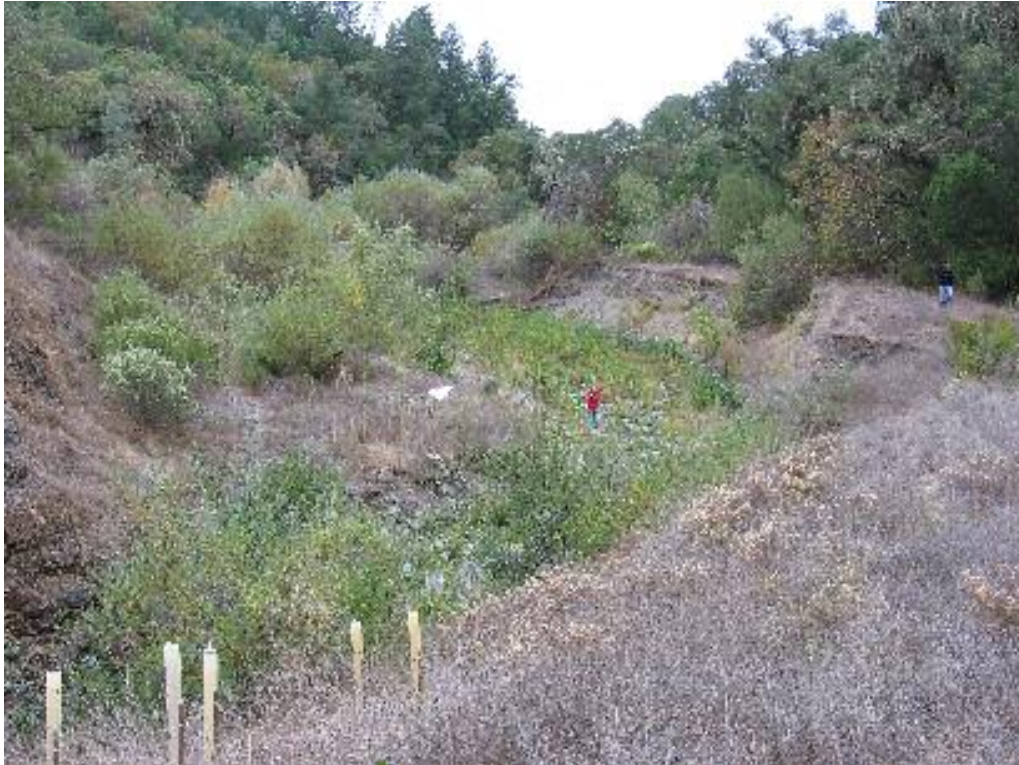
Revegetation efforts attempted to stabilize the projects regraded slopes as well as the bank of the creek. The success of the revegetation varies with the type of area considered within the project. Willows located on in-channel bars and on the banks near the waters edge appear established; whereas some areas of plantings further from the channel had a low survival rate (Table 1). The upstream end of the restored reach (Area IV) exhibits the establishment of willows in and adjacent to the channel along with an area of less successful plantings higher up on the regraded bank, Figure 16.

**FIGURE 16.** View downstream at Area IV. Established willows can be seen bordering the channel and in the floodplain; however, there were no survivors in the planting tubes higher on the bank (picture foreground). Photo taken by Colin Dudley on November 3, 2005.

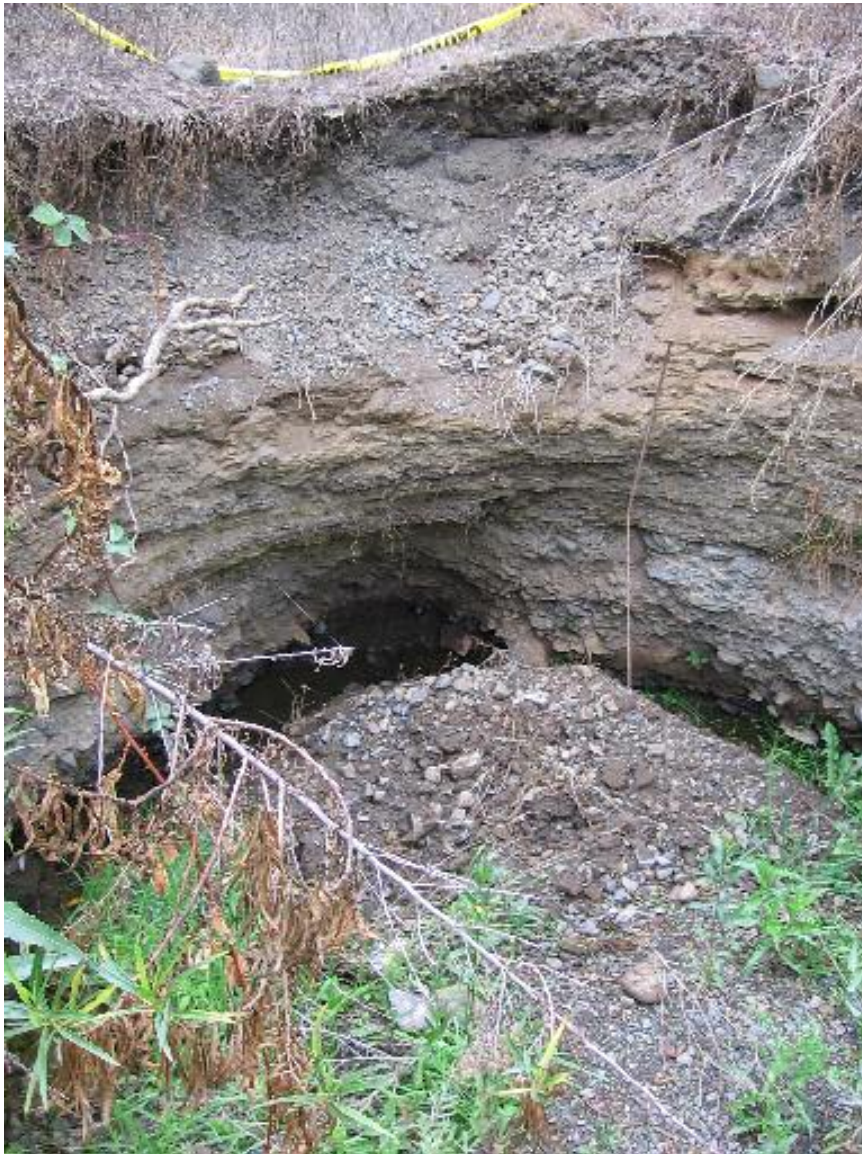
We identified several areas of bank erosion during fieldwork at the project site. One such area is along the right bank just downstream of Area IV, Appendix A. The channel splits just down stream of the log structures in Area IV, with the northern channel running directly into the bank at this location, where it is forced to turn 90 degrees to the left (south) to rejoin the main channel. The flow appears to be eroding the bank at this location, Figure 17.

**FIGURE 17.** View of bank downstream of Area IV. Bank erosion is evident next to north channel just before joining south channel. Photo taken by Colin Dudley on November 3, 2005.

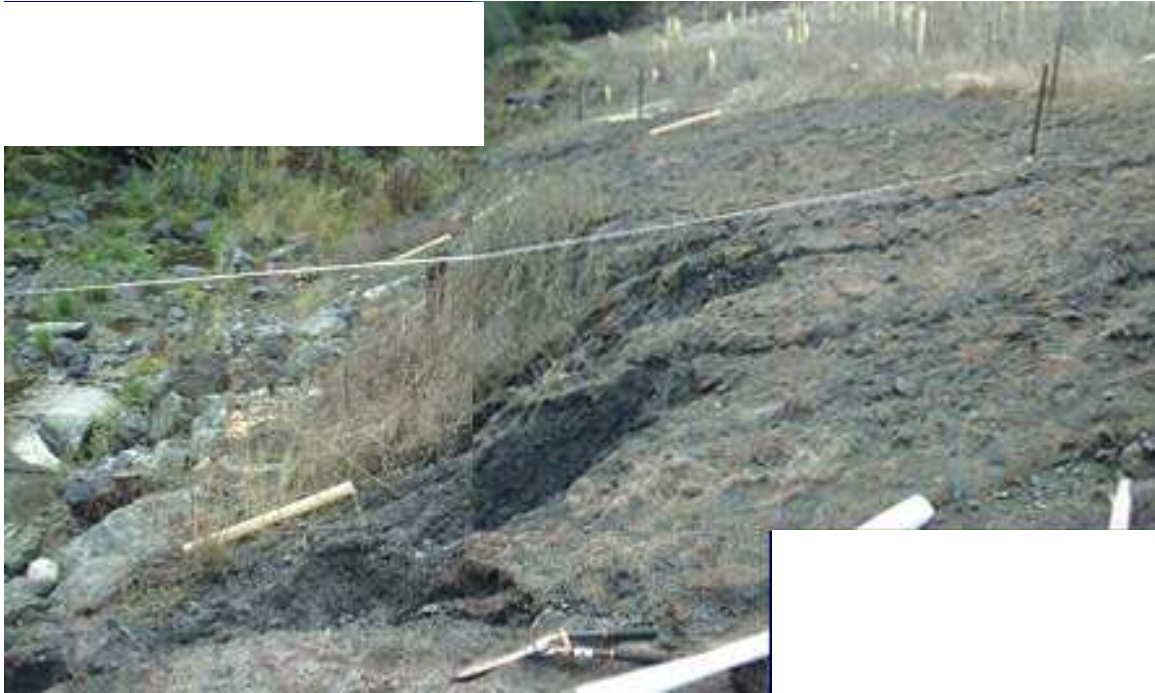
One area of successful bank stabilization is the north abutment of the dam, Appendix A. The slope of the bank at this location prior to the project was extremely steep. Grading the bank at this location to a shallower slope has apparently prevented mass failures. There is however, erosion at the transition of the upper slope to a slope of steeper grade leading to the channel, Figure 18. This erosion may be due to a lack of vegetation on the slope just above the channel.

**FIGURE 18.** View of north bank of Area I. Erosion at transition from stream bank to regraded hillslope is evident. Photo taken by Alicia Gilbreath on November 3, 2005.

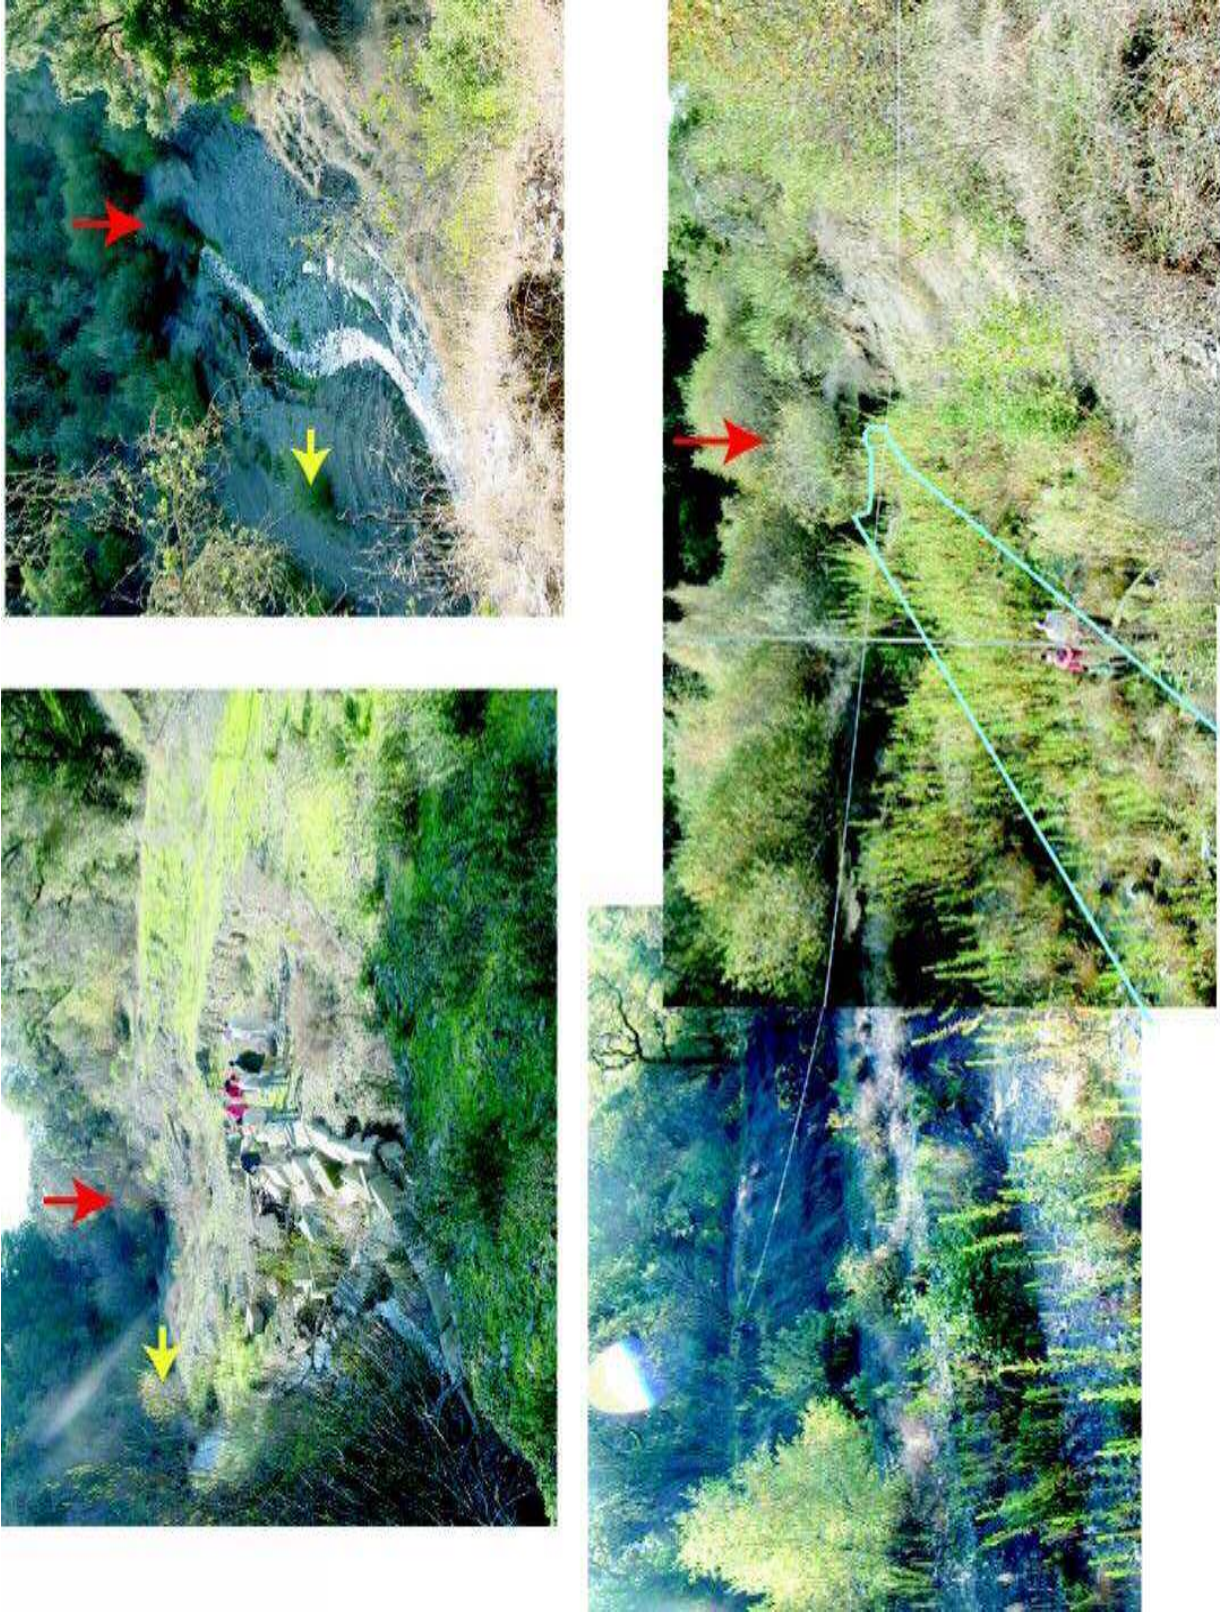
Initially, to stabilize the right bank of the channel in Area IV, four cable-anchored log structures were installed to hold the channel in its pre-project location, Appendix A. During the first winter following installation, the channel re-established itself between the middle two log structures. Based on conversations with the project engineer, Remleh Scherzinger (personal communication, 11/3/05), this failure occurred due to additional flow from an unknown gully entering the creek from the North just upstream of the first of the four logs structures, which had not been included on the pre-project survey. Regrading the bank and placing rock, vegetation, and geotextile material were performed to protect the right bank in the area where the channel is currently located, Figure 19. A second channel then formed paralleling the original as shown in Figure 19. The progression of the channel in Area IV from before the project in 1998 until our post-project appraisal in November 2005 is seen in Figure 20. Comparing the vegetation highlighted by arrows in this progression, the channel appears to have incised since the completion of the project.

**FIGURE 20.** Photo sequence of Area IV looking downstream in 2003 (top two photos) and 2005 (bottom two photos), showing progression of channel and development of secondary channel. Top two photos courtesy of SCWA, bottom two photos by Alicia Gilbreath on November 3, 2005.
