Hydrology and channel form of an urban creek : Rheem Creek in the context of restoration efforts

Final Draft

Carolina Balazs and Micah Lang
Energy and Resources Group
University of California, Berkeley

May 13, 2005

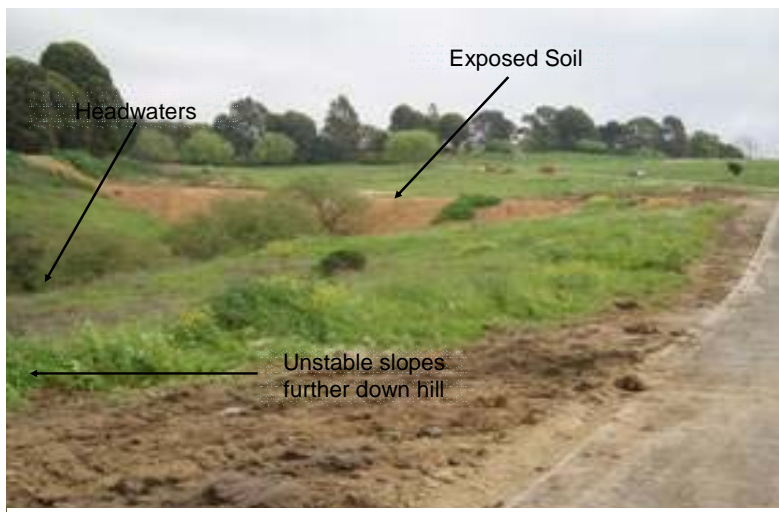
Rheem Creek emerges from the Rollingwood Hills in a narrow gulch that bisects the Rolling Hills Memorial Cemetery. The rim of the gulch is bordered by a cemetery access road to the south, burial plots to the east, a wooded buffer zone to the north, and Interstate-80 to the west. Immediately upstream of the area where Rheem Creek first coalesces into a discernable flow, large volumes of soil and fill material have been pushed onto the slope leading down into the gulch. Similarly, a strip of soil with no vegetation alongside the road near the southern rim of the gulch points to potential dumping activity.

Photo 1 – The headwaters of the Rheem Creek in the Rolling Hills Cemetery.

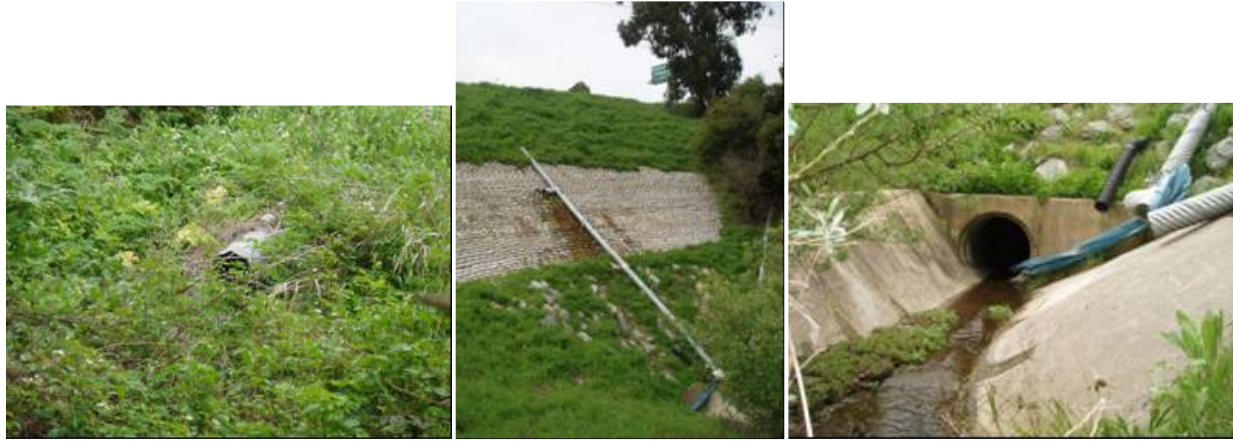
The entire length of the southern slope that leads down to the Creek is unstable. Large sections of the slope are migrating downhill towards the Creek. Several storm water pipes drain into the bottom of the gulch from the upper slopes (Photo 2). For all but the lower 25 feet, the streambed is densely vegetated with blackberries, poison oak, and willows. Native oaks are located on the slopes leading down to the Creek.

Photo 2 – Drainpipe emptying into the Rheem Creek gulch in Rolling Hills Cemetery

Photo 3 – Drainpipe leading from I-80 to Rheem Creek in the Rolling Hills Cemetery.

Photo 4 – Drainpipes entering Rheem Creek as it leaves Rolling Hills Cemetery beneath I-80.

The last 100 feet of bank and adjacent slope, before Rheem Creek enters a cement channel and disappears through a culvert beneath I-80, has been cleared of trees and equipped with 4 storm water drain pipes, which drain directly into the Creek (Photo 3, 4).

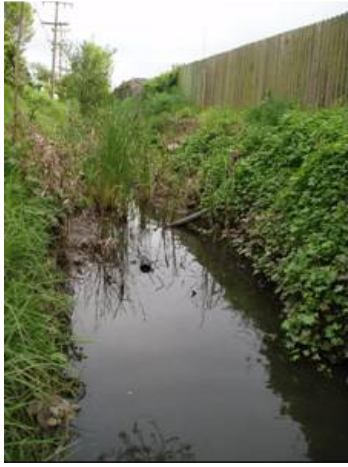
In the Rollingwood neighborhood at Shane and Fordham Streets, Rheem Creek is boxed-in by single family homes, with fences and backyards within 5-15 feet of the stream bank (Photo 5). At its widest, the riparian corridor is 25 feet from left bank to right bank. Our visual observations indicated that water quality was poor. In especially stagnant pools the water had a black, sludge-like appearance, with strong sulfur and sewer odors (Photo 6). Disturbing the sediment layer on the stream bed initiated the release of

Photo 5 – Rheem Creek in Rollingwood Neighborhood

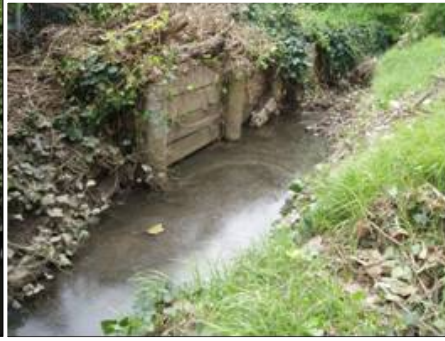
Photo 6 – Stagnant water and unstable bank

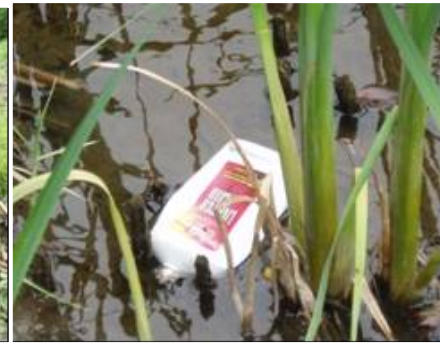
gases, which continued to bubble to the surface for several minutes. Garbage, including paint cans, spray paint bottles, shampoo and soda cans, was scattered in the stream and along the stream banks (Photo 7). Two dead rats were observed floating in the water (Photo 8). In one 400 foot stretch, we observed at least three homes with informal pipes that empty into the stream (Photo 9). The culvert that stretches beneath Fordham Street was submerged except for the top five inches (Photo 10).

Photo 7 – Garbage in Rheem Creek

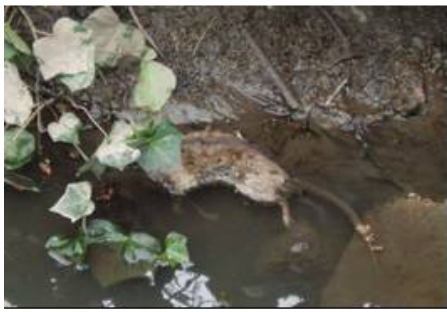
Photo 8 – Dead rat in Rheem Creek

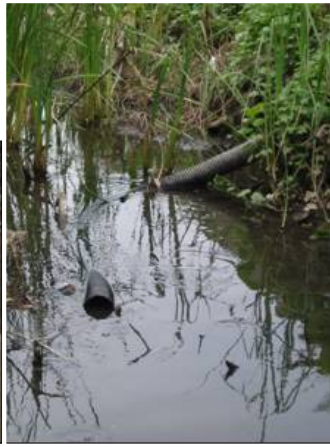
Photo 9 – Informal drain pipe from a house

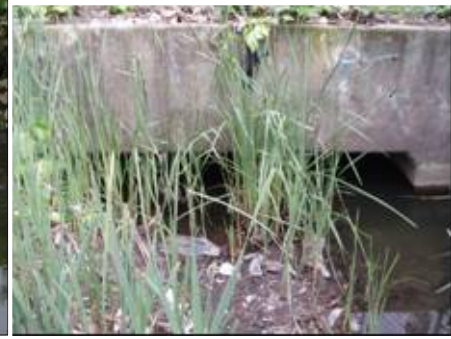
Photo 10– Downstream opening of culvert at Fordham St

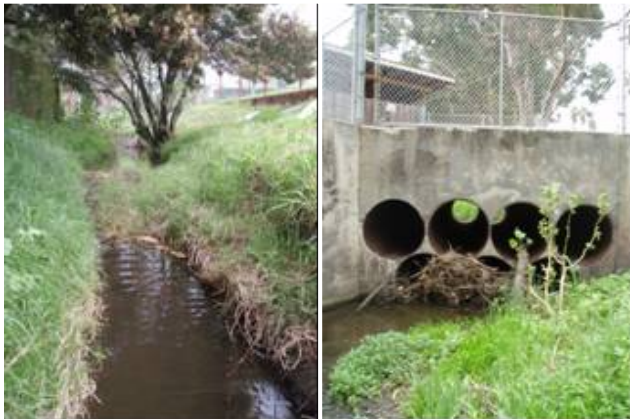
As Rheem Creek flows through the grounds of the College, the water quality and riparian corridor health are much improved from the conditions in the Rollingwood neighborhood. Within the first 150 feet, at the upstream reach of the College, there was minimal suspended sediment in the water, but a faint sewer odor could be discerned, not unlike that which plagued the Creek further upstream (Photo 11).

Photo 11 – Upstream extent of Contra Costa College campus, looking into the Rollingwood neighborhood

Photo 12 – Looking downstream at a debris-constricted culvert at bottom of Reach 1 on Contra Costa College campus

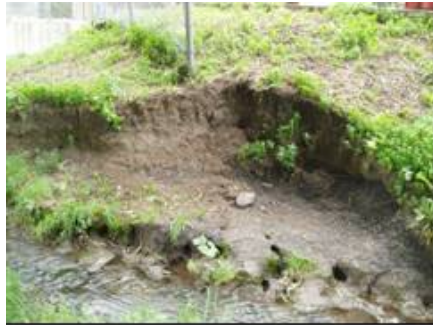
Photo 13 – Bank erosion in Reach 1

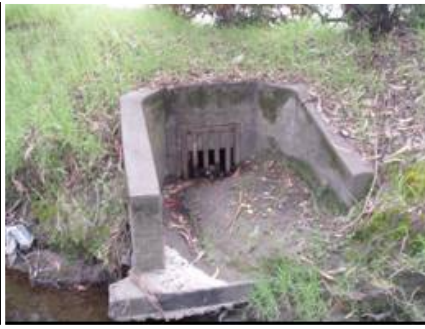
Photo 14 – Creek overflow grate in Reach 2 (waypoint 28)

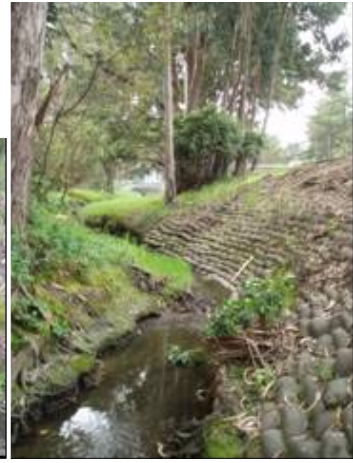
Photo 15 – Sackrete lined bank looking downstream from top of Reach 3

On a related note, the sackrete-lined right bank of Reach 3 appears to accelerate stream flow, resulting in deeper streambed depths and more variation in the streambed elevations. This is in contrast to the conditions of Reach 4 and Reach 5, where a wider floodplain appears to result in much less pronounced streambed elevation changes and shallower streambed depths (See figures G-1 and G-2 in Appendix G). In sum, human constructed gradient and channel width changes in the form of streambank reinforcement and culverts appear to be largely responsible for the hydrologic variance within and between reaches. Another indication that the hydrologic differences between the three reaches are due, in large part, because of the culvert and sackrete bank reinforcement is the difference in water surface elevation slopes. The emerging pool-riffle sequences in all three reaches *could* also be an indication that despite channelization and the presence of numerous stormwater pipes, Rheem Creek is regaining some of its original character.

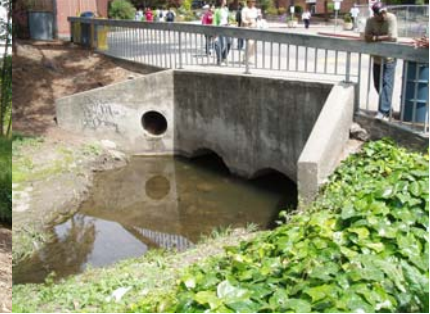
Photo 18 – Downstream end of culvert at Castro St. at top of Reach 4

Our survey at the College highlights the importance of considering the effects of the culverts and streambank modifications on channel conditions. The concrete lined culvert underneath Castro Street has resulted in the formation of a large pool (1.8 feet deep on the day we measured it) on the downstream end and a nick point resulting in a shallow pool on the upstream end of the pool. The culvert and road that separate Reach 3 from Reach 4, and the sackrete bend at 800 ft, appear to be having a significant effect on the flow and channel form of the Creek.

potential for a campus-wide stream restoration project. We recommend that such a plan attempt to remove or improve the culverts (specifically, their ability to transport water on high flow days), remove non-native vegetation, and have design efforts take into account the 5 separate reaches identified.

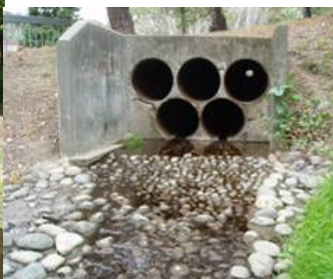
Photo 20 – Tributary joining Rheem Creek at bottom of Reach 4

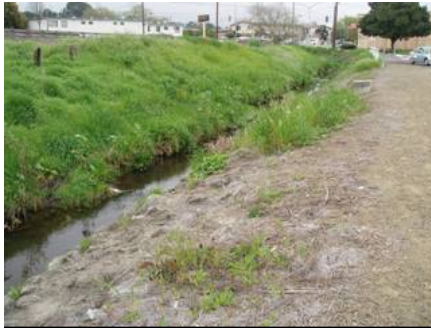
Downstream of the College, Rheem Creek travels underneath San Pablo Avenue, and surfaces at Wanlass Park. Visually, there was no discernable difference in water quality between the turbid, grayish brown water that flowed through Wanlass Park and the College. A grazed or mowed meadow flanks the right bank of the Creek, while a gravel access road hugs the left bank approximately 8 feet from the stream. Dead grass at the streamside edge of the access road appeared to be killed using herbicides. At the downstream end of Wanlass Park, Rheem Creek enters a concrete channel, which crosses underneath 20th Street and continues through a residential neighborhood in its channeled form. Garbage was strewn along the stream and in the stream channel (Photos 23 – 25)

Photo 23 – Looking upstream toward San Pablo Ave in Wanlass Park

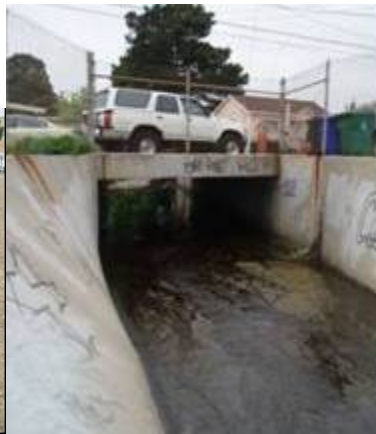
Photo 24 – Looking downstream at the 20th St. culvert

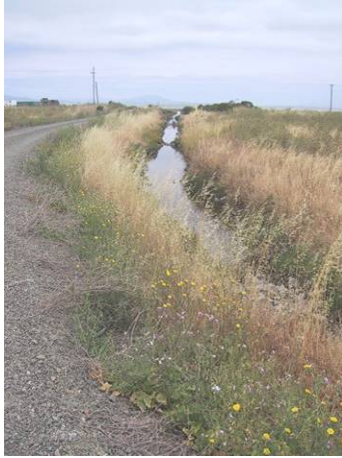
After emerging from Giant Road, Rheem Creek flows through Breuner Marsh and enters San Pablo Bay. As it flows through Breuner Marsh, Rheem Creek parallels a dirt access road in a straightened channel with a consistent width of approximately 8 feet. Mixed native and non-native grasses dominate a flat, featureless landscape. The riparian corridor is hundreds of feet on either side (with the exception of the access road along the left bank) with promising potential to restore native vegetation and stream sinuosity. (Photo 26).

Photo 26 – Breuner Marsh looking downstream toward San Pablo Bay (photo courtesy of the Natural Heritage Institute)
