Post-project appraisal of Martin Canyon Creek restoration

Post-Project Appraisal of Martin Canyon Creek Restoration

Final Project
LAEP 227
Fall 2006
Wayne Wagner
Jesse Roseman

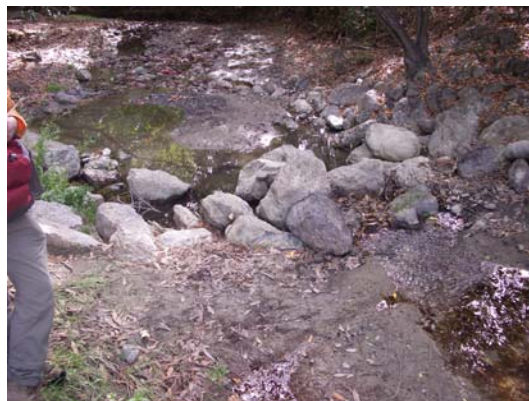
Directly upstream of the grade control structures, the stream bed is aggrading, with fine sediments collecting and visible (Figure 5). The long profile matches that expected by the project designers (Figure 6). Directly below grade control structures however the opposite trend is occurring with localized degradation. This could just be the effect of the plunge pools, but the results are more extensive than just these small areas (Figure 7).

Figure 5: Aggradation upstream of GC1

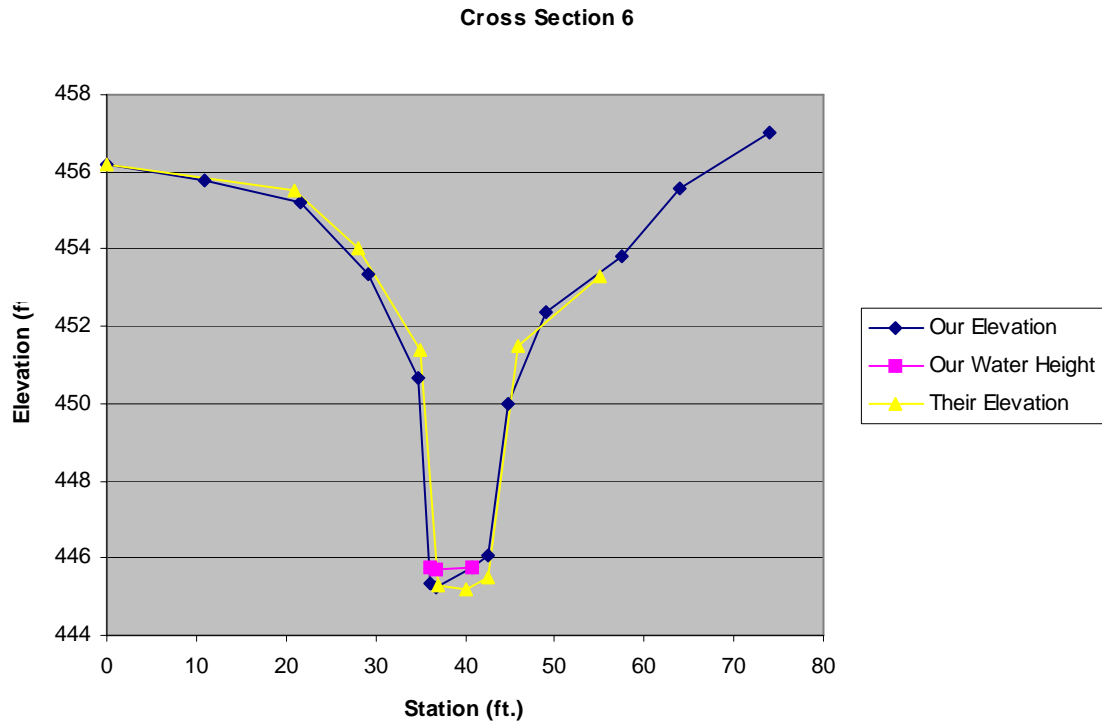
A small amount of deposition has occurred in the bed in the cross section between grade control structures 3A and 4 (Figure 8). This is probably due to the formation of a point bar and some movement of the thalweg.

Figure 8: Cross section below GC4

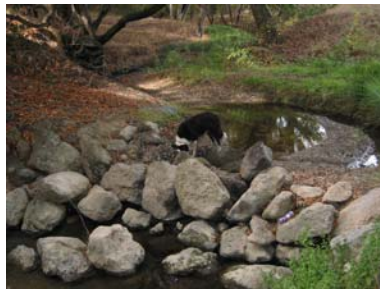
The visual and photo analysis largely supports this result, the majority appearing stable with a minimal amount of displaced rocks and scour (See figure 9 as an example and summary in Appendix 2). Grade control structure 4 however has many issues. The right and left banks have scoured downstream below the wing walls. A large number of rocks have washed out and are now downstream of the structure. This was the only grade control placed in a bend and was constructed in half the time of other structures using a different method. Interestingly the designers stated that as the entire width of structure 4 was installed simultaneously, it is likely that it would “possess greater structural integrity.”¹⁵ Its stationing was 135 feet upstream of its original placement on plans. It also had the most significant change in upstream slope, from 2.53 to .7%, a change of 1.83%.

Figure 9:GC2 from downstream appears stable

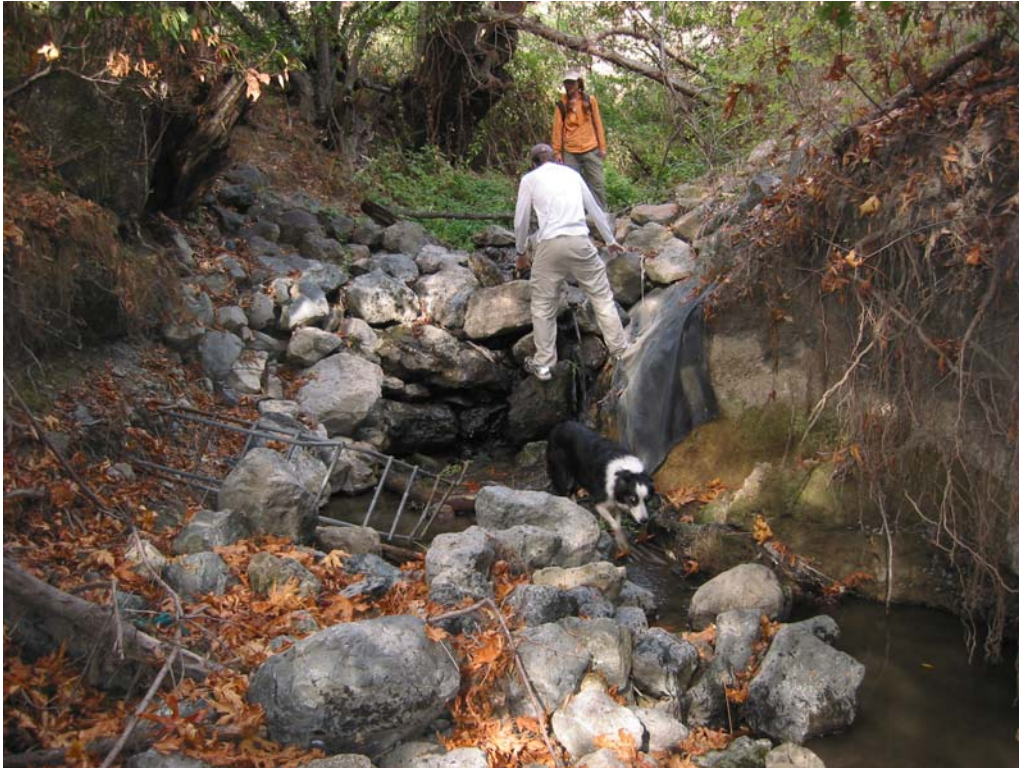
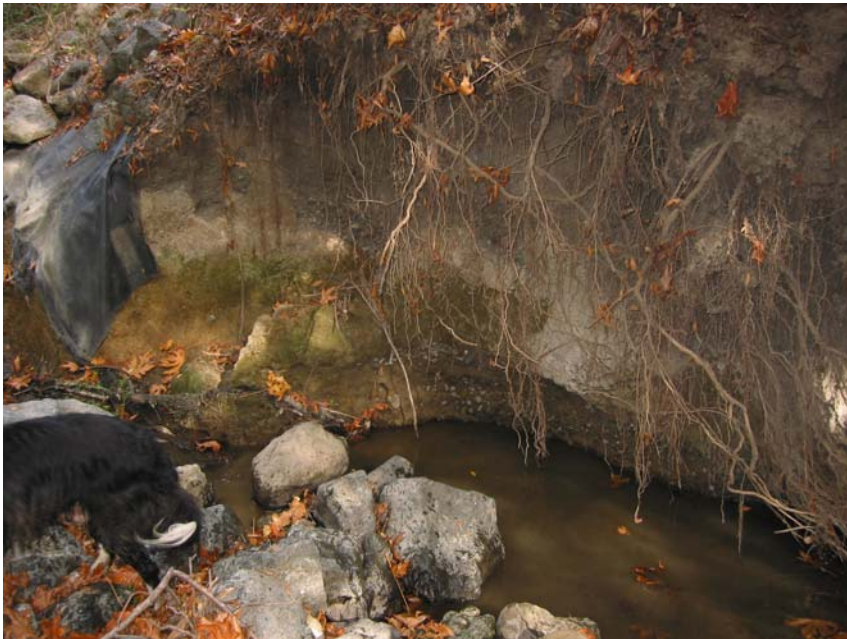
Figure 10 and 10a: GC4 from downstream with rocks in channel and sides eroded

There is some amount of maintenance that is required, particularly on GC4 and Structure 16. Should one of these fail there would be further cost than if they were fixed. Overall the structures do appear to be functioning as designed, resulting in a minimum of maintenance costs. This is further explored in the Conclusions.

The long-term effects of this project are dependant on the survival of the structures, although it is not clear that they were an absolute necessity. The project has not yet experienced flows above 5-10 year floods, and yet GC4 is already showing significant signs of wear.¹⁷ If any were to fail, the effects could override any positive effects they have so far created. GC4 seems to be the most vulnerable. The scour near GC4 may be the reason GC3A was added to the project, as early documents did not include this structure. GC4 is the only one that is built in a bend in the stream, contradicting PWA’s specifications regarding building grade control structures only in straight reaches.¹⁸ While more study is needed, one could assume that this has played some role in its progressive scour. If this structure were to fail, the slope in the channel could change dramatically in a relatively short period of time, establishing a new dynamic

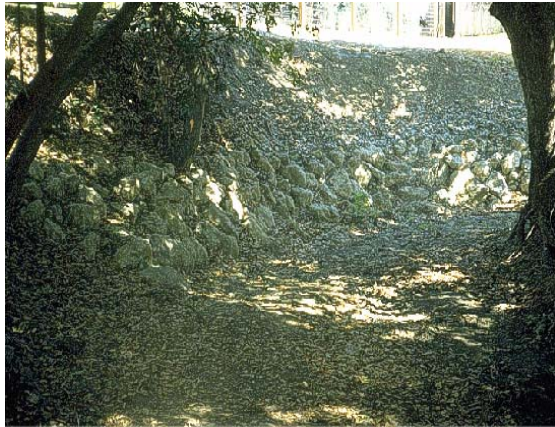
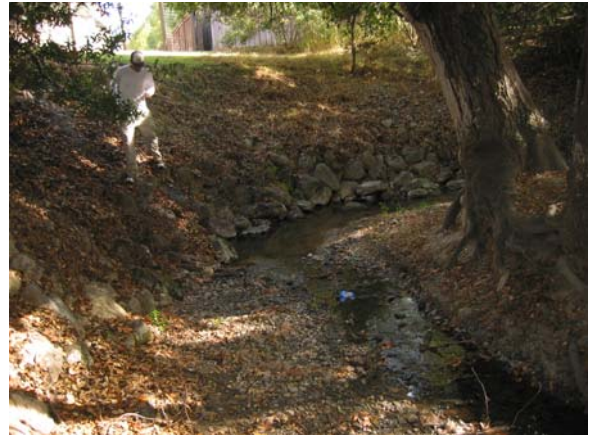
The bank stabilization structures appear to be largely intact and functioning (See figures 11 and 12, and Appendix 3 for complete notes). The most common problems with these structures were endcutting on the upstream end and loss of rocks. In addition, quite a few had exposed erosion fabric.

Figure 11: Upstream of Structure 7 1999 vs. 2006

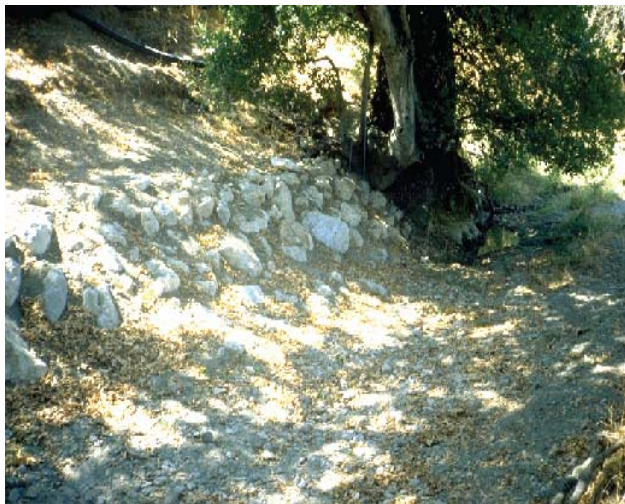
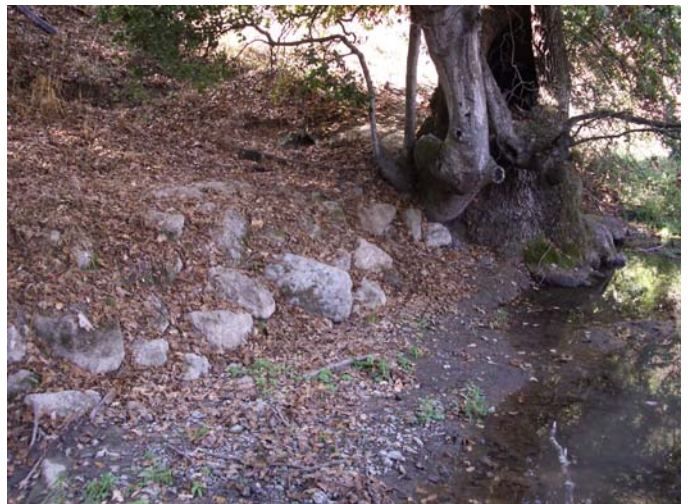
Figure 12: Upstream of structure 3 1999 vs. 2006

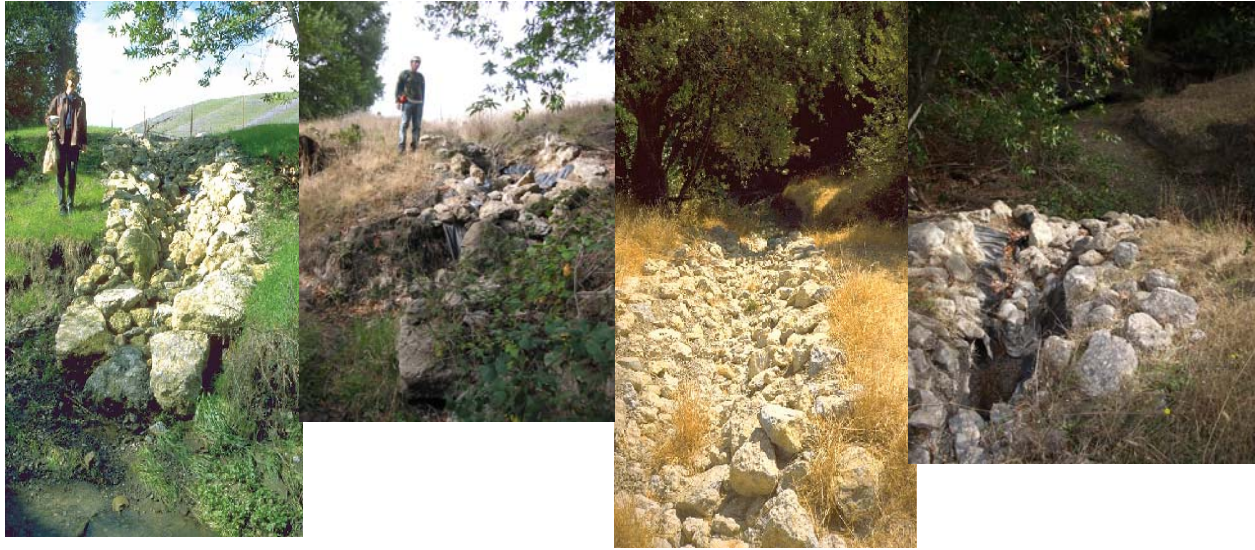
Structure 16 was designed to drain the ranch road into the creek and prevent erosion. The erosion fabric and rocks placed to prevent erosion have not performed however, and a large nick point is moving up this drain towards the ranch road (See figure 13).

Figure 13: Structure 16 storm drain
