Post Project Appraisal of Village Creek Restoration, Albany, CA

# **Post Project Appraisal of Village Creek Restoration, Albany, CA**

**LA 227 Restoration of Rivers and Streams**

*December 12, 2005*

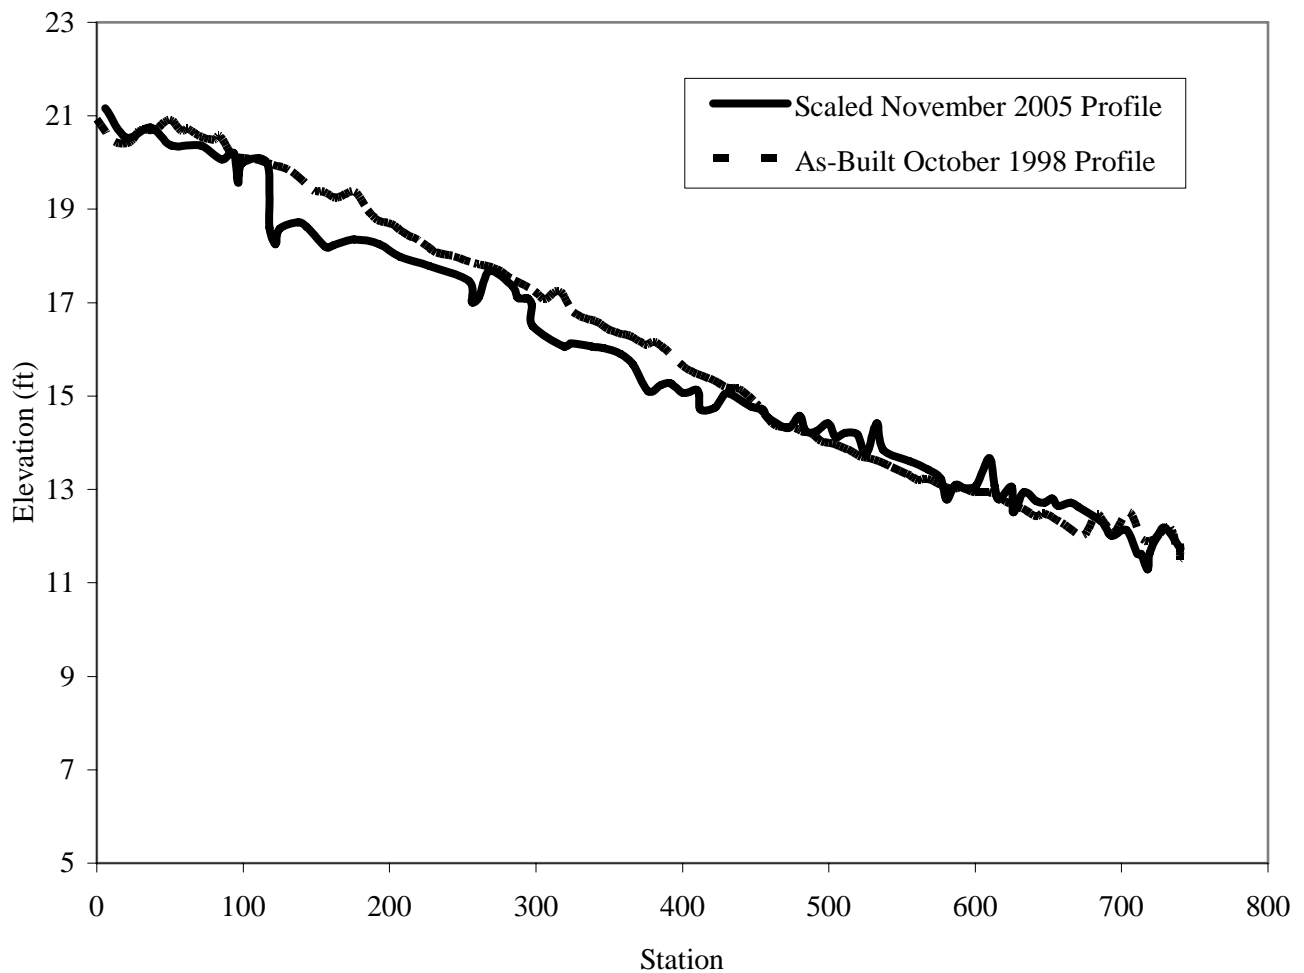
**Figure 4: Scaled Long Profile Comparison**

The channel has become more complex since its first construction in 1998 (Figure 4). The elevation of the creek in the mid-section, from approximately 100 feet to 500 feet from the upstream culvert, has eroded resulting in a less uniform channel slope than the as-built channel.

Some areas of the channel have scoured to form small pool areas, increasing the possibility of aquatic habitat in the creek. However, the lack of base flow eliminates the possibility of sustainable aquatic habitat year round, while only providing habitat for birds and insects during the rainy season.

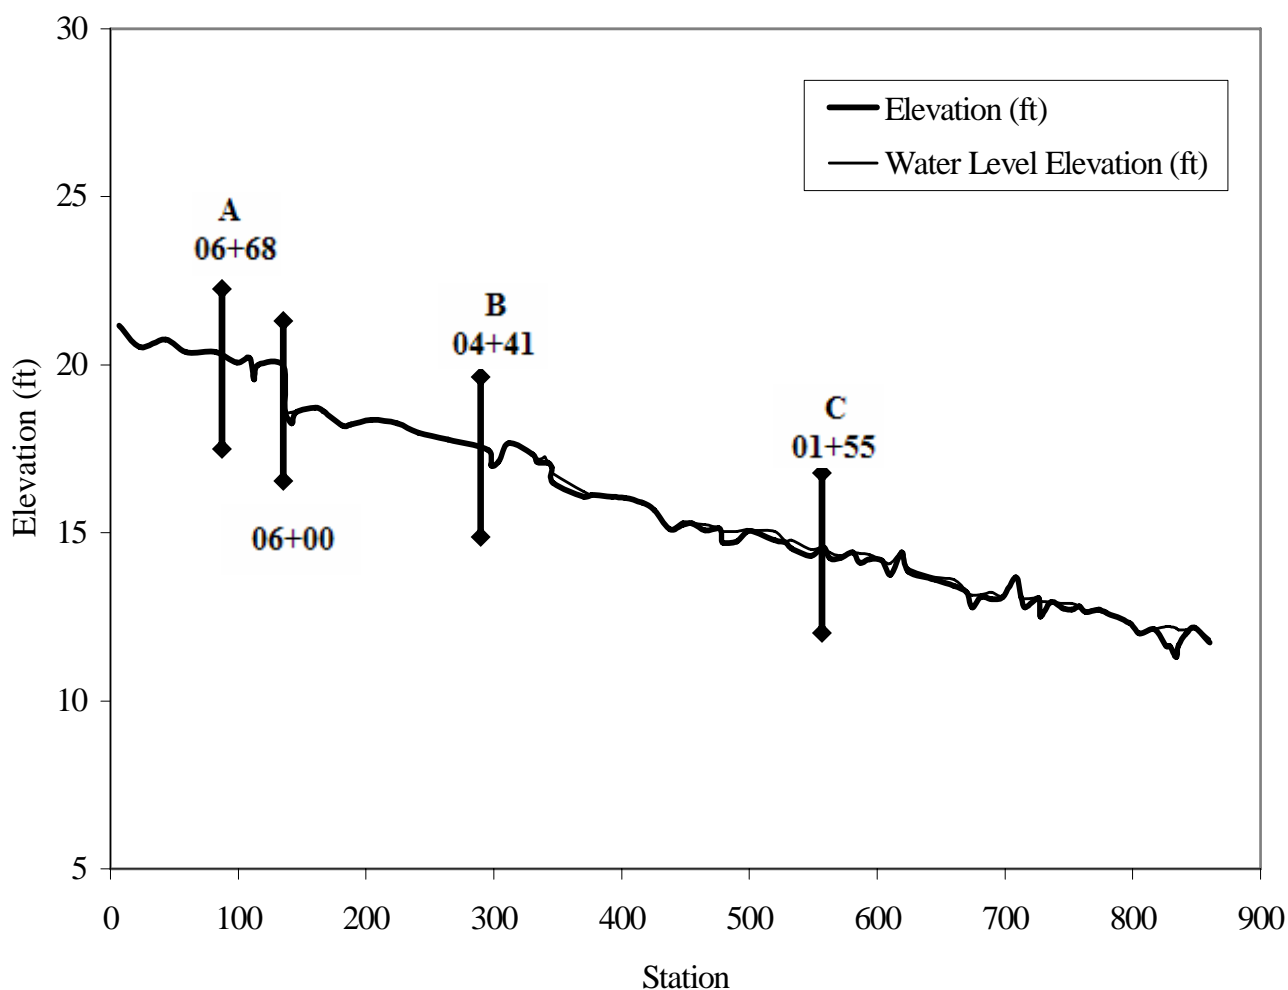
*Figure 5: Longitudinal Profile with Water Depth (November 2005)*

A graph of the longitudinal profile reveals that the channel ranges from an elevation of 21.16 at the upstream culvert to an elevation of 11.74 at the downstream culvert. The pool and riffle structure of the channel currently consists of a mostly dry bed with several small pools of standing water with the largest pool at around 830 feet from the upstream culvert and a large,

scour pool around at Station 06+00 (Figure 5). The thalweg of the channel is approximately 860 feet long, thus the average channel slope is 0.011 feet/feet, same as that of the as-built slope (Table A.2). It is evident therefore that even though the average channel slope is the same as the as-built slope, the complexity of the channel's thalweg has changed.

portion of the creek can lead to flooding near the upstream culvert. In the future, sediment augmentation may become necessary to replenish the lost sediment in the middle reach. We recommend installation of rock or log weirs to minimize channel erosion as well as close monitoring of the headcut.

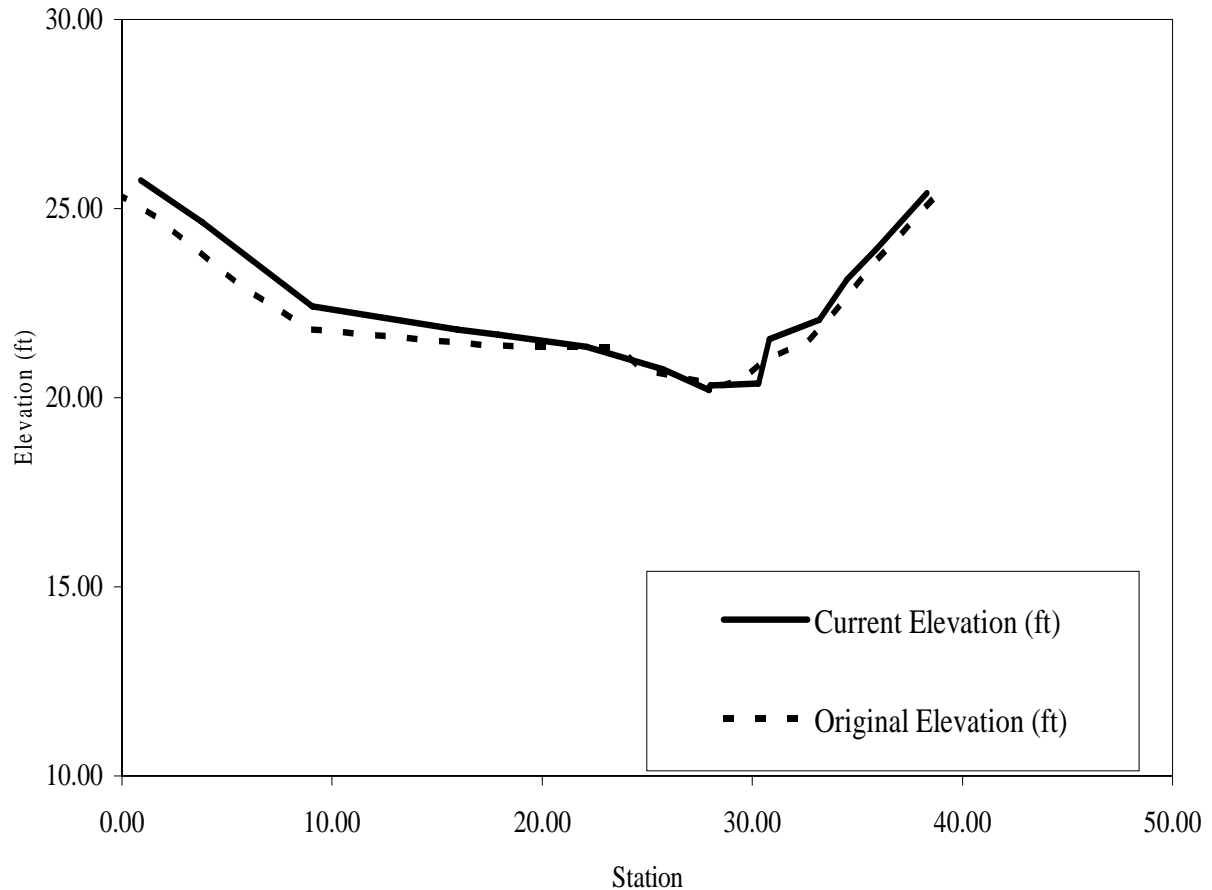
*Figure 6. Cross-section A (06+68) - Looking Downstream*

The three completed cross-section surveys showed slight changes in channel form. Cross-Section A at station 06+68 (Figure 6) shows the current ground elevation, water level elevation and the as-built ground elevation. As seen from the figure, there was a slight change in the channel bed. Due to both deposition in channel bed and erosion along channel bank, the left bank is now less distinct. The current left upper bank slope has a grade of 1.5 and the right slope a grade of 2.4. The as-built slopes were at a grade of 1.57 and 2.56 for the left and right upper banks, respectively. Since we are unlikely to be at the exact same location as the original cross-section, these slight changes do not conclusively indicate change in slope. The incision of the channel bed has resulted in the formation of a stagnant pool in this area with 0.09 feet of water, which has no noticeable aquatic life.

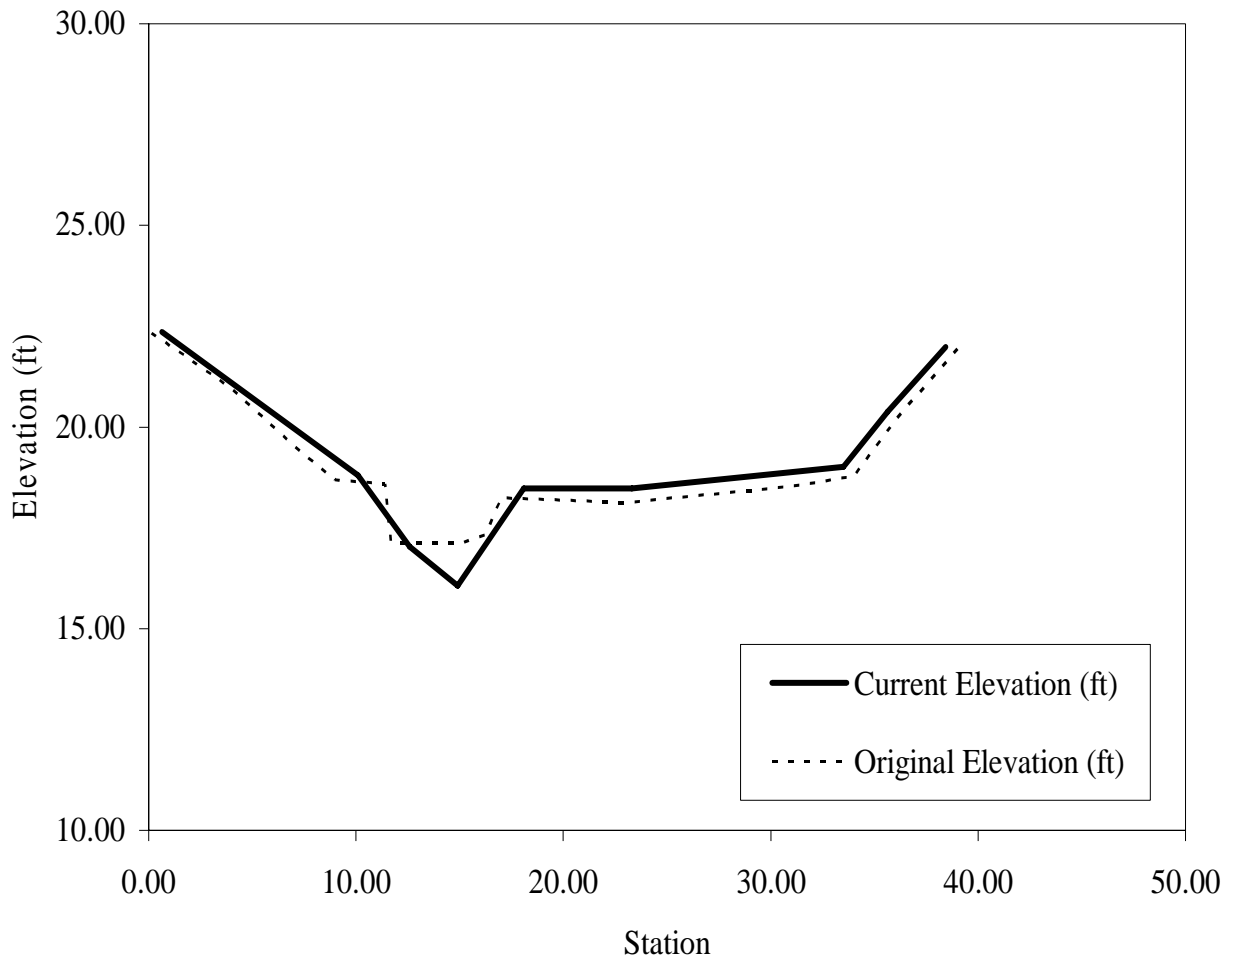
***Figure 7. Cross Section B (04+41) - Looking upstream***

In Cross-Section B at station 04+41 (Figure 7), it is evident that there is significant scour of the channel bed. The originally designed channel bed was at an elevation of 17.1 feet above Mean Sea Level, while the new elevation of the bed is at 16.07 feet, implying almost 1 foot of scour. There is also some erosion of the right and left bank due to this incision. The as-built slopes were at a grade of 1.59 and 2.4 for the left and right upper banks respectively. The current upper bank slopes have a grade of 1.66 and 2.67, indicating little change in upper bank slope.

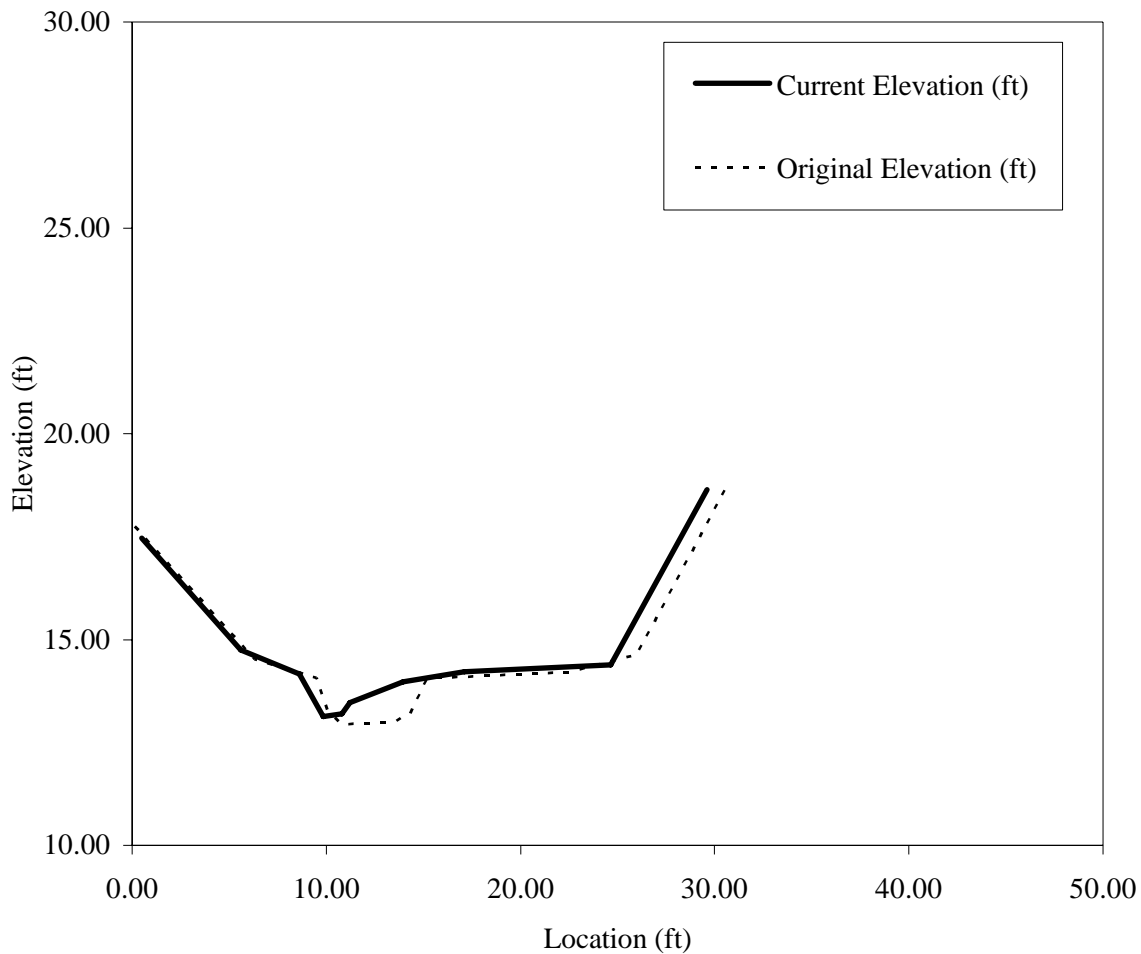
*Figure 8. Cross Section C (1+55) - Looking upstream*

Cross-Section C at station 01+55 is located at the apex of a meander bend (Figures A1-3) and its cross-section (Figure 8) shows significant deposition on the right, inside bank with no significant change in upper bank slope. The as-built left and right upper bank slopes had a grade of 1.9 and 1.13 respectively, while the current slopes were had grade of 1.88 and 1.16. This figure also shows deposition of sediment on the left, outside bank of the channel bed. This type of bed evolution is congruous with the fact that the cross-section is a turning point in the meander, where velocities on the inside of the channel curve are significantly less than those on the outside of the channel. However, in this case, the area of sediment erosion is less than the

area of sediment deposition. Therefore there has been more deposition on the inside bank than erosion on the outside bank, resulting in a reduction of the bed flow capacity.

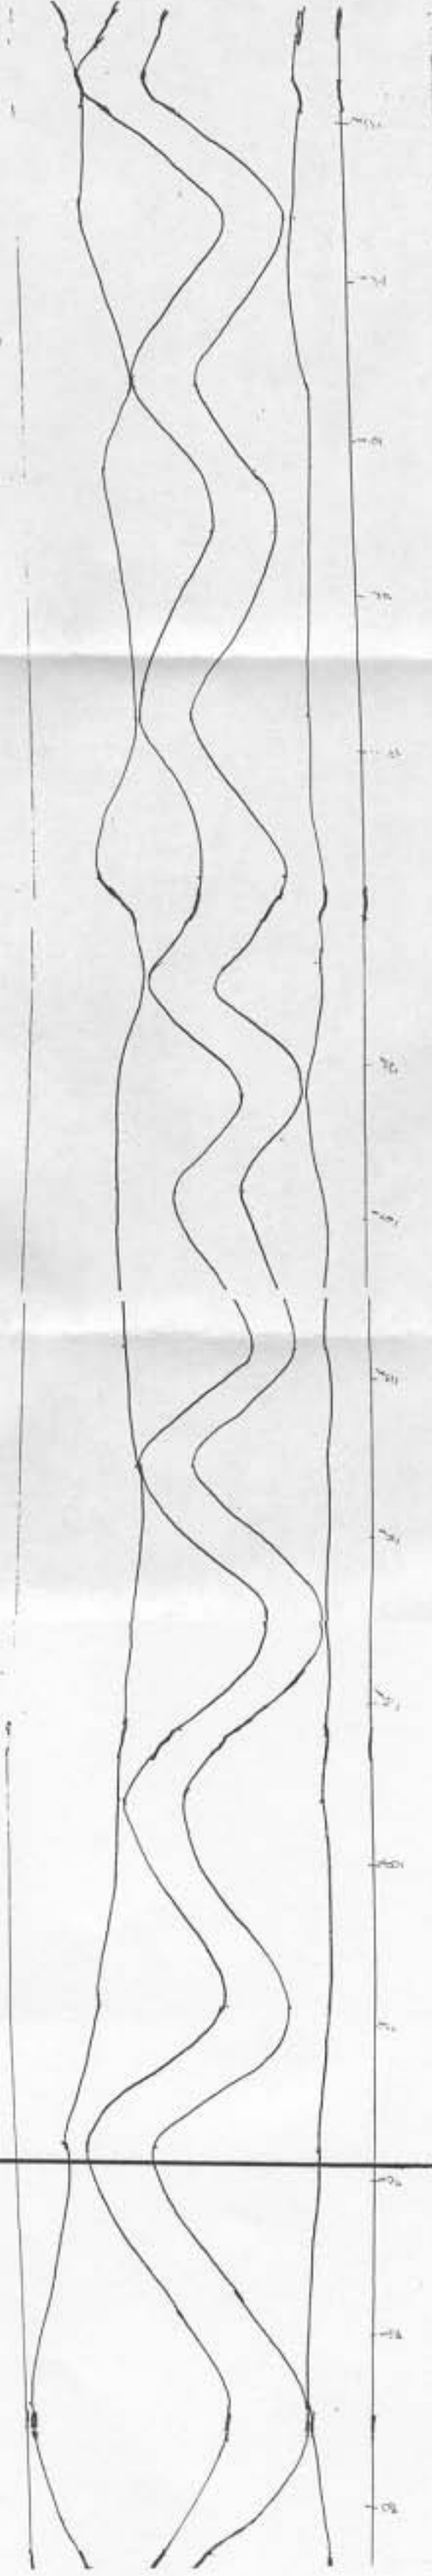
Figure A.2: Channel Map - Section 2

The channel map shows the evolution of the channel bed since 1998. The general shape of the channel has not significantly changed except for slight movement in some meanders (Figures A.1-3 and B.1-3). One significant difference is that the current channel bed changes directions 41 times during the 740 feet between the two culverts, while the as-built channel shape included 42 changes. The bend located at approximately 250 feet from the upstream culvert (04+90) has straightened since the restoration. We found that there is 860 feet of meander for the 740 linear foot reach. This results in approximately 116 feet of meander per 100 linear feet. Although we do not know the as-built meander length, the design called for 160 feet of meander per 100 linear feet. Therefore, the current channel contains about 324 feet less meander than the original design. Considering the channel shape has not changed significantly, except for the loss of one meander bend, the as-built meander length could not have been the design length of 160 feet per 100 linear feet. It would have been slightly larger than the current ratio of 116 feet of meander to 100 linear feet.
