Gully incision in Gerbode Creek, Rodeo Lagoon watershed

Title: Gully Incision in Gerbode Creek, Rodeo Lagoon Watershed

Raymond L. Costantino
Dept. City and Regional Planning
University of California, Berkeley
Final Paper
December 17, 2003

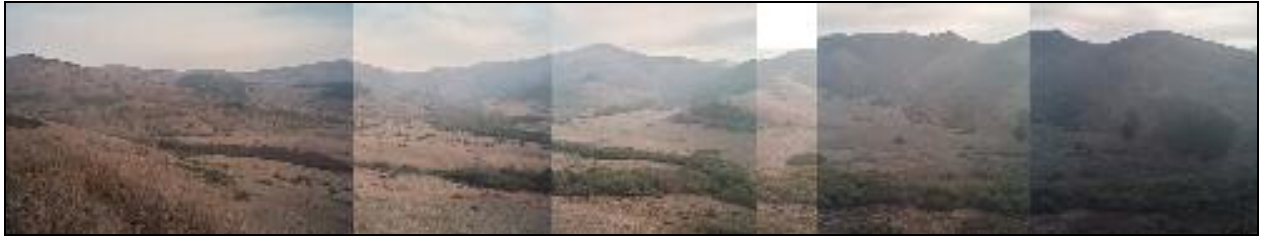
Observations: The Northern Tributary #1 is below the Miwok Trail and runs 400 feet. Riparian vegetation primarily consists of Willow trees. However, there is a stretch in the middle that is less vegetated (Point C) and is covered with Coyote Bush and grasses.

Figure 2. View the confluence of the North Tributary #1 and the main stem. I took these photos from Miwok Trail looking down into Gebode valley. Notice that the riparian vegetation on the creek in the foreground dies out in the middle and then appears again.

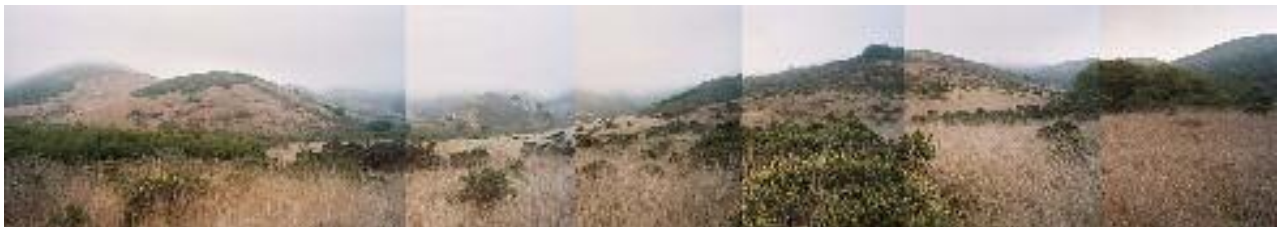
Observations: The Southern Tributary passes through a culvert under Bobcat Trail and has riparian vegetation on its banks for most of its stretch. The majority of its banks are covered with willows. However, the middle section, represented by points C through F, is filled with sediment and covered with wetland grasses and Coyote Bush. An old wooden road structure crosses the tributary over this middle section. Head cuts are forming gullies closer to the confluence at points M, K and H.

Figure 3. View the riparian vegetation on the South Tributary. The left side is down stream near the confluence and the right side is up stream near the source. Notice the dense riparian vegetation down stream and up stream, while the middle is less vegetated with Coyote Bush and grasses.

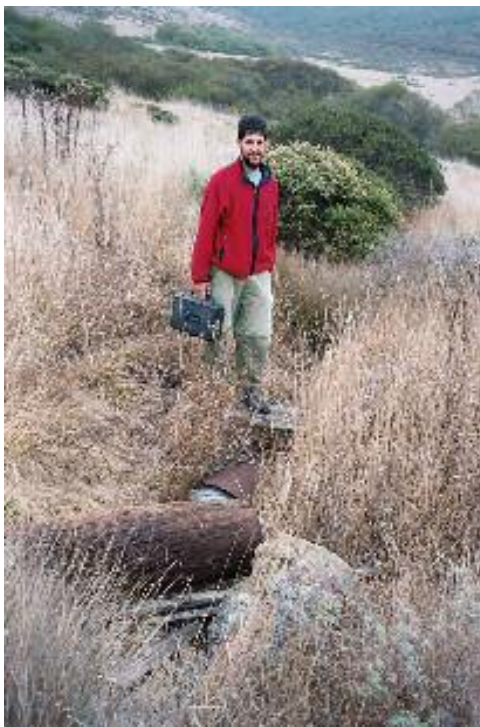
Observations: Northern tributary #2, seems to be an old ditch and runs 437 feet along side of Northern Tributary #1. An old road traverses the creek at point D and there are remains of an old culvert (Figure 4&5). The surface of the ditch is covered with grass for the entire stretch. The creek has several gullies that cut through its bed (Figure 6). No grass grows inside gullies

Figure 4. David Shaw standing on

remnants of old bridge and culverts
on the North Tributary #2.

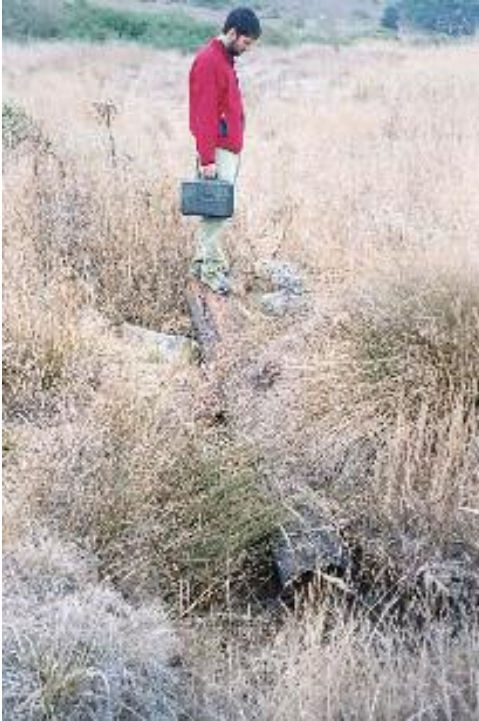
Figure 5. David Shaw standing on
remnants of old bridge and culverts
on the North Tributary #2.

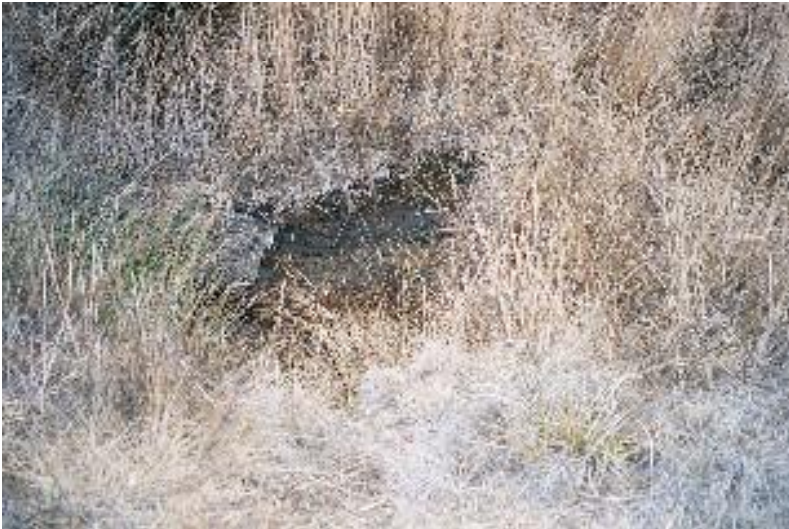
Figure 6. An exposed gully North Tributary #2.

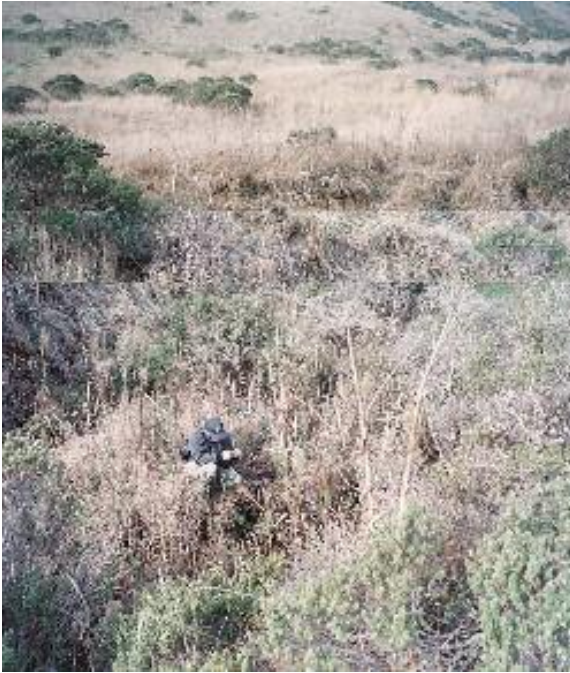
Figure 7. David Shaw inside a section of North Tributary #2. The Coyote bush on the bottom right corner shows where the right bank starts. The Coyote Bush on the top left corner shows where the left bank ends. The channel is filled with grass.

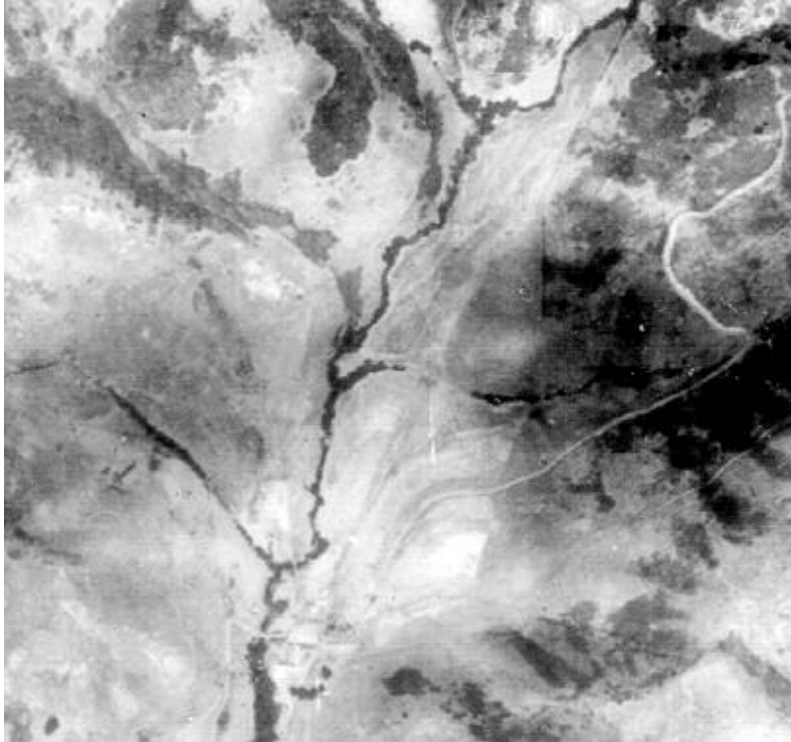
I compared the aerial photos from 1940, 1960 and 1996 it seems that riparian vegetation has reestablishing itself along the banks of North Trib. #1 and South Trib. I also looked for changes in channel form and old roads that could have impacted the creek. There was no evidence of changes in channel form. However the 1940 photo shows more agricultural and less riparian vegetation. It also shows remnants of a bridge and road in the vicinity to North Trib. 2. The 1960 photo shows the same type of evidence. All photos show less vegetation on the hills surrounding North Trib. 1 and 2., compared to South Trib. This might be the reason why North Trib.1 has four times more sediment transport than South Trib. (Figures 8,9&10)

Figure 8. Aerial photo of the site in 1940.

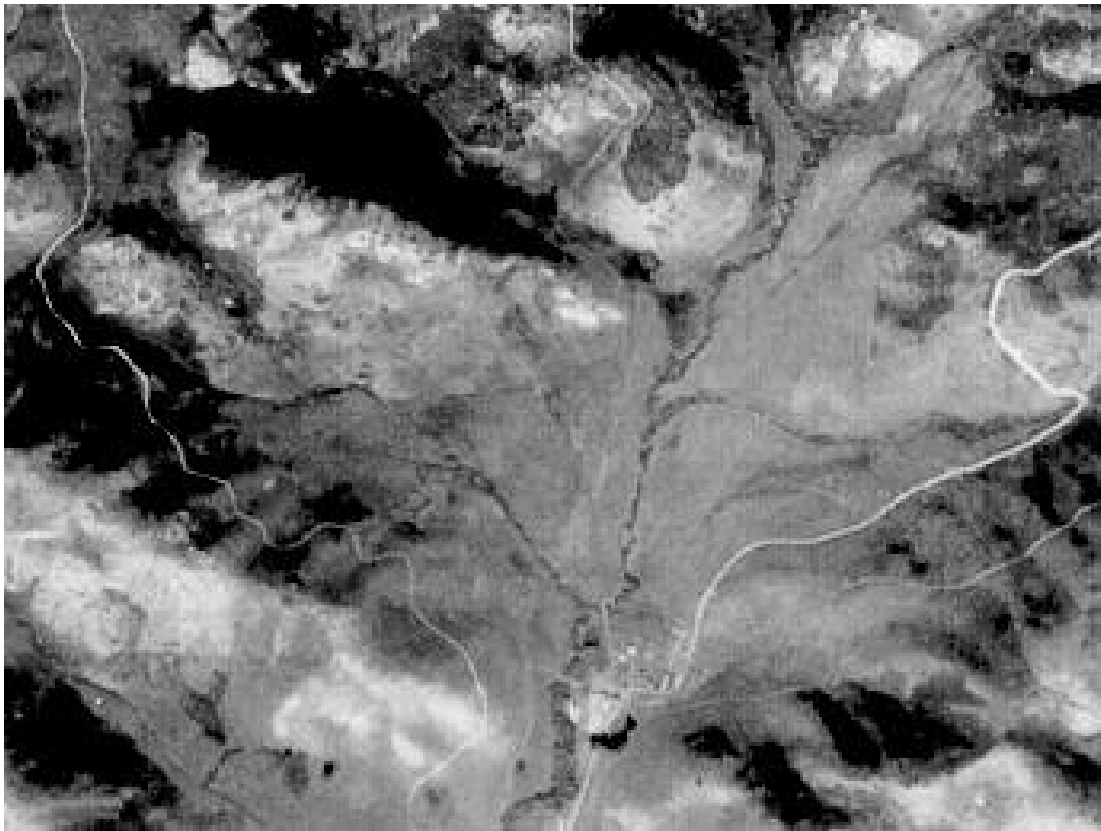
Figure 9. Aerial photo of the site in 1960.

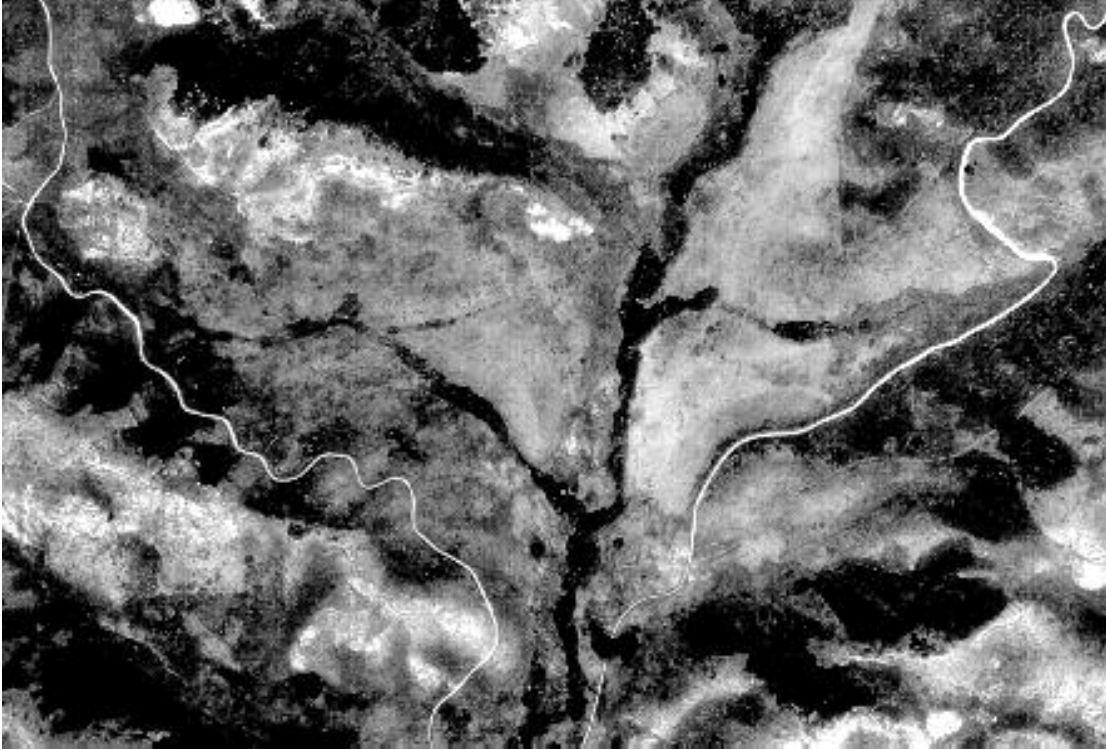
April 1996	The entire stretch looks re-established. The middle section has a thin line of green but much more	The bridge and the road are no longer visible, but there are green lines in the landscape that suggest	The vegetation in the upper and the lower parts of the stretch have grown significantly and are

Figure 10. Aerial photo of the site in 1996.
