Evaluation of Riparian Restoration to Enhance Anadromous Fish Habitat along a Napa County Stream

Final Draft
January 30, 2008

Christine O. Gaber
LAEP 227

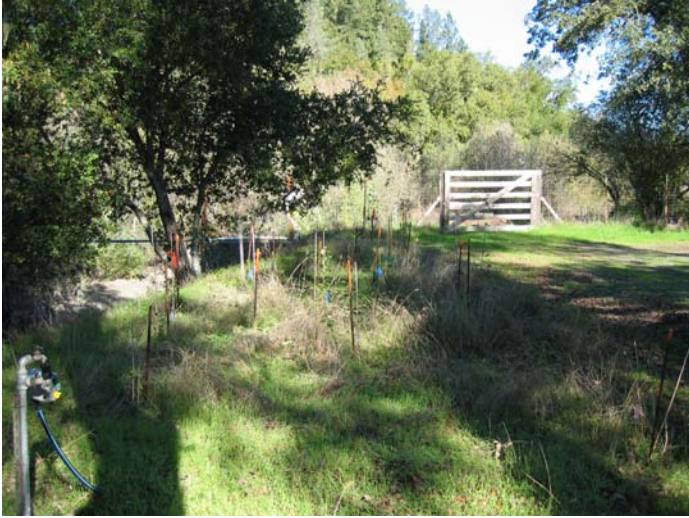
Near Shed Area – facing downstream

Area A consists of three subareas along the Project Stream: Near Shed, Downstream of Dam, and Opposite Bank (Figures 1 - 3). Both the Near Shed and Opposite Bank subareas are located under existing riparian canopy just upstream of the wingwalls and sill that remains from the old check dam removed as part of the project. A dirt road runs adjacent to the eastern side of the Project Stream and the Near Shed subarea. This side of the Project Stream lacks cattle exclusion fencing at this location but it does not appear that livestock have access to this area. The Opposite Bank subarea is located along the top of bank and along a lower terrace of the western bank. The western side of the Project Stream is fenced to exclude cattle in the adjacent pasture from entering the stream.

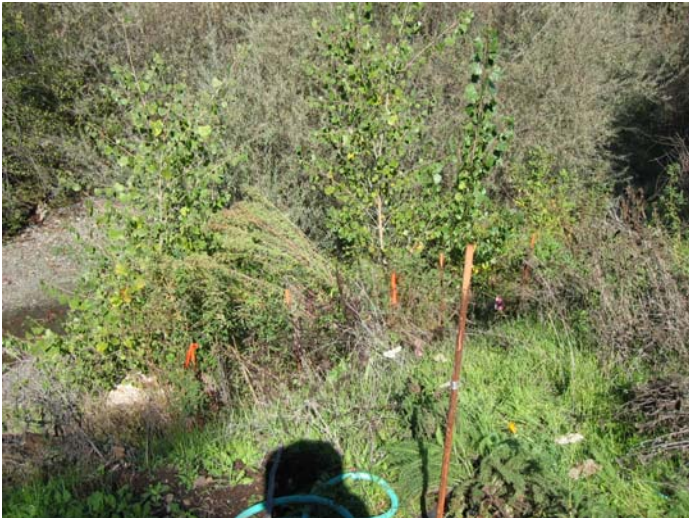
The Downstream of Dam subarea forms the largest portion of Area A. Plantings occur from the top of the bank down to the toe of the channel under the existing willow canopy. The older California wild rose, cottonwood, dogwood and Oregon ash plantings located low on the banks of the Downstream of Dam subarea were mostly in healthy condition, indicating good placement of these plantings along the stream bank. Fencing excludes cattle from this area but some browse protectors are missing and evidence of wildlife browsing exists. Vegetation differences above and below the dam are consistent with other

**Downstream of Dam Area – facing stream,
showing successful cottonwood plantings**

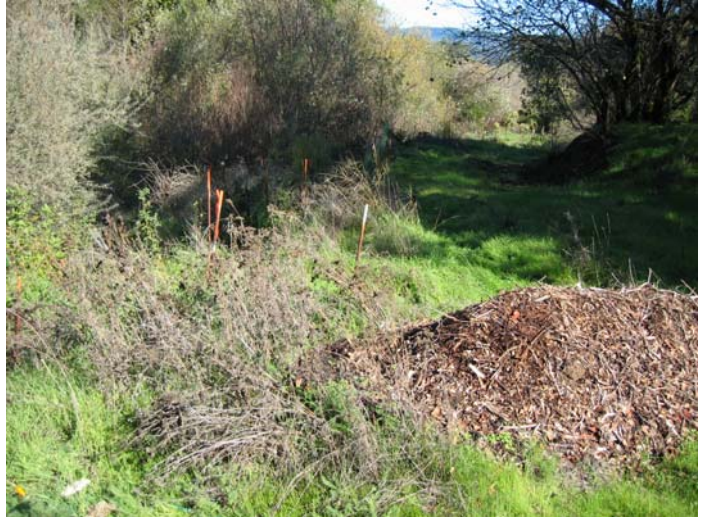
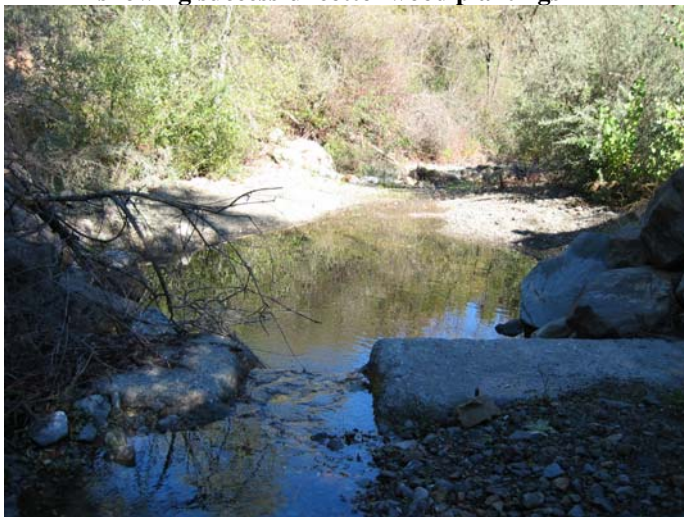
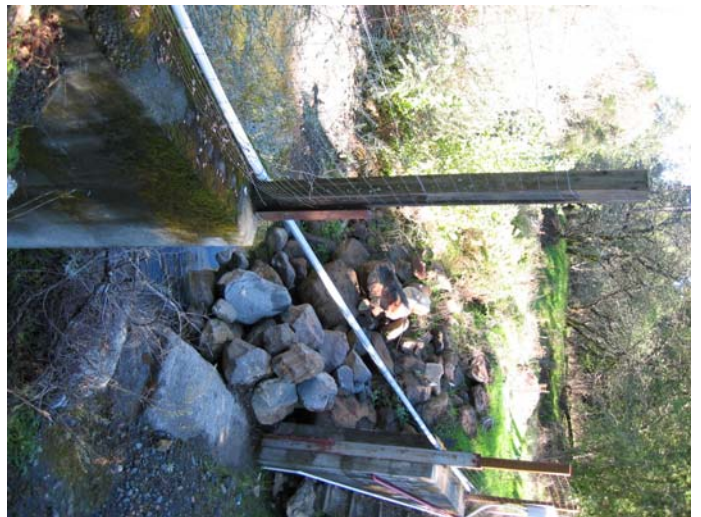
studies that report higher canopy cover and vegetation height upstream of check dams (Bombino et al. 2006). The Downstream of Dam subarea is a much more open reach that lacks the high canopy cover and stream shade of the dense tall oaks and other woody species present upstream. The willows along the lower banks do not extend all the way over the channel or across the floodplain (Figure 2). This reach is also wider than upstream, partly due to bank scour that occurred after the January 2006 flood (Napa County RCD 2006).

Downstream of Dam Area – facing downstream

Downstream of Dam Area – at old dam

Downstream of Dam Area – facing revegetation area

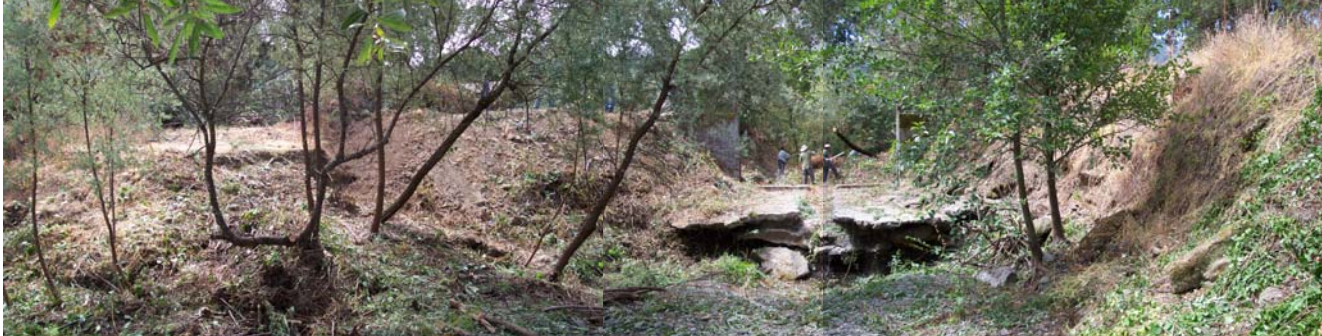
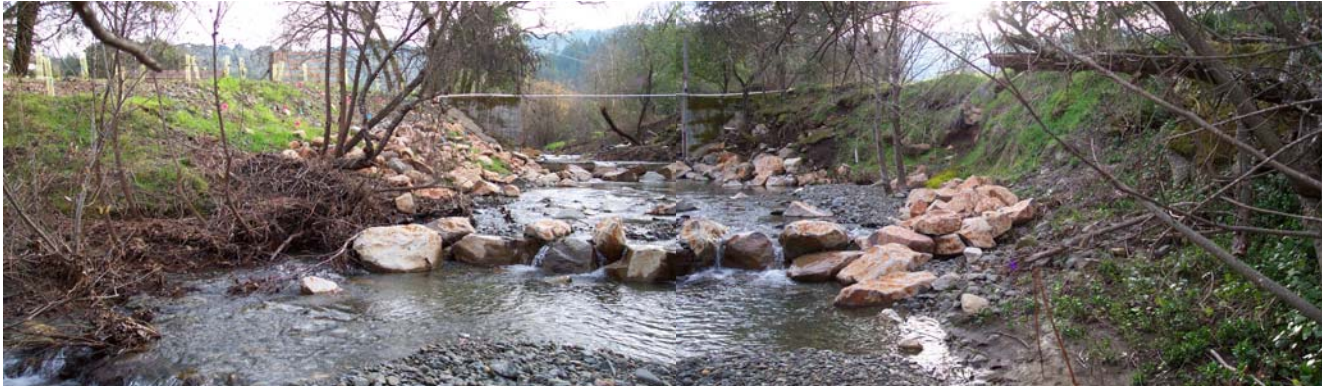
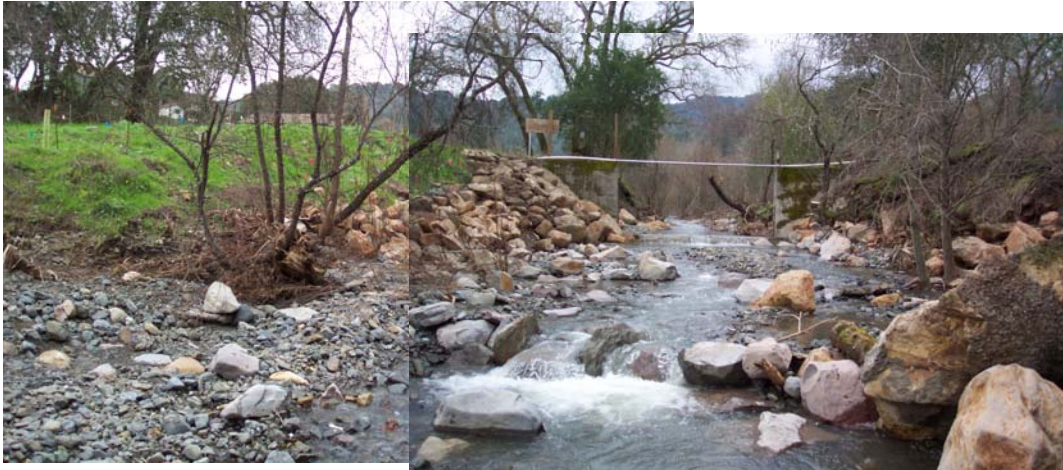
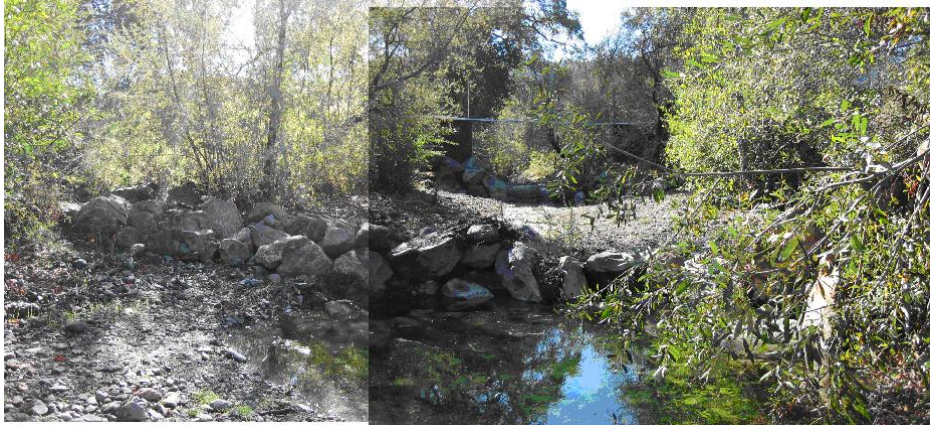
Figure 3. Area A Check Dam Site 2004 -2007

The lack of shading for maintaining cool temperatures reduces the value of pools just downstream of the dam as steelhead refugia during dry months. Though the central part of the dam was removed and some sediment was observed moving downstream after this flood (Napa County RCD 2006), the remaining wingwalls may be partially restricting flow and sediment transport through this location and influencing downstream hydrology. Riparian revegetation occurred within this subarea to increase channel canopy cover and shade, restore connectivity of the large tree species present within other reaches of the Project Stream, reduce erosion, and improve instream habitat for steelhead. No steelhead were observed in these pools during the November survey, though a lower pool contained steelhead in August of 2005 (Jonathan Koehler, Napa County RCD, personal communication, November, 2007) and the concrete apron no longer obstructs fish passage.

**January 2006
After Flood**

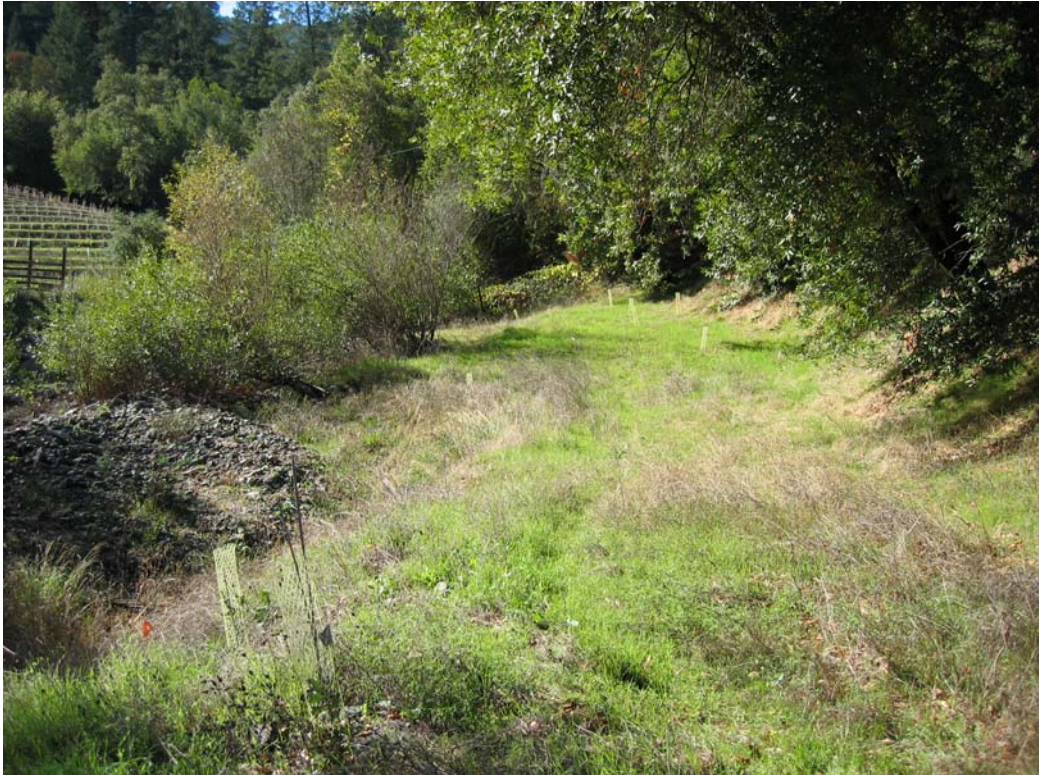
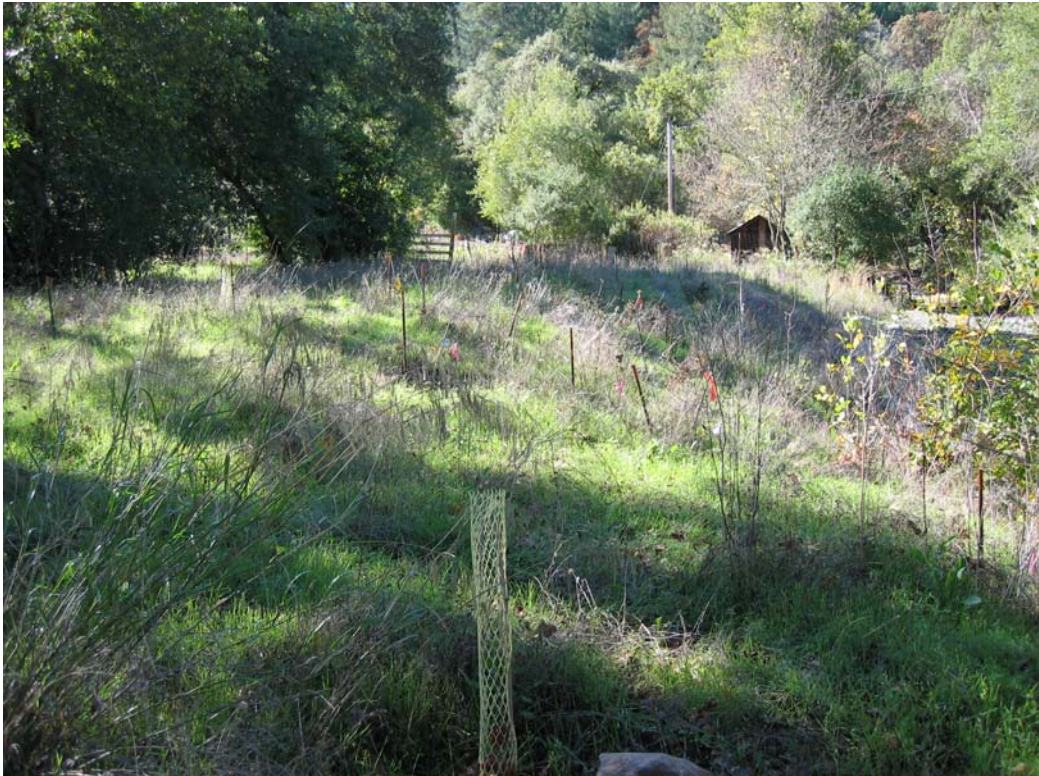
Figure 4. Revegetation Area B

Revegetation occurred along this reach of the tributary to enhance habitat by providing canopy cover, shade and connectivity of large woody riparian species. Area B is excluded from livestock grazing and surrounded by valley oak and California bay laurel woodland. These trees overhang portions of the Opposite Bank while the Terrace Area is primarily adjacent to this habitat. Area B met the revegetation success criteria with a survival of 75%. However, survival of plantings was much higher in the Terrace Area than in the Opposite Bank (86% versus 48%). This difference could be due to the hotter and drier conditions along the Opposite Bank compared to the Terrace Area, but it is also possible that the drip irrigation system is not functioning properly in the western portion of this subarea.

Opposite Bank – facing upstream along tributary

Terrace Area – facing upstream along tributary

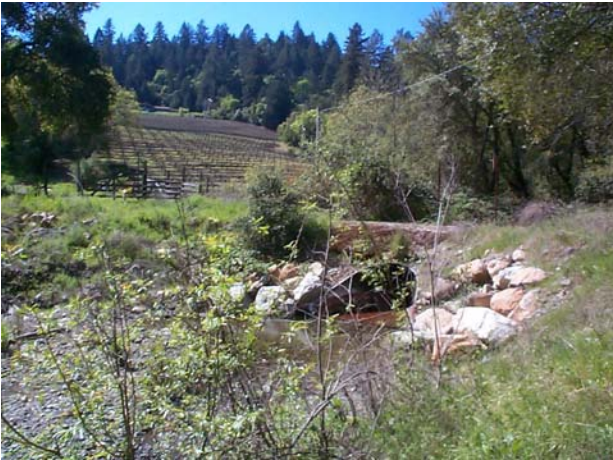
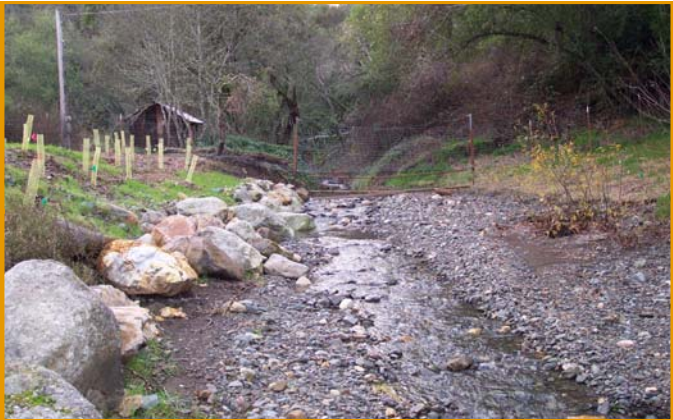
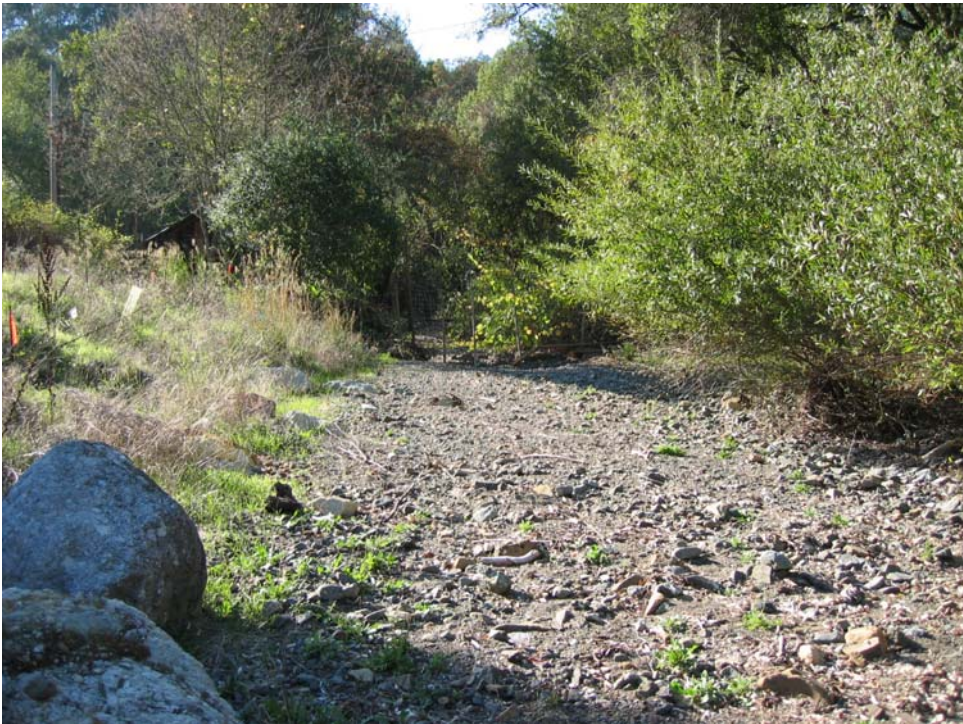
Figure 5. Area B Culvert Removal Site 2002 -2007

The two subareas of Area B (Terrace Area and Opposite Bank) are located along an unnamed seasonal tributary to the Project Stream. Similar to the Downstream of the Dam subarea of Area A, this reach represents a break in stream canopy cover dominated by large trees. Upstream and downstream of this reach the tributary supports a shady riparian corridor of coast live oak, valley oak and California bay laurel. However, vegetation along this reach consists primarily of some in-channel willows (Figures 4 and 5). The vegetation difference in this reach could be the result of its location downstream of a former barrier to flow (earthen fill with a corrugated metal pipe culvert) removed in 2004. This reach lacks pools and canopy cover for steelhead, but project removal of the instream structure opened up the tributary to

spawning steelhead. Debris that has washed up against a fence across the tributary at the location of the former culvert should be cleared to ensure passage.

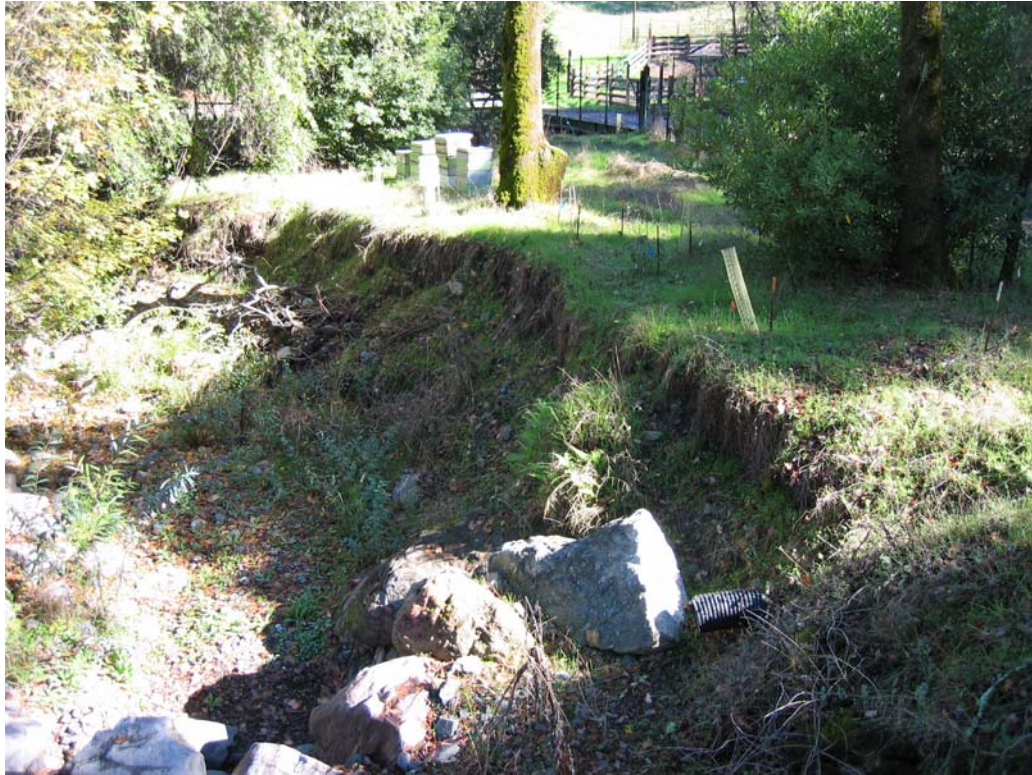
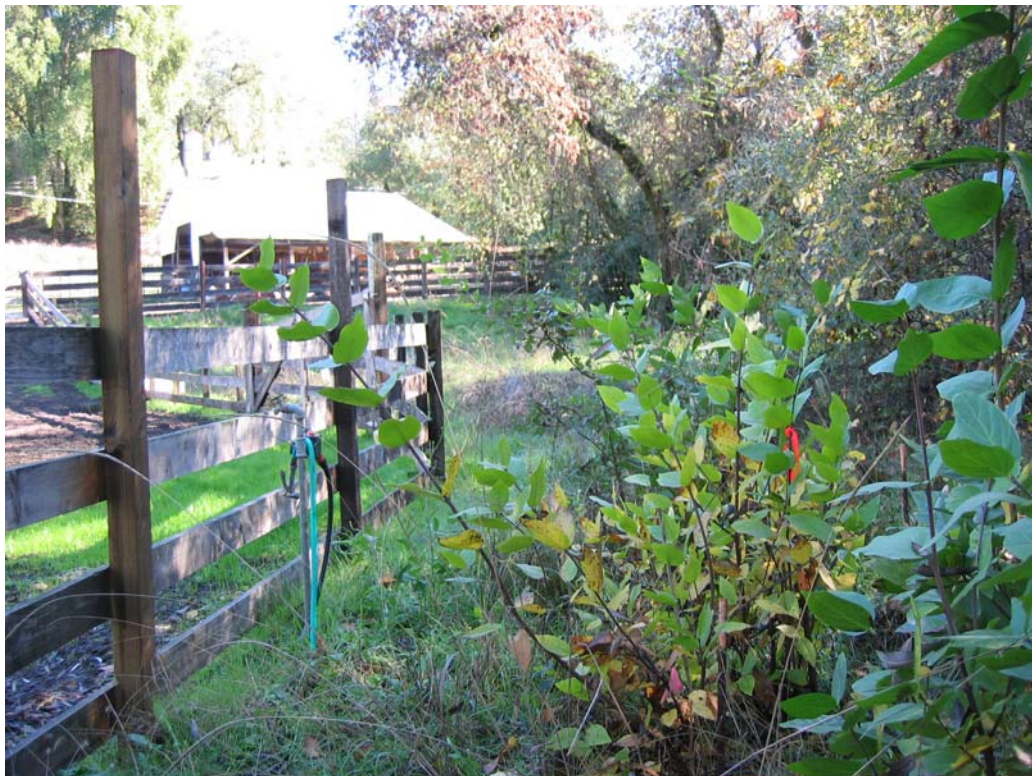
Figure 6. Revegetation Area C

Both the Bee Area and Corral Area subareas of Area C are located above the top of bank under existing riparian canopy (Figure 6). The Bee Area runs along the unnamed tributary and Project Stream near their confluence just downstream of the newly installed railcar bridges. The Corral Area is located between the Project Stream and a livestock corral. These areas are fenced to exclude livestock and show little evidence of browsing or volunteer tree seedling presence. Overall survival of revegetation plantings since the first installation in Area C was 78%, meeting the project success criteria, and likely driven by the highly successful western spicebush and new and replanted species. All plantings that survived had a condition of OK or better. Planting survival was higher in the Bee Area compared to the Corral Area (90% versus 72%).

Bee Area – facing downstream along tributary

**Corral Area – facing upstream along Project Stream,
Showing successful spicebush plantings**

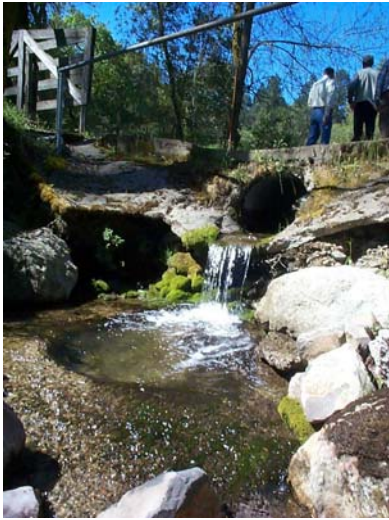
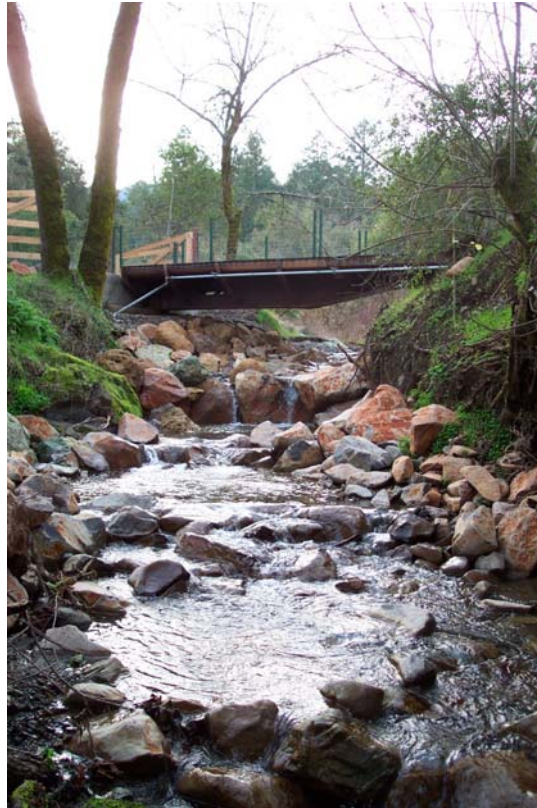
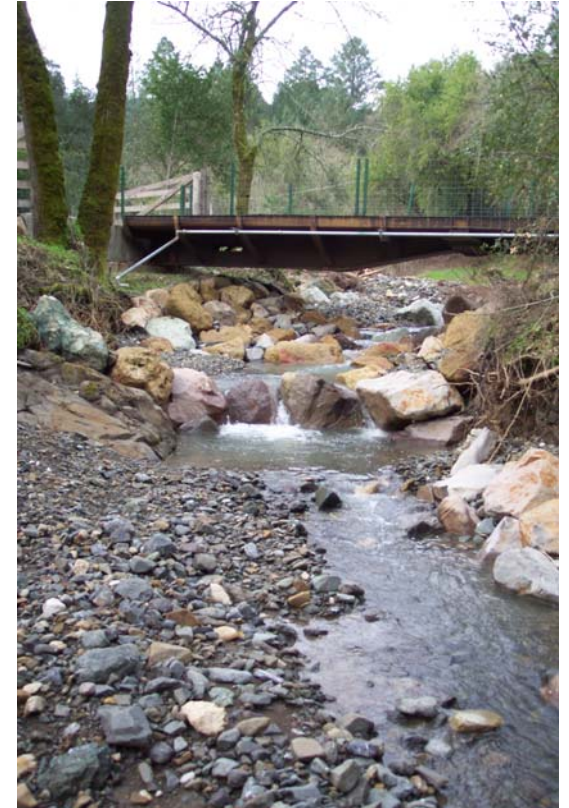
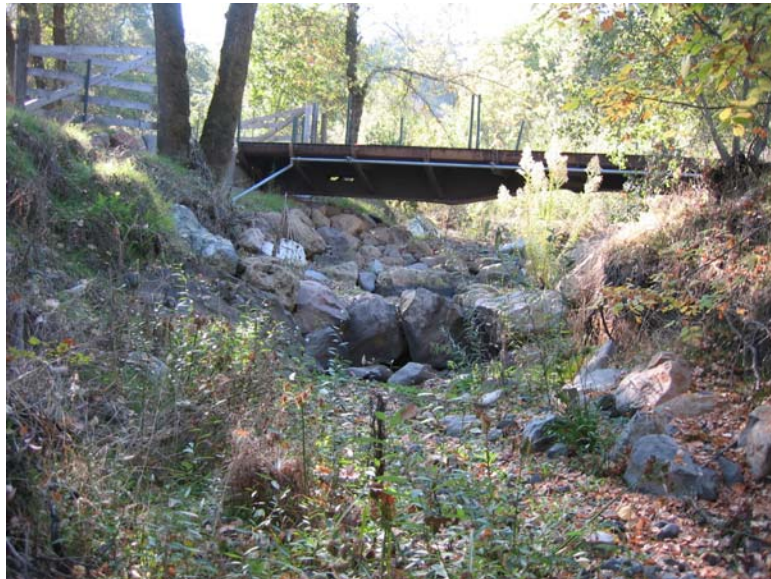
Figure 7. Area C Tributary Bridge Installation Site 2002 -2007

The southern bank of the tributary in the Bee Area is highly eroded potentially due to restriction of flow from the smaller pipe culvert that was located in this area prior to its replacement with the bridge (Figure 7). Additional erosion occurred during the January 2006 floods (Napa County RCD 2006). Riparian revegetation occurred within this area to stabilize the eroding stream banks and provide additional shade for pools within the Project Stream. Removal of the double culvert and asphalt just upstream of these pools and the addition of boulders enhanced the pool habitat and passage for steelhead.

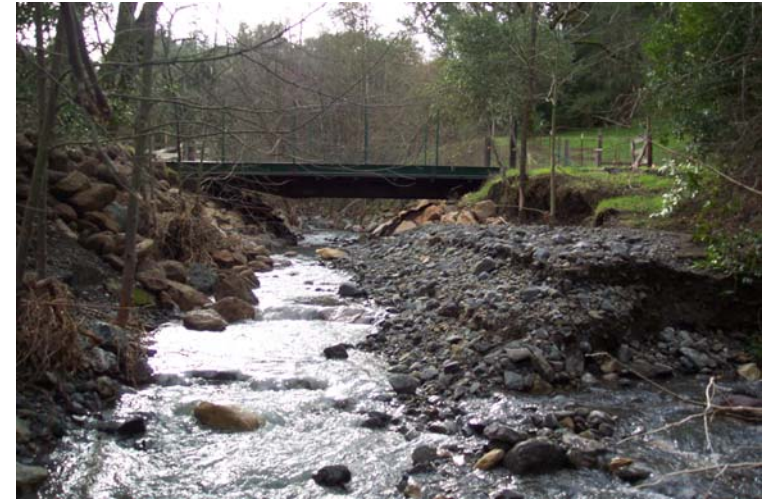
Steelhead were observed in the largest of these pools in August of 2005 (Jonathan Koehler, Napa County RCD, personal communication, November, 2007) and during the November 2007 field survey (C. Gaber, personal observation). The January 2006 flood deposited approximately four feet of sediment along the west bank of the Project Stream just downstream of the double culvert removal site (Napa County RCD 2006) (Figure 8). However, much of this sediment had washed downstream by November 2007 (C. Gaber, personal observation). Similar to Area A, this area experienced erosion and sedimentation during the flood and the Landowner restabilized the banks with boulders. Sedimentation in Area C was much more severe than in Area A, potentially because the remaining wingwalls of the former dam in Area A were holding back some sediment.

January 2006 – showing sediment deposition and rock repair on bank

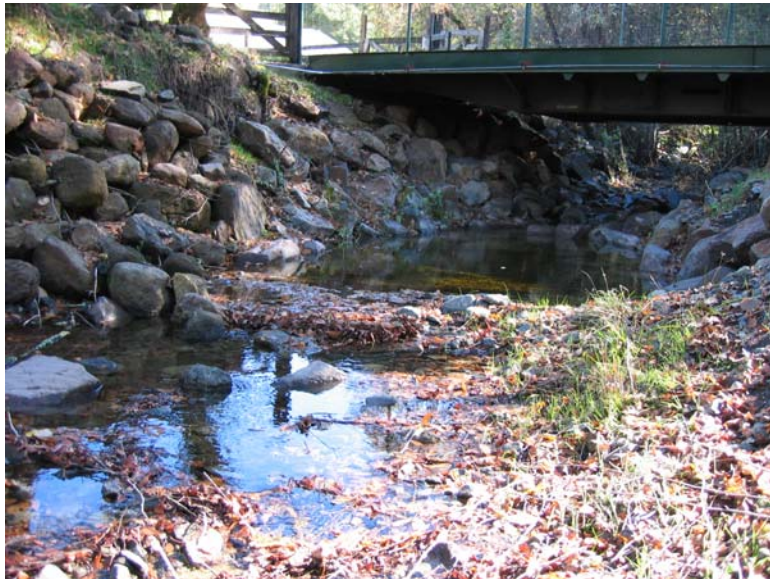
November 2007- pools below bridge

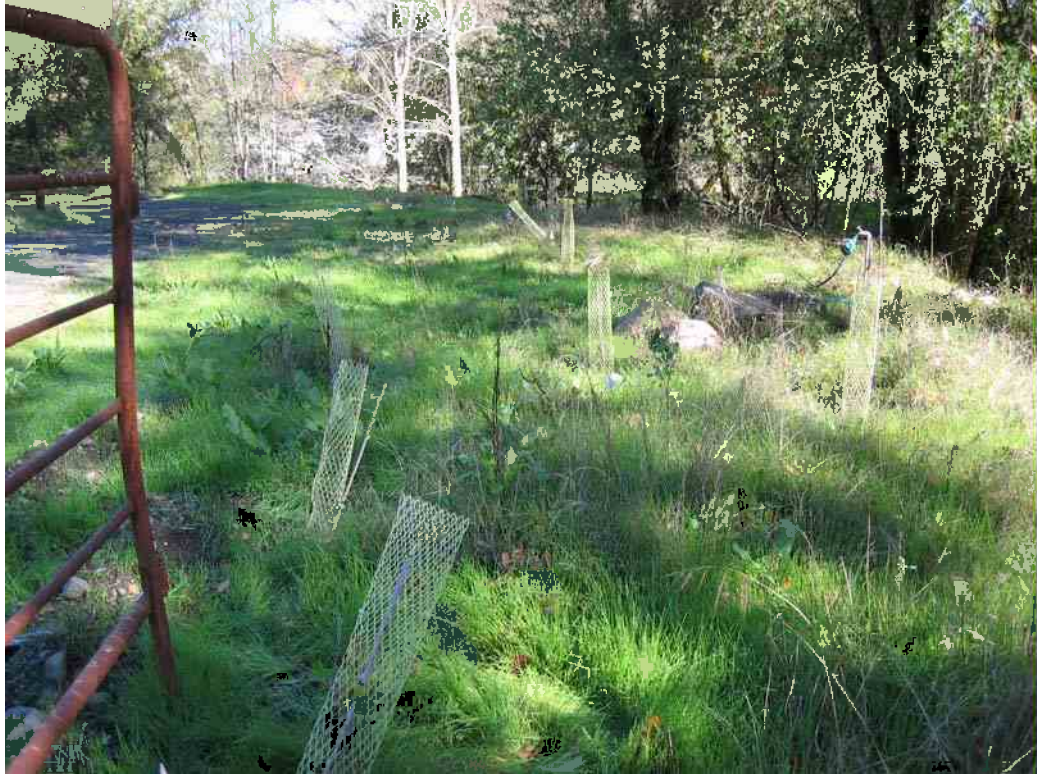
Figure 9. Revegetation Area D

Revegetation activities within Area D began in the spring of 2006. This area is located above the top of bank at the Project Stream and tributary confluence, under the riparian canopy, and next to a dirt road similar in setting to the Near Shed subarea of Area A (Figure 9). Coast live oak, alder (*Alnus* sp.) and willow overhang this area. Cattle occasionally have access to this unfenced area. Evidence of large herbivore browsing was present but the majority of the herbivore damage to big leaf maple, western spicebush and snowberry (*Symphoricarpos albus* var. *laevigatus*) plantings appeared to be due to insects, resulting in low survival (33%) of healthy plantings (condition of OK or better).

Area D - facing upstream near tributary / Project Stream confluence
