A post project appraisal of the restoration/rehabilitation of Alamo Creek

A Post Project Appraisal of the Restoration/Rehabilitation of Alamo Creek

UC Berkeley Department of Landscape Architecture 227 River Restoration

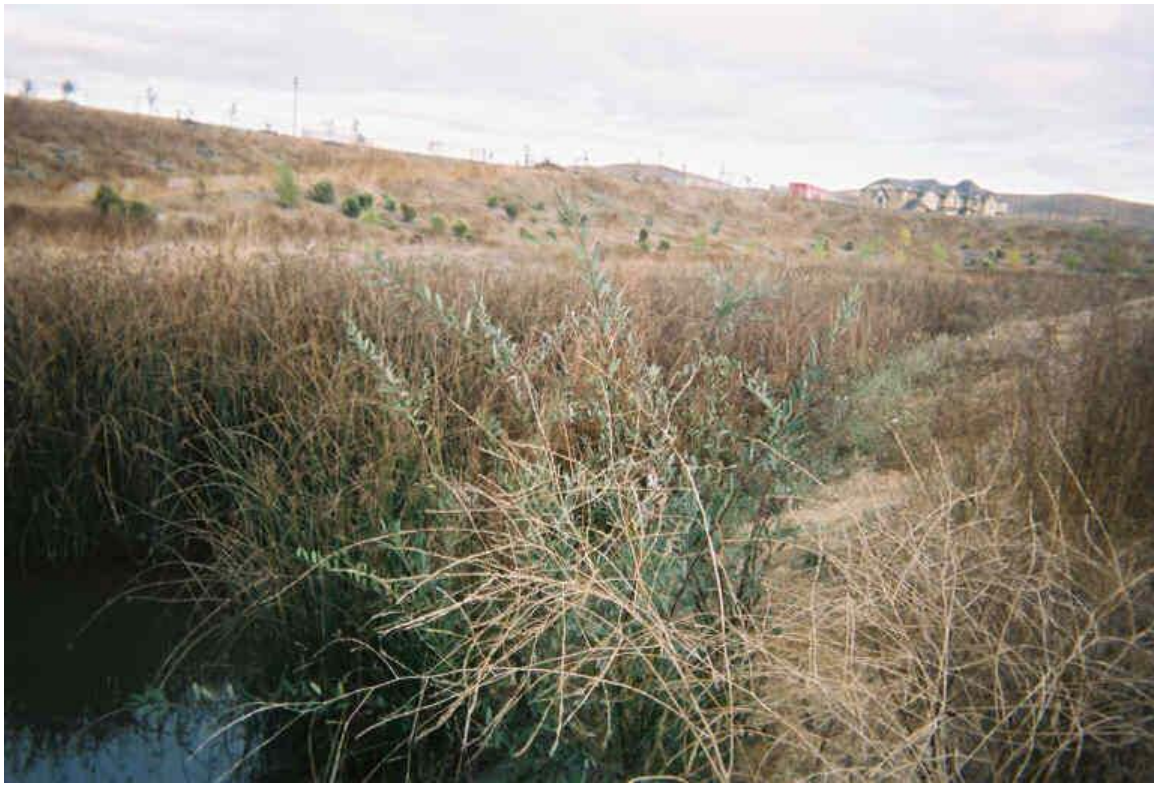
Figure 3

However, the vigorous growth in the floodplain caused some sections of the reach to be strangled by Tule and Cattail. The vegetation encroachment in some areas is so densely packed that the channel has effectively turned into a linear wetland (Figure 3). While this is good for reducing stream energy and slowing incision it is contributing to heavy sedimentation in the channel. In the three cross sections measured, the channel contained 6-10" of fine silts and clays. This has caused the channel bed to become anoxic and has most likely suffocated much of the natural benthic organisms. Vegetation encroachment is degrading the natural processes of the channel, but may be effective at removing pollutants (Horne & Goldman 1994). This sedimentation may be scoured away during the next flood event, but it may not remove that much sediment due to the dense vegetation and if the sediment is removed it will aggregate downstream and decrease downstream channel capacity. This could lead to flooding in areas downstream of the restoration reach.

These two images illustrate the vegetation encroachment in the main channel. The densely packed tule and cattail stands have given the channel attributes of a linear wetland.

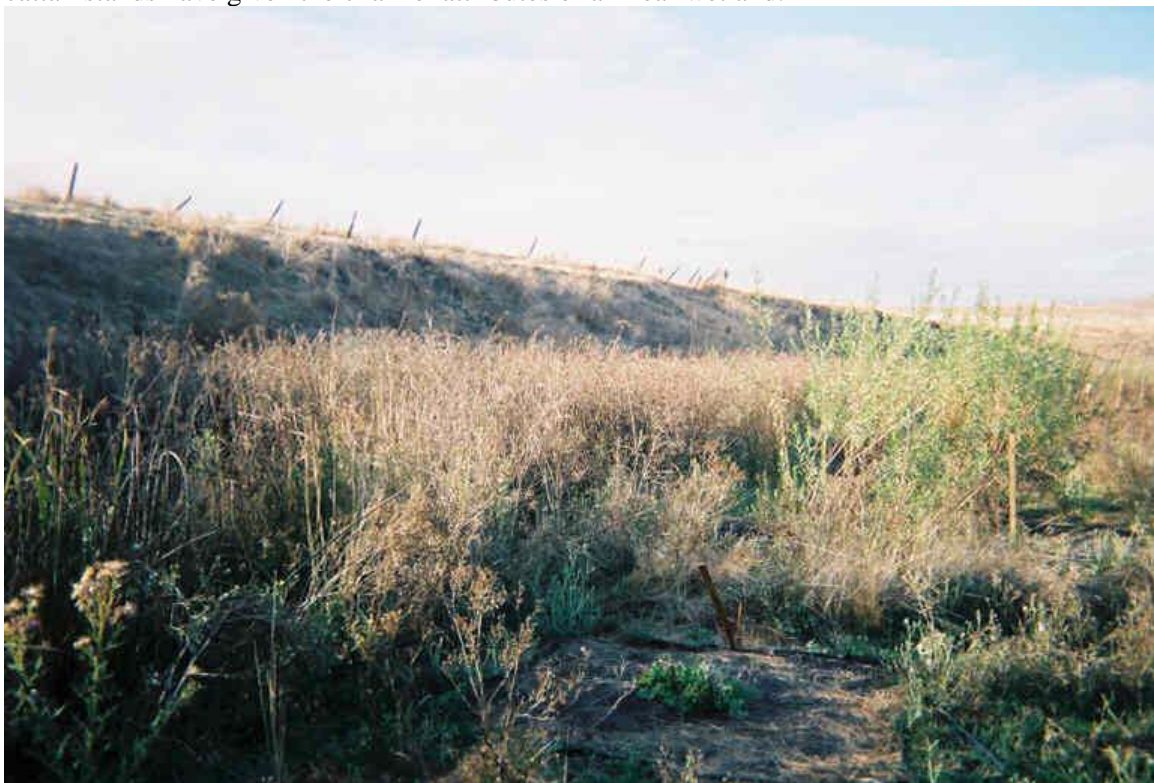
Figure 4

Consequently, the right-bank has a much steeper slope than the left bank (45-vertical) and in many places it is devoid of vegetation (Figure 4). Bank destabilization occurred in many of the sections where hard engineering such as rocking the banks was not employed. This is specifically evident in figure x 50' upstream of cross section 2 at the outside of a meander bend that has eroded the right-bank. This observation may support the case for hard engineering in this project and the success of the project may be due to hardening the banks, creating rock grade control structures, and rock splash pools in conjunction with the riparian zone. This is not an ideal design for restoring the creek's natural processes however, with so much of the creek being unnatural due to grazing and development it may be an unpleasant but necessary design.

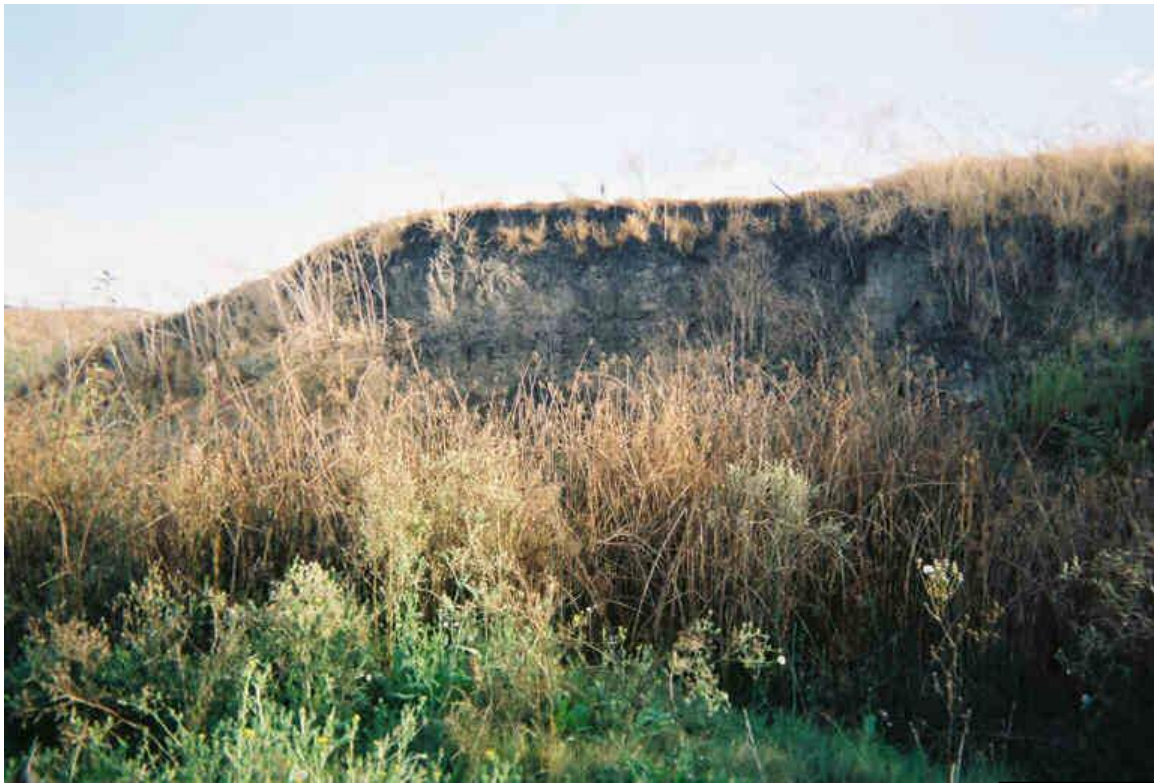
Figure 5a

This image looks across the tule congested channel at a meander bend onto the steep right bank that is devoid of vegetation due to bank destabilization and erosion.

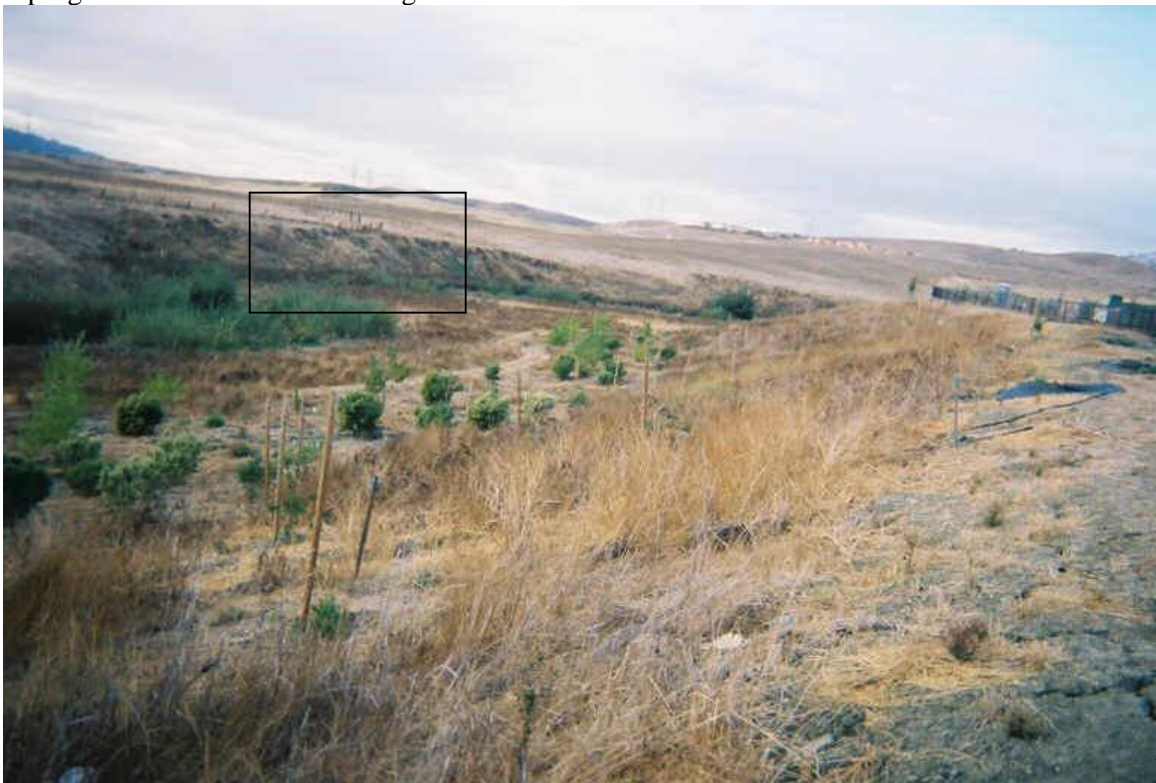
Figure 5b

Although the image is poor it can be seen that the fence line is being undermined due to an unstable bank.

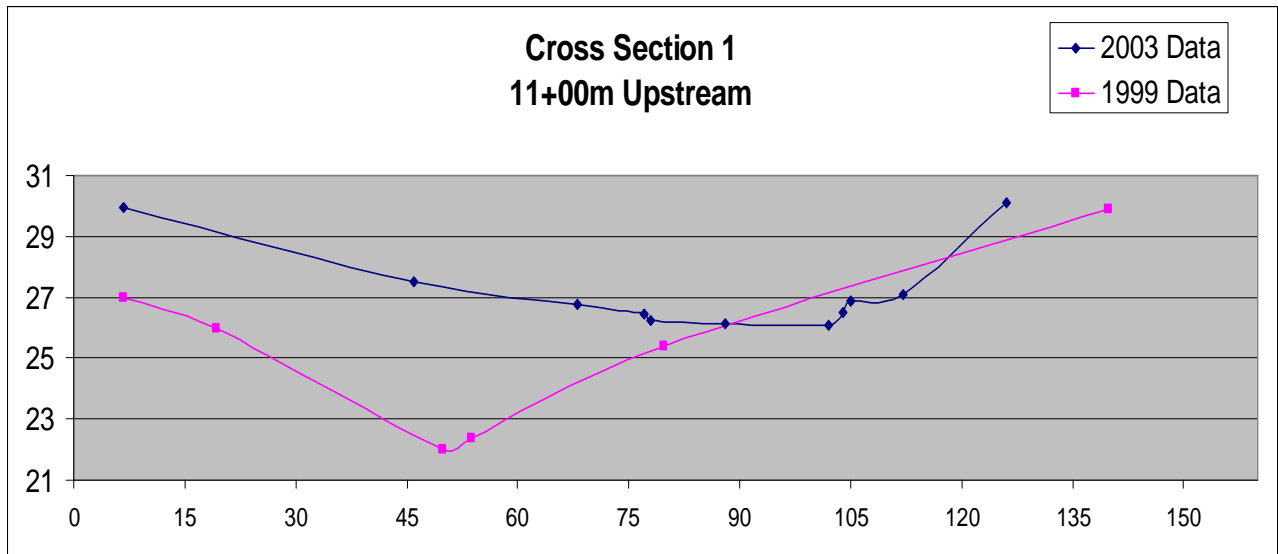
Figure 9

This graph shows the pre-design cross section compared to the current cross section. Unfortunately, these two cross sections were not taken at exactly the same location but they are within 100m of each other. It can be seen that a wide floodplain now exists and the left bank has a more gradual slope.

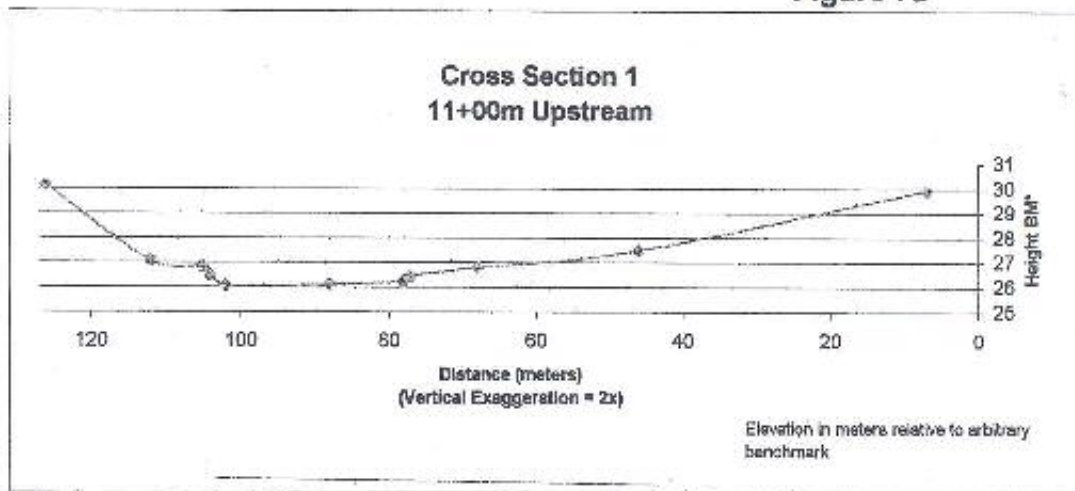
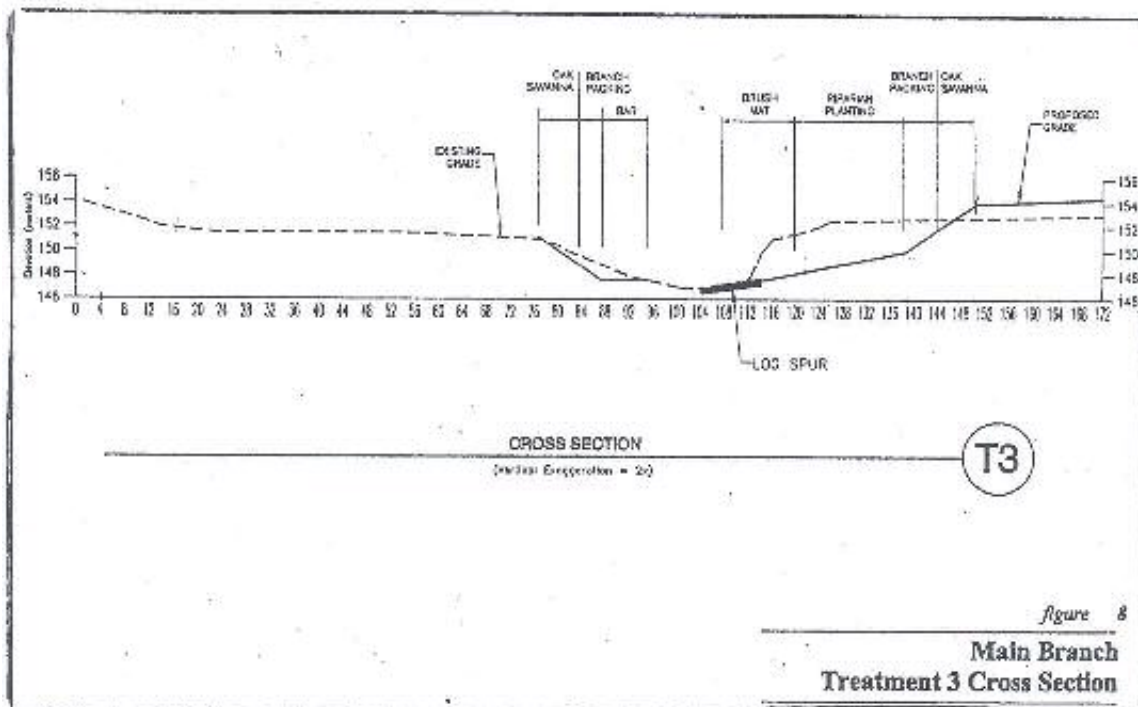
Figure 7a

As can be seen when comparing the as designed treatment three ³ to cross section 1 a wide flood-plain still exists and the proposed grade on the right of the figure has maintained its slope at approximately 3 : 1. However, on the right bank (left side of figure) the slope has increased resulting in bare soil, no vegetation and sediment erosion into the channel.

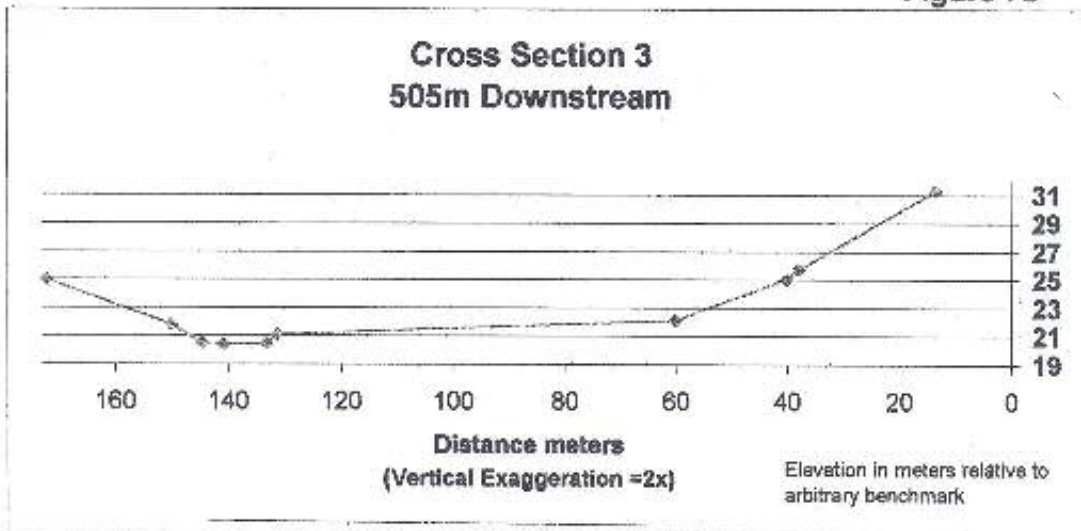
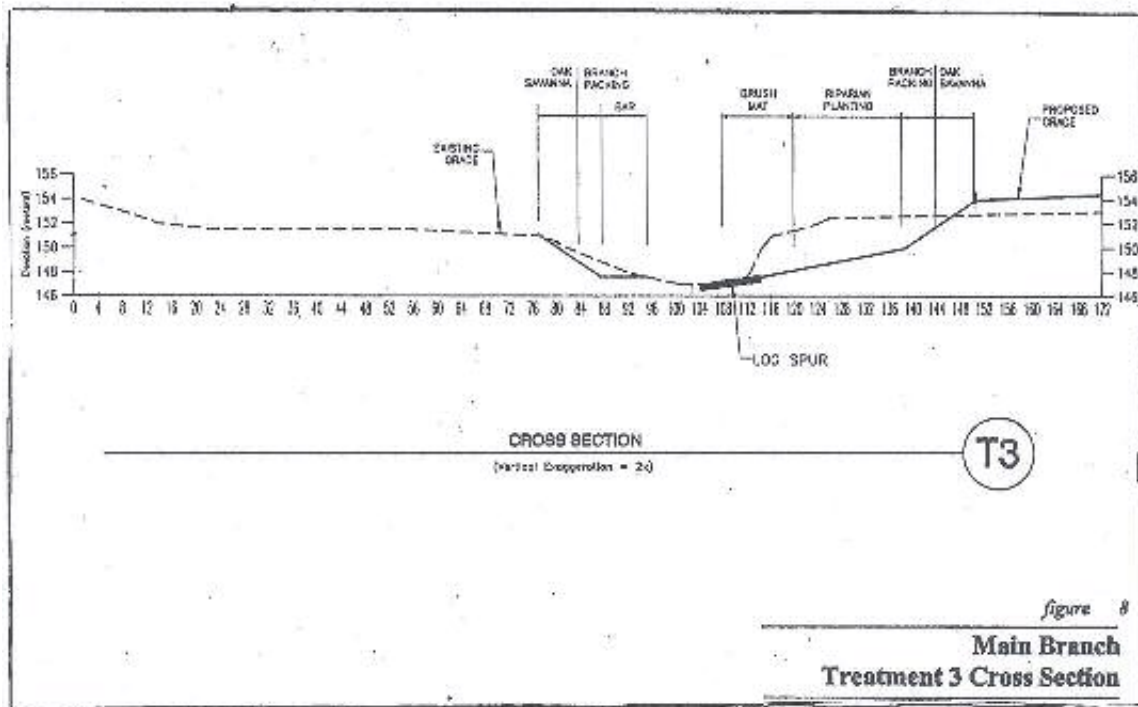
Figure 7b

As can be seen when comparing the as designed treatment three to cross section 3 a wide flood-plain still exists and the proposed grade on the right of the figure has maintained its slope at approximately 3 : 1. However, on the right bank (left side of figure) the slope has increased resulting in bare soil, no vegetation and sediment erosion into the channel.
