Post-Project Appraisal of Baxter Creek at Booker T. Anderson Park : Shopping Carts - The New Boulders

Post-Project Appraisal of Baxter Creek at Booker T. Anderson Park
Shopping Carts: The New Boulders

December 2005

By:
Colleen Bronner
Maggie McKeon
Janel Weston

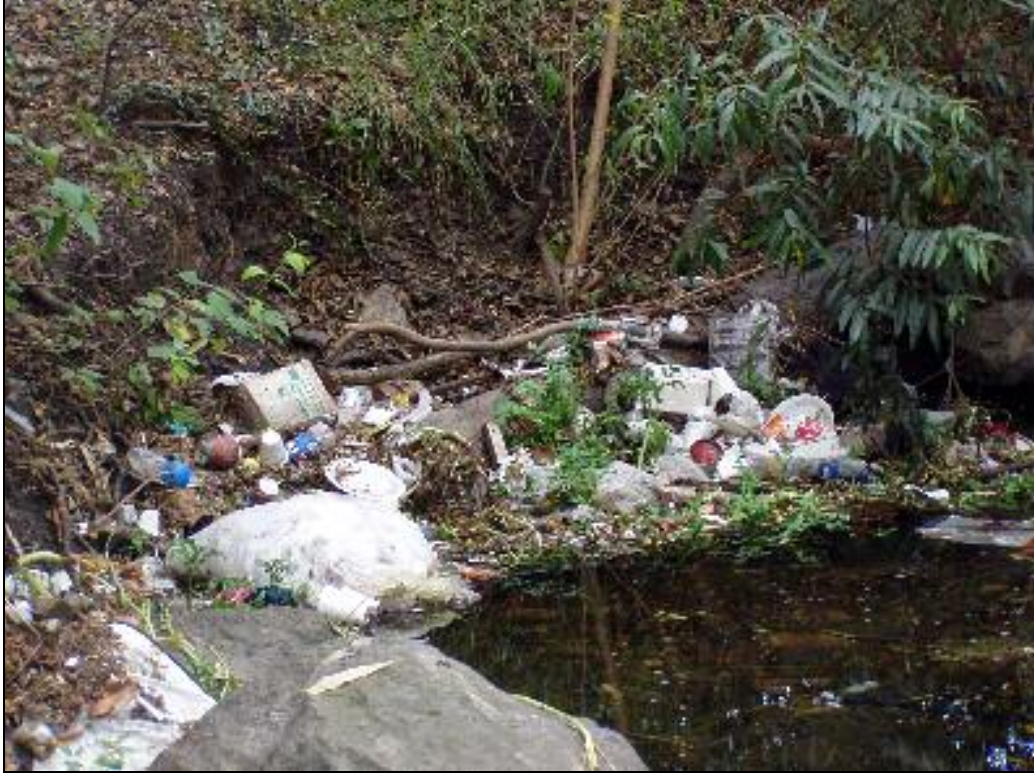
Figure 8: Site 4 – Trash Bar

Site 2	Site 3	Site 4
Visible Insects & other wildlife	Ants. Small, green hopping insects. Files. Heard frogs croaking and some birds.	Ants. Small, green hopping insects.	Ants. Small, green hopping insects. Black millipedes approximately 2-4 inches long burrowing into soil and trash.
Shading	Some shading from trees. Shading immediately upstream from concrete.	Partial shading from tree on right bank.	Well shaded by trees/shrubs on both banks.
Vegetation	Not much in wetted channel. Large amount of vegetation in non-wetted channel.	Vegetation in wetted channel. Large amount of vegetation in non-wetted channel.	Not much vegetation in wetted channel. Vegetation covering banks.
Visible Pollution	Trash all around the area. Pile of trash the width of the stream and approximately 8 inches long is creating a small "dam" effect, with a pool immediately after the trash pile.	Multiple cans and plastic wrappers in surrounding area (in wetted channel and non-wetted channel). Golf ball in wetted channel.	Site is overrun by trash. Shopping cart immediately downstream of sampling site. Bicycle gears and vacuum cleaner in creek immediately upstream of sampling site. Plastic bag of trash and piles of loose trash at sampling site. Bank eroded near trash pile.

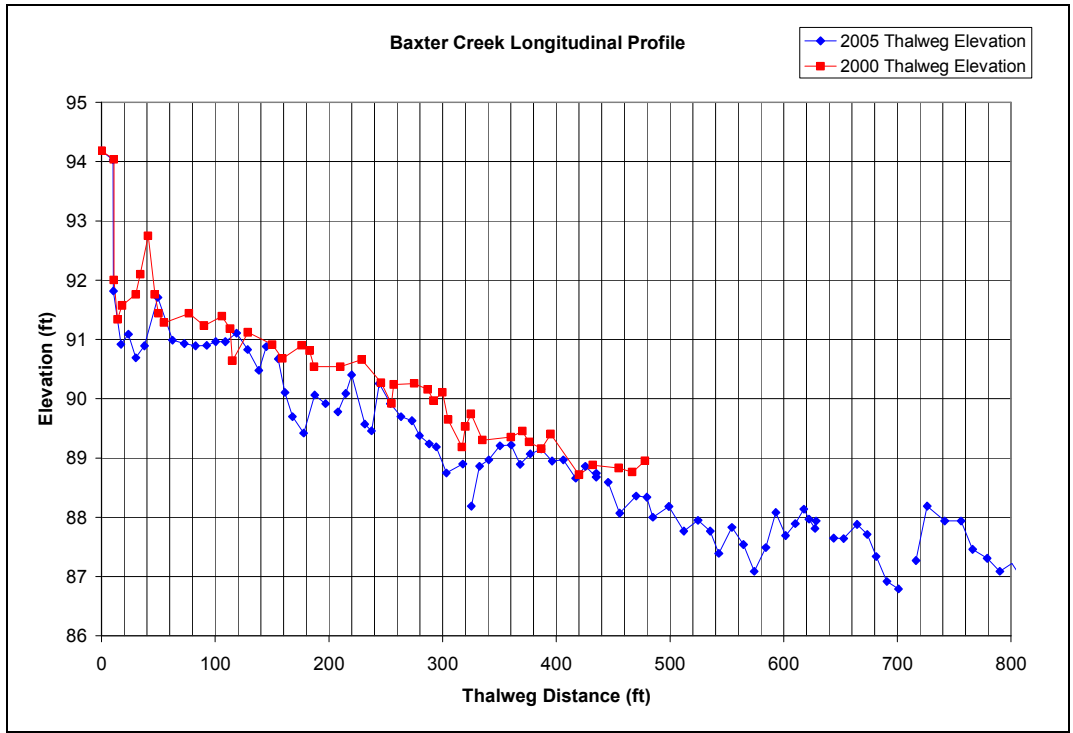
Figure 13: Longitudinal Profile

Results of the cross section profiles V, VI and VII are shown in Figures 10, 11 and 12, respectively. Figure 13 shows the longitudinal profile. The 2000 longitudinal profile indicates a slope of 0.80 ± 0.05 %. We used a regression analysis of the thalweg elevation to calculate the slopes; our 2005 survey shows a slope of 0.78 ± 0.06 % in the reach surveyed in 2000 and an overall slope of 0.56 ± 0.03 %.

Due to the uncertainty in our cross section locations, the longitudinal profile is a better indication of changes since 2000. The profile shows that the slope in the upper reach has not appreciably changed. A visual comparison suggests that there has been some channel incision, but the difference in average thalweg elevation is only 0.6 ft, indicating that the channel as designed has been relatively stable since its implementation in 2000. Although there is more uncertainty associated with a comparison of the cross sections V and VI (Figure 10 and 11), they also roughly indicate channel stability—certainly no drastic changes have taken place.
