The influence of large woody debris on channel form, upper Scott Creek, Santa Cruz County

**The Influence of Large Woody Debris on Channel Form**  
**Upper Scott Creek, Santa Cruz County**

**Landscape Architecture 222 – Hydrology for Planners**

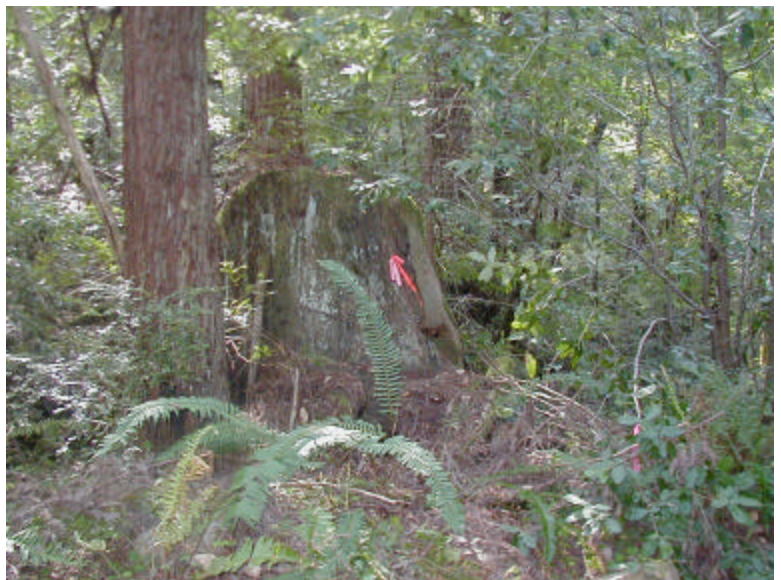
**Image 2: Benchmark Nail at Tree**

Our benchmark was a spike marked with red tape on the side of a tree stump at the right top of bank, at an approximate elevation of 1,045 feet above sea level, about 10 feet from the channel. This benchmark was used as a land surveying monument and indicates the line between Sections 17 and 20. The elevation is approximated because the surveyor records could not be recovered by the time of submission.

The longitudinal survey establishes baseline data of channel condition. The survey spike in the old growth redwood stump was selected as the benchmark because it will likely remain as a landmark for many years. It will certainly exist for long enough to detect any changes to the watercourse morphology, such as down-cutting or aggradation, through several timber harvesting cycles. Down cutting or aggradations of stream channel is directly affected by channel roughness.

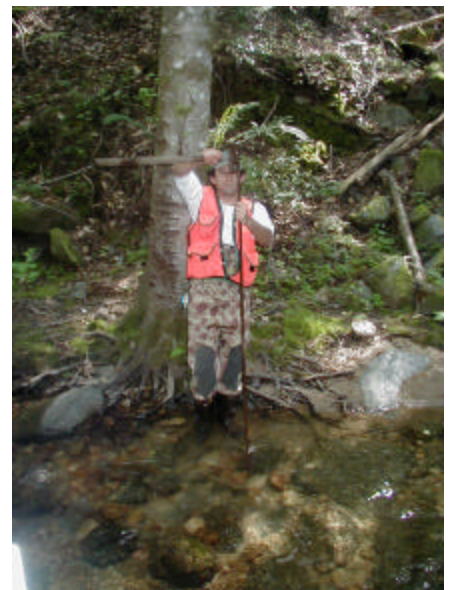
**Image 3: Sediment Depth Measurements**

To record sediment depth, we used a ½ inch diameter reinforcement bar (rebar) that was 6 feet long, which we pounded through loose sediments in the creek bed with a sledgehammer until we hit a more resistant material, and measured the thickness of the sediment from the rebar. We measured sediment depth at every cross-section from the edge water spaced approximately one-foot) apart and at the clumps of LWD where sediment deposition appeared greatest and at various points to define the extent of the sediment deposit.

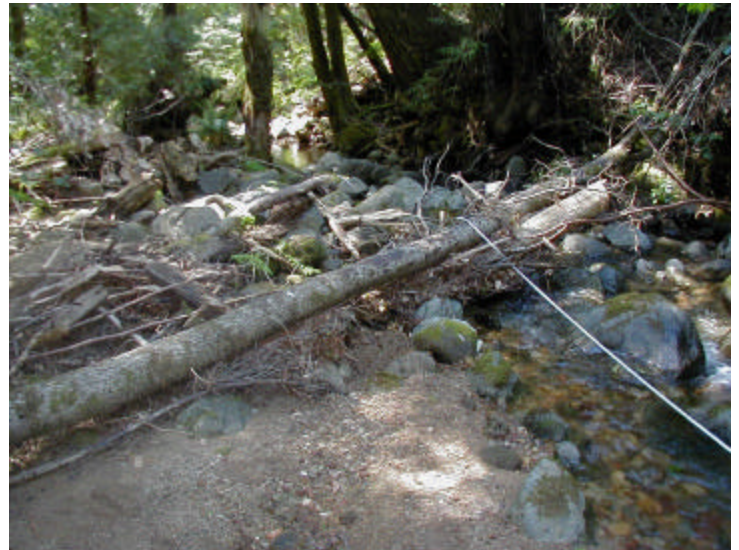
**Image 4: LWD Stations 1 and 2**

Along the survey reach we took pictures and made notes on changes in channel form, such as steps, pools, runs, and riffles, and locations of LWD. We made field sketches and took pictures of the channel areas containing LWD, to show the extent of modification to the channel form due to the debris.

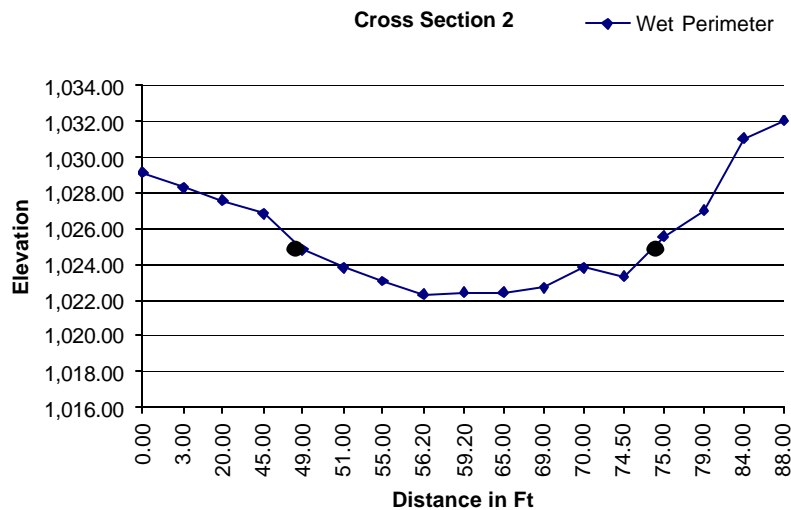
**Figure 3**

high water mark = 1,024.60 ft

The cross-sections in Figures 2 through 5 depict a slice of the channel from bank to bank. Please note that scale varies from figure to figure. The high water marks, wetted perimeter, and cross-sectional area are noted on the first and last figures. This data was later used in the Manning’s equation for the Flood Frequency Analysis. It is interesting to compare the cross sections with the long profile and the sketches.

Figures 2 through 5 show the cross sections taken at the 0, 164, 328, and 492-foot markers of the longitudinal profile for Scott Creek (cross sections 1, 2, 3, and 4, respectively). Estimated peak flow (Q), at the high water mark of Sections 1 and 4, is 202.30 and 281.94 cubic feet per second, respectively, with an average slope for the surveyed stretch of 3.83%.

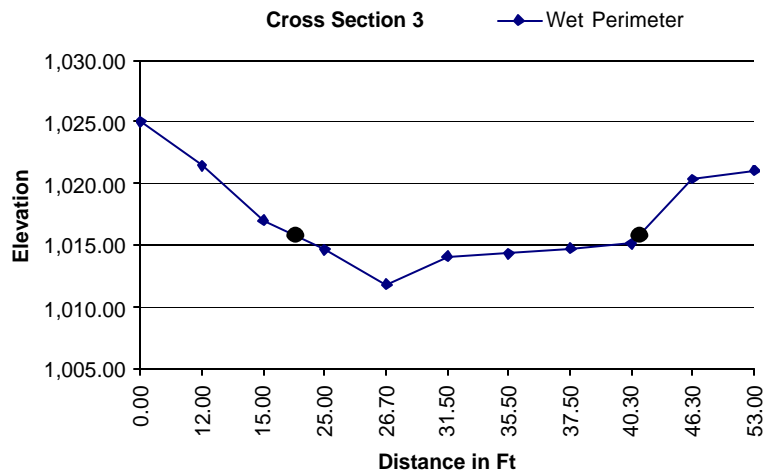
**Figure 4**

high water mark = ● 16.88 ft

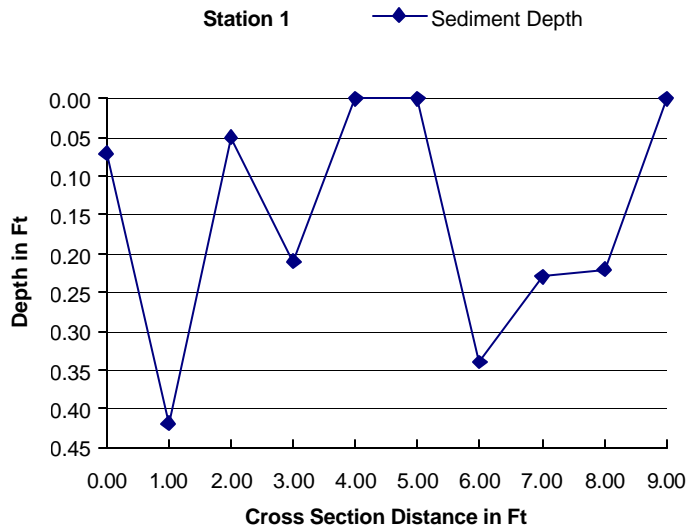
Figure 6

Figures 6 through 9 show the sediment depths at cross sections 1, 2, 3, and 4, respectively. Figures 6-9 show that there were usually greater sediment deposits at the edges of the creek channel. Sediment depths of zero mean that we hit a rock at the channel surface, so that the rebar could not be pounded into the ground. The existence of deeper sediment along the channel edge is most likely due to the constant contact and friction between moving water and channel banks and debris, to the depositing of sediment along the outer edges of meanders, and to the reduced speed of water along the edges of a channel relative to the speed of the water along the center of the channel, which causes deposit of sediment along the edges and carrying of sediment along the center. Data tables for all sediment depth measurements are shown in the Appendix of this report.

It is curious to note for Figures 6 through 9 that stream width remained fairly constant 8 to 9 feet in width.

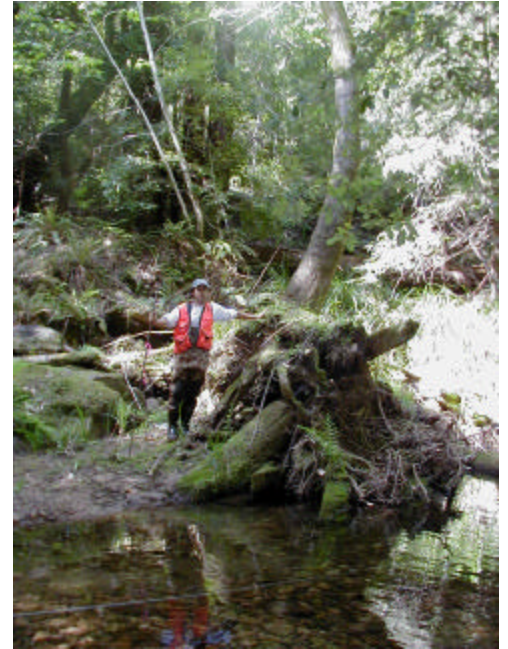
Sediment depths at the LWD locations were greater overall than sediment depths at non-LWD locations (see Appendix for data tables). The deepest sediment was found at sediment depth station 10 (Image 5), which is located at 400 feet (122 meters) into our stretch of Scott Creek, behind a big-leaf maple tree that, because its roots began to grow roughly five feet above current ground level, showed signs of substantial scouring since the tree grew on that spot.

We measured the sediment at four feet downstream of this big-leaf maple tree at 4.23 feet deep. The location of this LWD well within the creek channel created back eddy deposits and point bars downstream of the debris. These deposits and sand bars are deep with sediment because of the slow water currents created directly downstream of obstructions in the stream flow. All suggestions are mere postulation of channel morphology it is difficult to distinguish vertical scour from lateral bank erosion because vegetation failed.

**Image 5: Big-leaf Maple Tree Shows Signs of Creek Bed Scouring**

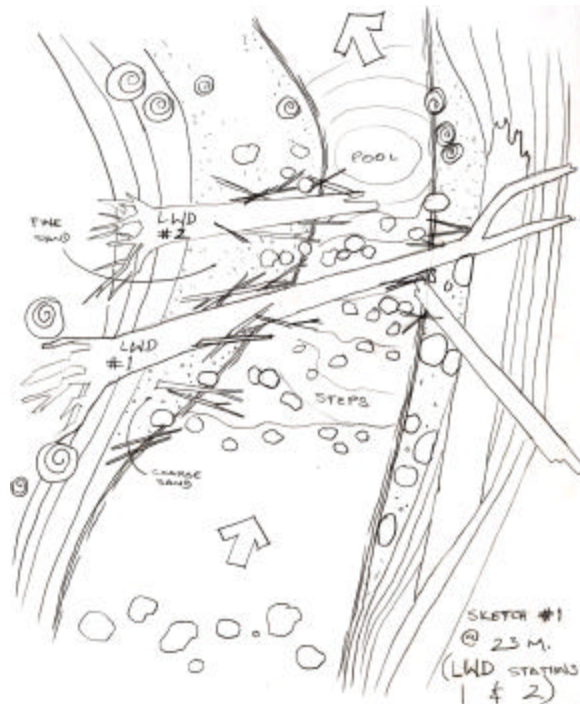
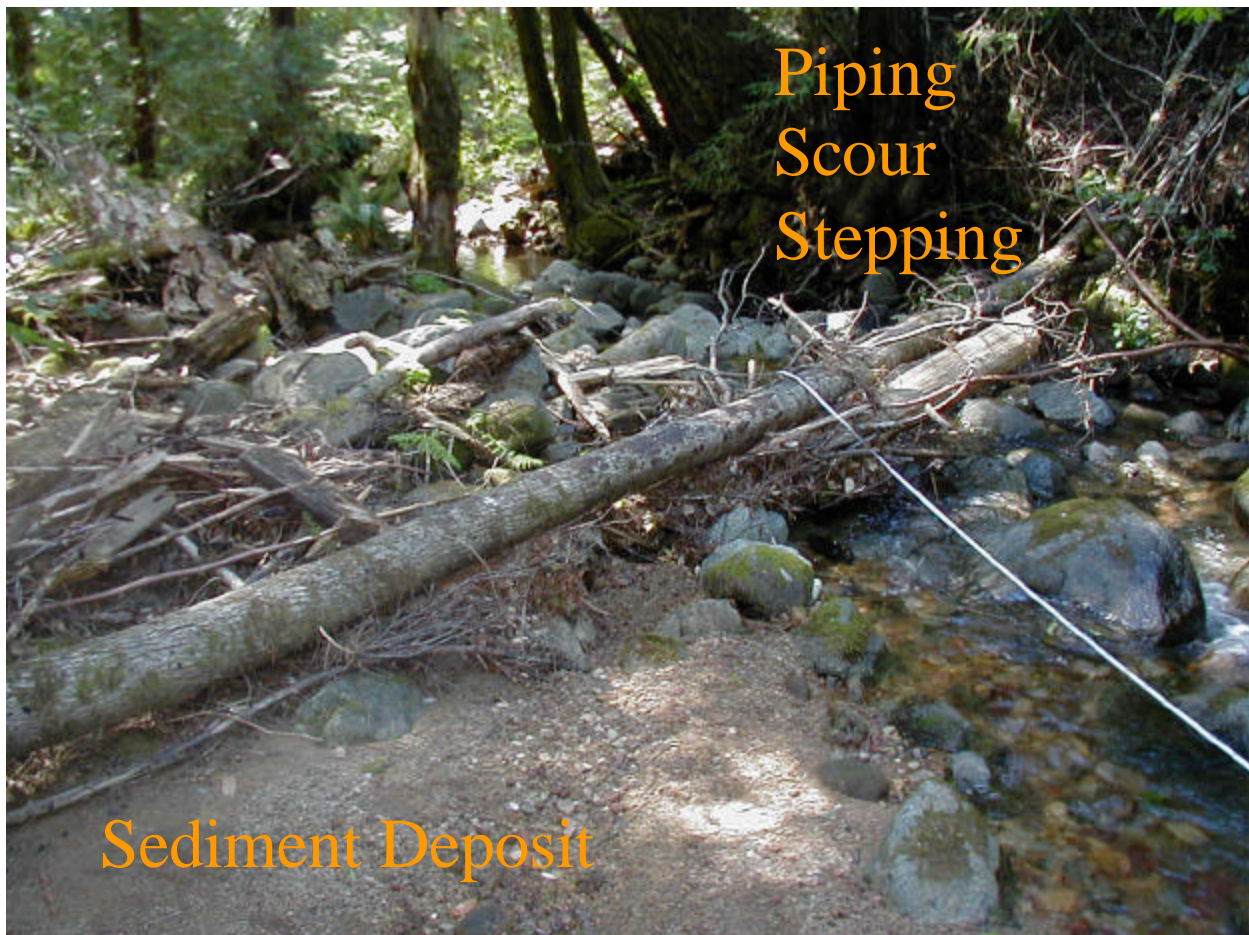
Sketch 1 – LWD at Stations 1 and 2

In Sketch 1, it is difficult to determine which fell first, however, either LWD #1 or #2 contributed to the morphology depicted in sketch 1 being oriented horizontally and perpendicular to channel flow. It is also difficult to tell if either created a dam by spanning the width of the channel.

Regardless, it is apparent that the root wads on the left edge deflected flows to the right. As the flow was concentrated, it gained

energy and proceeded to pipe and scour under the log, creating a series of steps to the pool.

Image 7: Photo of area of Sketch 1

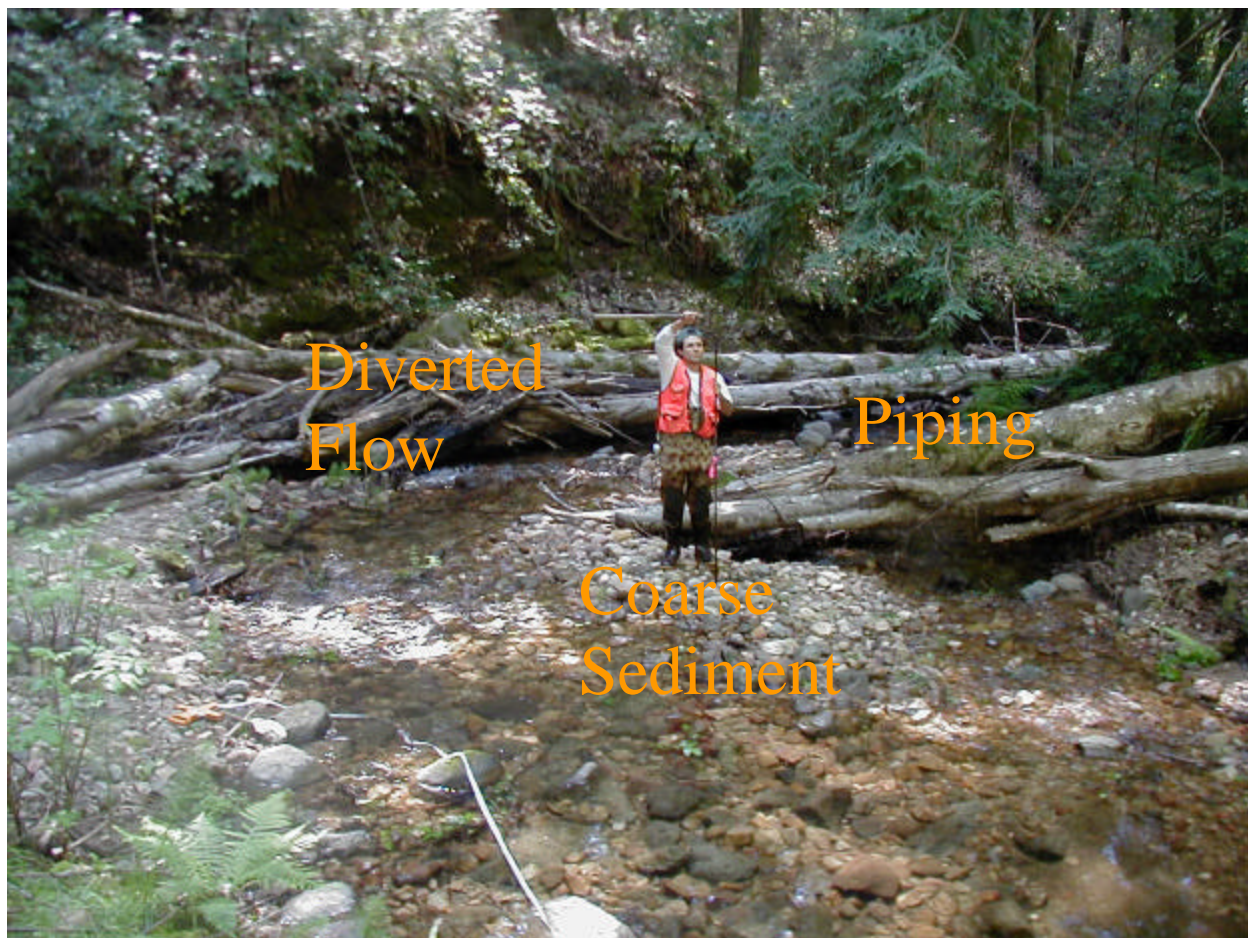
**Sketch 2 – LWD at Stations 3 and 4**

In Sketch 2, we would like to draw your attention to LWD station #3. The LWD structure is perpendicular to the flow and extends across half of the observed channel width. The LWD creates a bar with coarse sediments in front of the point of the LWD. Flow is diverted to the left. Perhaps, at higher flows, water pipes and scours under the logs. Burying the top of the log into the bed and extending out of the channel at an acute angle, may classify this station as pitched.

Image 8: Photo of area of Sketch 2

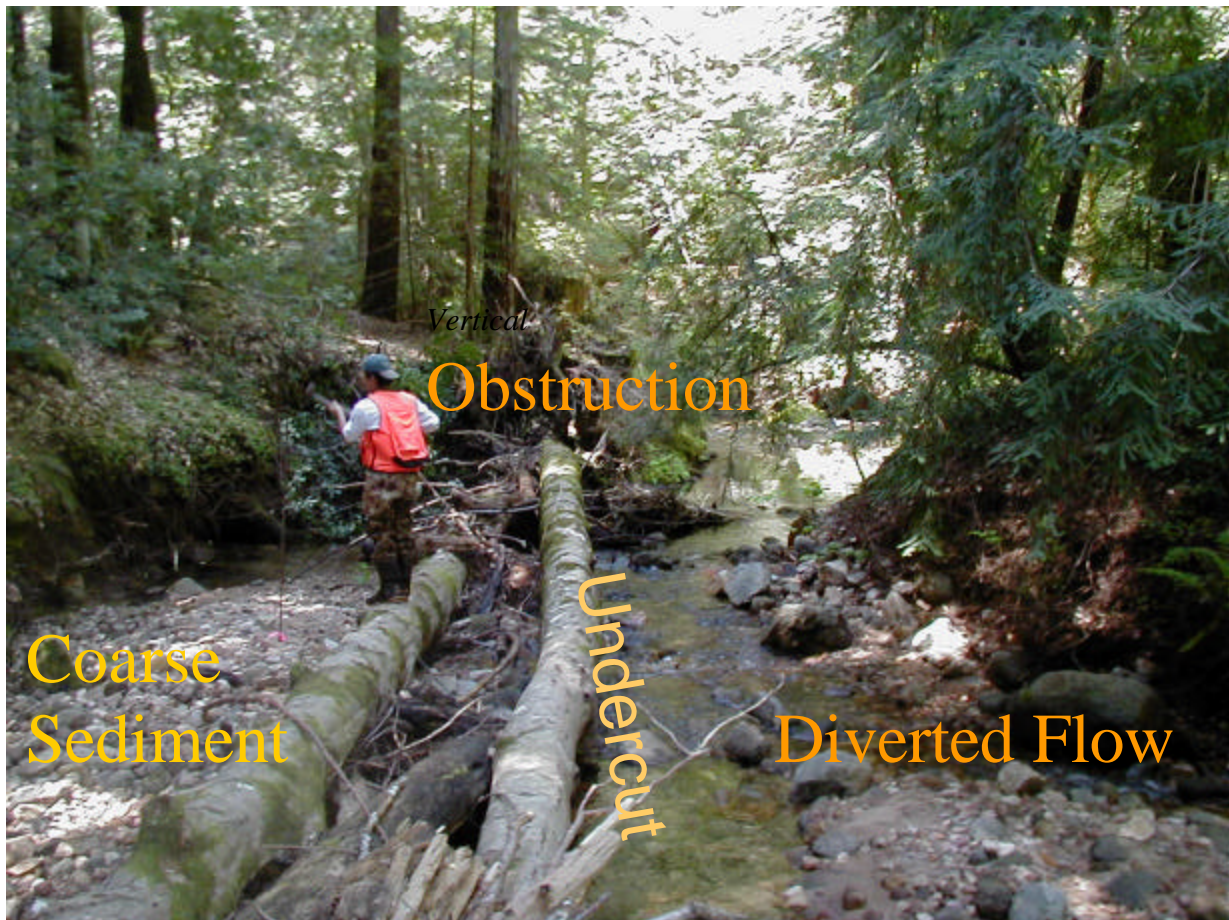
**Sketch 3 – LWD at Station #4**

Sketch 3 depicts LWD that is horizontal and parallel to the stream channel, and vertical LWD. Scour was observed under the deflecting flank of the parallel LWD and a straight, confined channel. The side opposite the flow was filling in with sediments. The upturned root-wad created a vertical LWD structure. Water is deflected from the root-wad both down stream and back against the bank to scour the observed shallow pool.

Image 9: Photo of area of Sketch 3

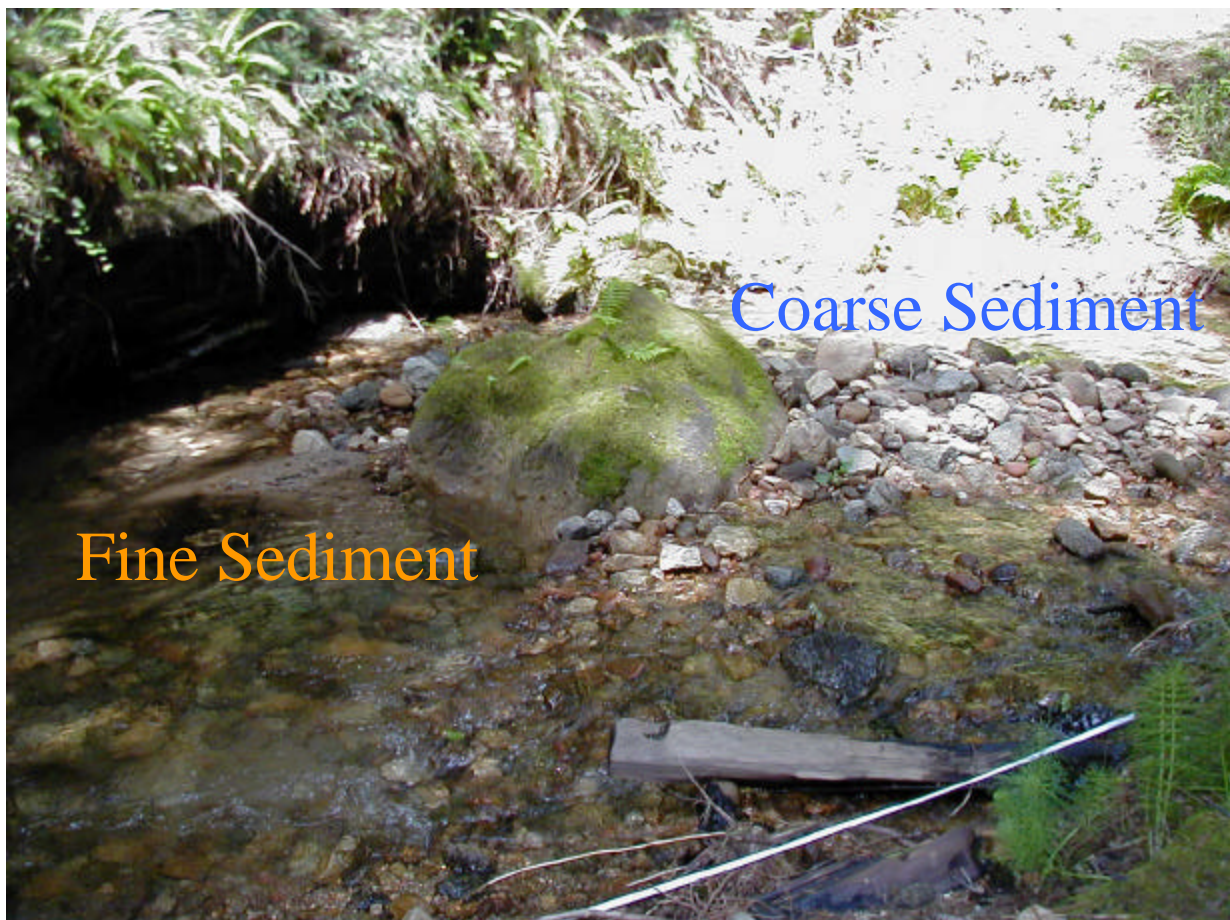
**Sketch 4 – Debris at sharp left turn**

The boulder in Sketch 4 was examined for comparison purposes. The deposition of coarse deposits in front of the obstruction and fine sediments below, appear very similar to sediment stratification by LWD station #3. As also seen at LWD station #3, the stream becomes divided.

Image 10: Photo of area of Sketch 4

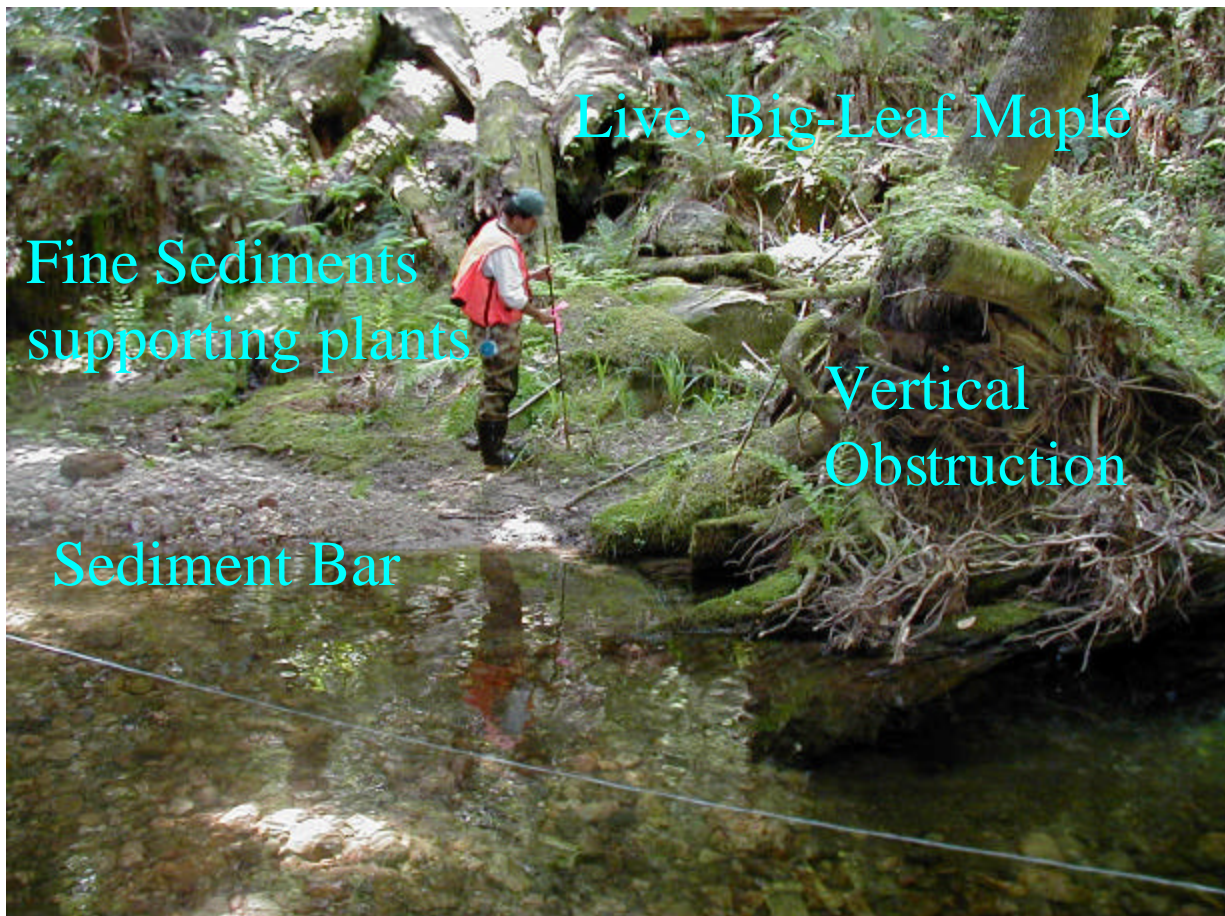
**Sketch 5 – Back eddy deposits and point bars**

Sketch 5 depicts a unique opportunity to view vertical LWD structures that mirror each other. As the flow is forced around the structure, velocity in crease, causing scour and a back eddy. The eddy deposits were significantly deeper than other areas absent LWD structures. What was interesting to note was the stratification of sediments within the deposition bar.

Image 11: Photo of area of Sketch 5

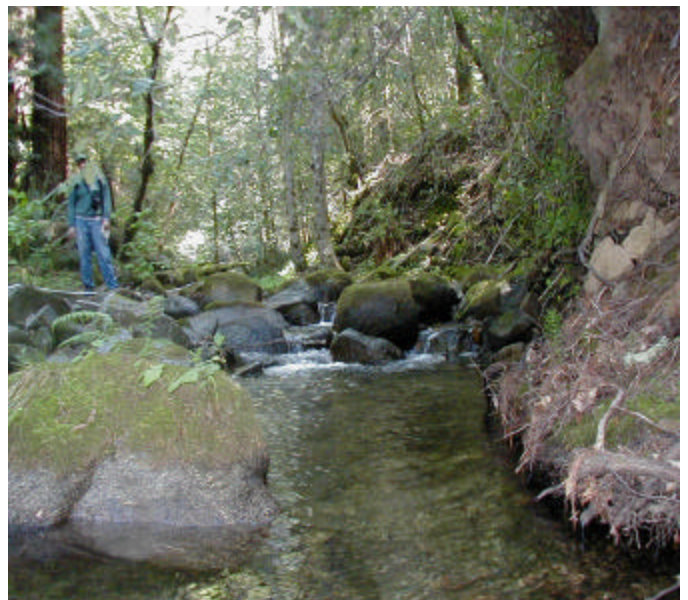
We observed pools along the creek bed that are located after a stepping of the creek profile. Image 12, looking upstream, shows a pool formation after the stepping of the creek. Another interesting note about the image above is that the pool is forming at the base of a bank-side tree.

**Image 12: View of Creek Upstream  
Shows Pool and Steps**
