Driver Behavior at Rail Crossings: Cost-Effective Improvements to Increase Driver Safety at Public At-Grade Rail-Highway Crossings in California

DRIVER BEHAVIOR AT RAIL CROSSINGS

COST-EFFECTIVE IMPROVEMENTS
TO INCREASE DRIVER SAFETY
AT PUBLIC AT-GRADE RAIL-HIGHWAY
CROSSINGS IN CALIFORNIA

DOUGLAS L. COOPER
and
DAVID R. RAGLAND

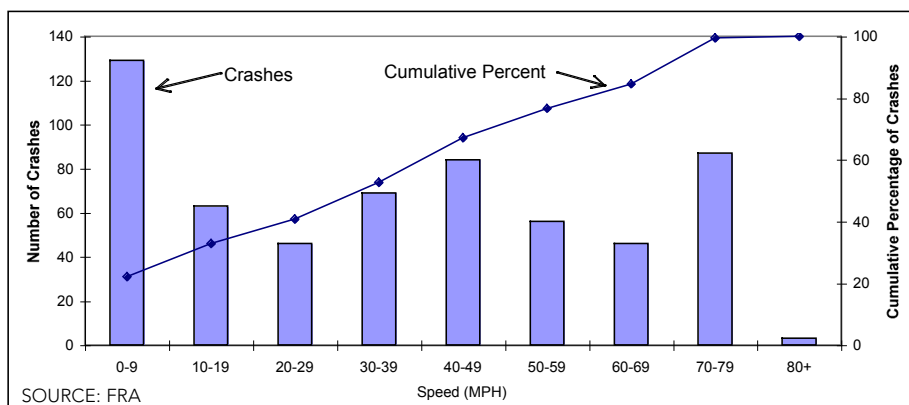
Figure 3

SPEED OF TRAINS INVOLVED IN CRASHES AT PUBLIC CROSSINGS IN CALIFORNIA (2000-2004)

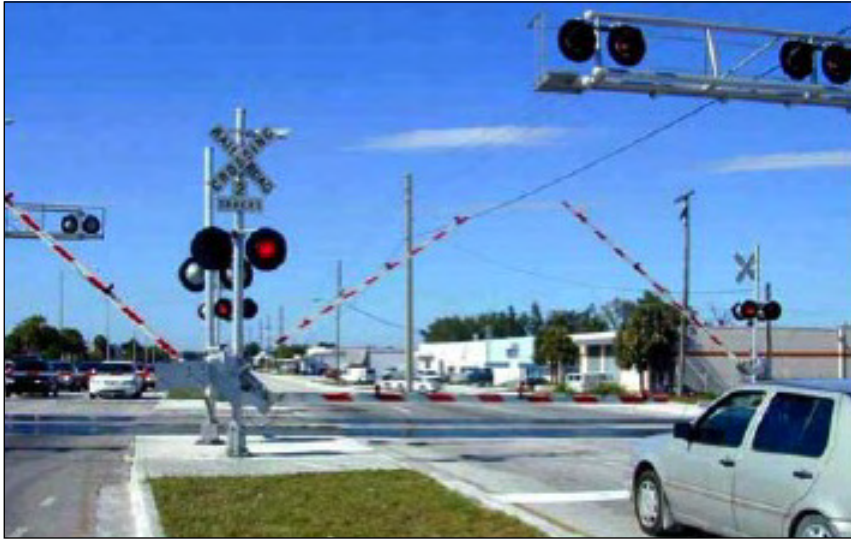
Figure 8

FOUR-QUAD GATE SYSTEM PICTURE AND DIAGRAM

Four-Quadrant Gate Systems consist of a series of automatic flashing-light signals and gates where the gates extend across both the approach and departure side of roadway lanes. Unlike two-quadrant gate systems, four-quadrant gates provide additional visual constraint and inhibit nearly all traffic movements over the crossing after the gates have been lowered. At this time, only a small number of four-quadrant gate systems have been installed in California and incorporate different types of designs to prevent vehicles from being trapped between the gates.

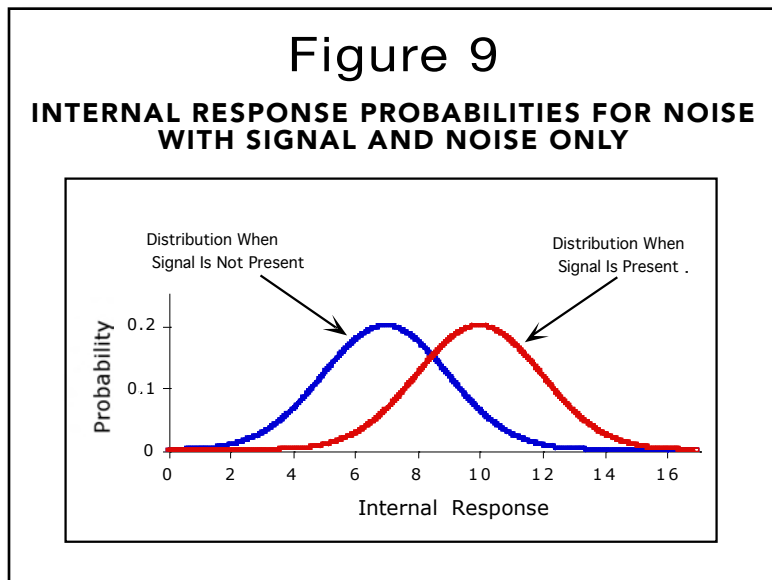
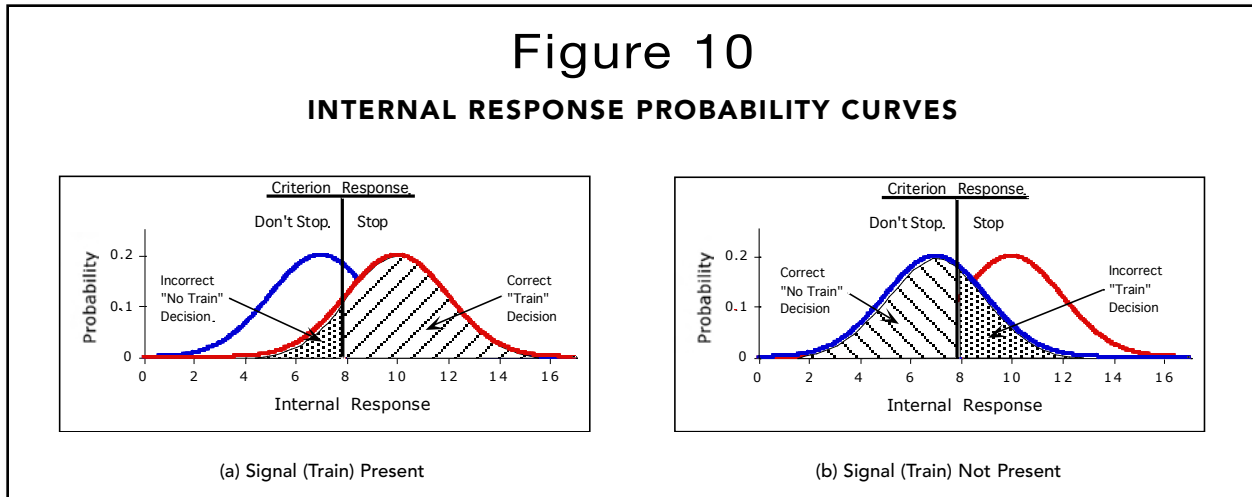
A typical representation of noise and signal plus noise only distributions are shown in Figure 9.

A key point to note is that the distributions overlap. Thus there are times when it is not possible to distinguish between signal and noise, necessitating the adoption of some other means to decide which it is and what action to take. This is the criterion and the point on the internal response axis at which this criterion is set is the criterion line (see Figure 10).

In the case of the motorist at a crossing, the criterion line provides the basis for the decision to stop (all points to the right of the line) or continue crossing (all points to the left of the line). There are four potential outcomes for the decision as shown in Table 11. There are two response categories: "Stop (the train is too close)" and "Don't Stop (the train is not too close)." And there are two possible events: a train is close to the crossing and a train is not too close to the crossing (or not present).

These outcomes can be seen in Figure 10 where the train is close in diagram (a) and not close or absent in diagram (b). For our purposes, the more important question is not whether or not the train is perceived as present but rather is it perceived as close enough and moving fast enough to represent a threat to the driver's crossing the tracks ahead of it.

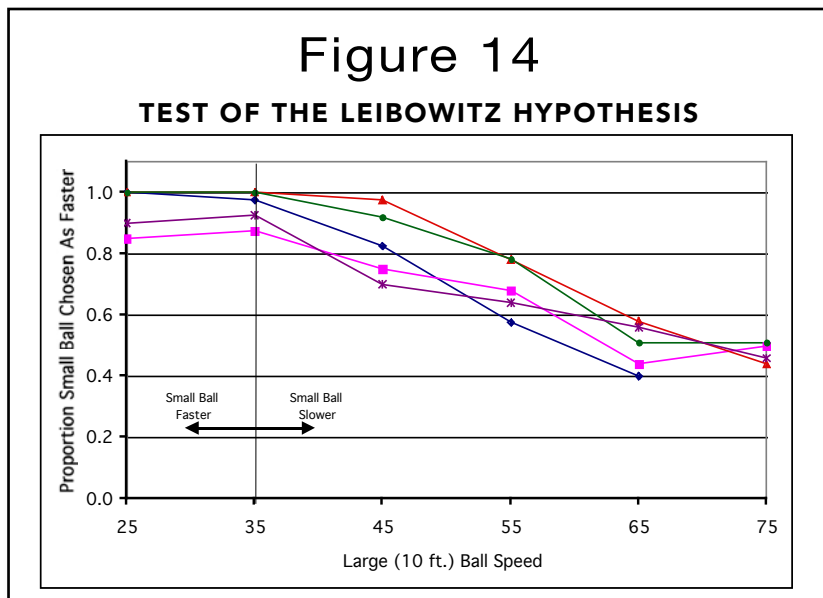
The authors tested the ability of five males, ranging in age from the early 20s to the mid 50s, with corrected normal eyesight to identify the faster of two different sized approaching spheres. The results of these tests are summarized in Figure 14, which plots, for each subject, the proportion of times the 5 ft diameter sphere was judged to be faster (P5) as a function of 10 ft sphere speed (V10). This shows a strong tendency to judge the smaller sphere as the faster, even when the actual approach speed of the larger sphere is 20 mph greater (V10=55 mph). Only when V10 reaches speeds of 65-75 mph (twice that of the smaller sphere) does the observer become unsure as to which is approaching faster (P5=0.5).

The experimental data, then, show a strong tendency to judge the smaller ball to be the faster, even when the opposite is the case, and often by a considerable margin. The plots in Figure 14 suggest that experimenters would have to include trials in which the large ball approaches in excess of 95 mph (2.7 times faster than the small ball) before subjects would unambiguously pick the large ball as the faster approaching.

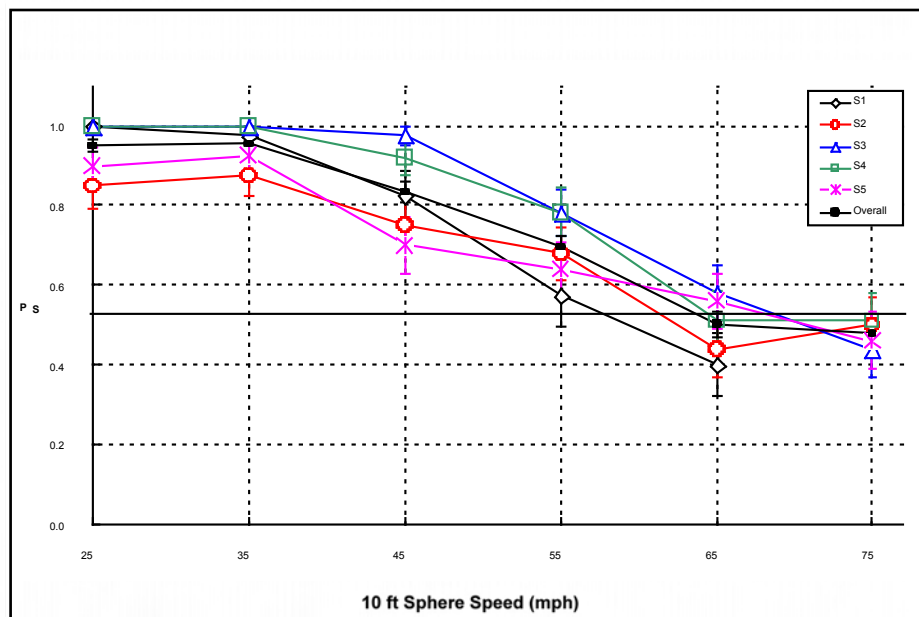
Figure G-2: Experimental Results

We tested the ability of five males (labeled S1 to S5, ranging in age from the early 20's to the mid 50's, with corrected normal eyesight) to identify the faster of two, different sized approaching spheres. The results of these tests are summarized in Figure G2, which plots the

proportion of times the 5 ft diameter sphere was judged to be faster (P_5) as a function of 10 ft sphere speed (V_{10}). This shows a strong tendency to judge the smaller sphere as the faster, even when the actual approach speed of the larger sphere is 20 mph greater ($V_{10} = 55$ mph). Only when V_{10} reaches speeds of 65-75 mph (twice that of the smaller sphere) does the observer become unsure as to which is approaching faster ($P_5 \approx 0.5$).

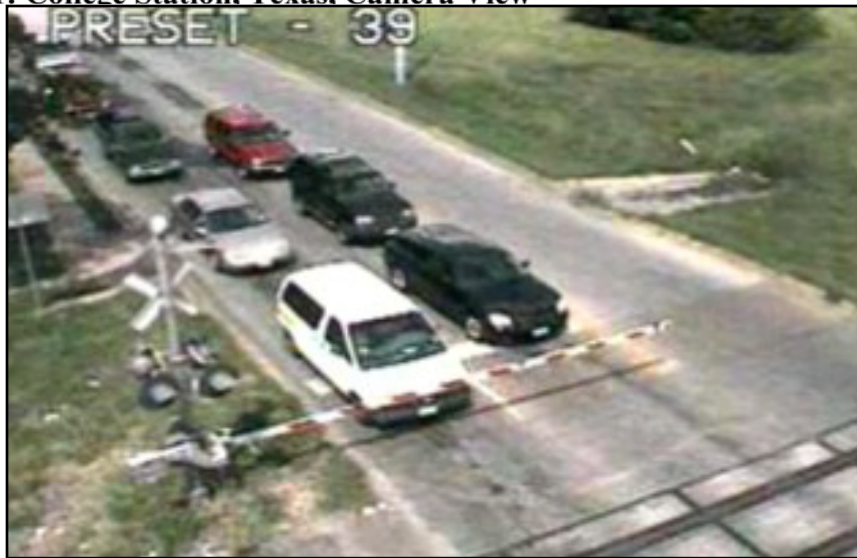
Figure I-1: College Station, Texas. Camera View

The camera used for our observations is located on a pole on the southwest corner of the intersection of Holleman Drive and Wellborn Road where the tracks cross Holleman. Since we did not control the camera, our view was limited to the west side of the tracks as Holleman approaches Wellborn. The camera view is shown in Figure 1. This is not an ideal location for driver behavior research in that there is room for only one car per lane between the tracks and Wellborn (Figure 2). This space is quite often full, thus taking away the possibility of driving under or around the rail line crossing gates. Also, the position of the camera did not allow us to observe the flashing lights.

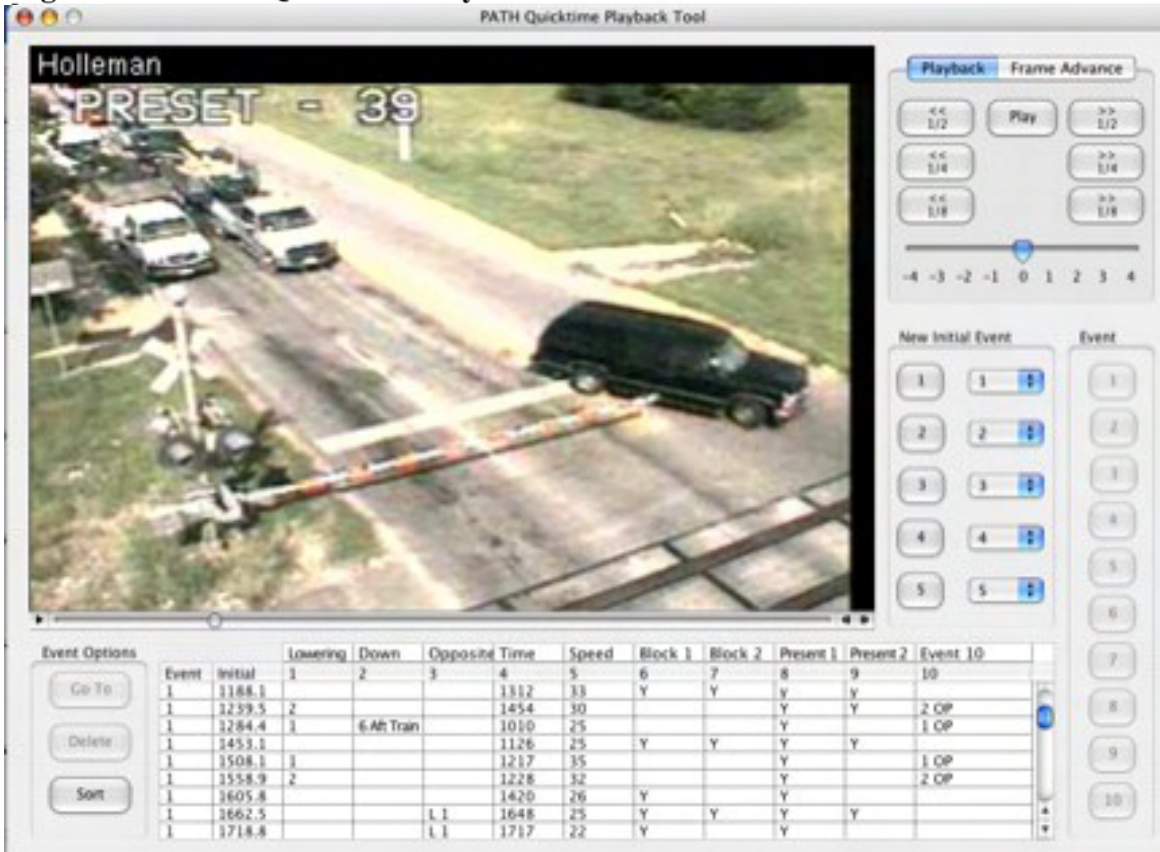
Figure I-4: PATH Quicktime Playback Tool

The final data collection step utilized the PATH Quicktime Playback Tool shown in Figure 13. This tool allowed us to view the video at various speed, including frame by frame, time stamp events, and record the various kinds of infractions and behaviors. The resulting text file can then be opened and analyzed in Microsoft Excel.

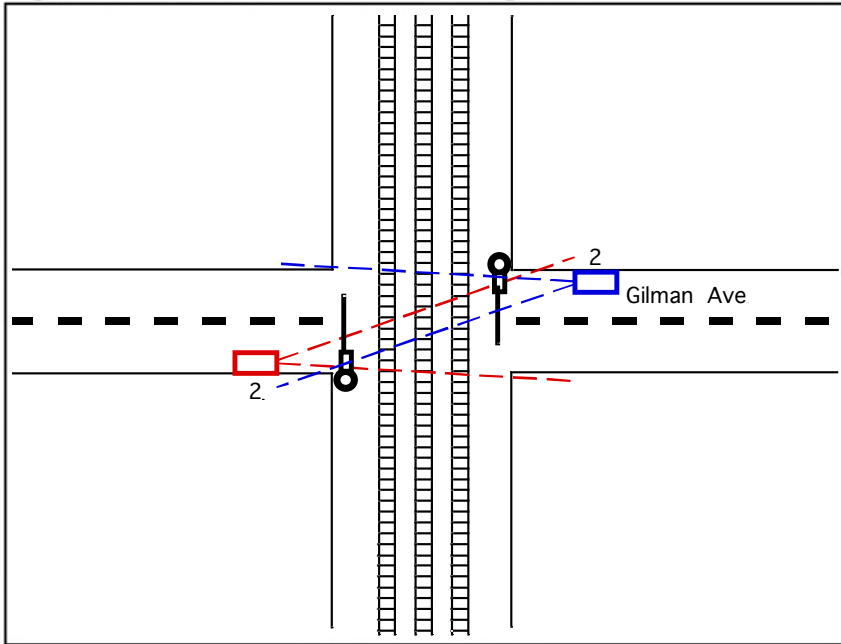
Figure I-7: Gilman Ave. Second Setup

These problems were solved by going to the setup shown in Figure 16. Here the vans were moved directly across the street from their original position so that they could view traffic diagonally across the tracks. Also, the cameras were mounted on poles which offered a much better view.
