Piloting A Monitoring Program For CCC LWD Projects

PILOTING A MONITORING PROGRAM FOR CCC LWD PROJECTS

LD ARCH 227

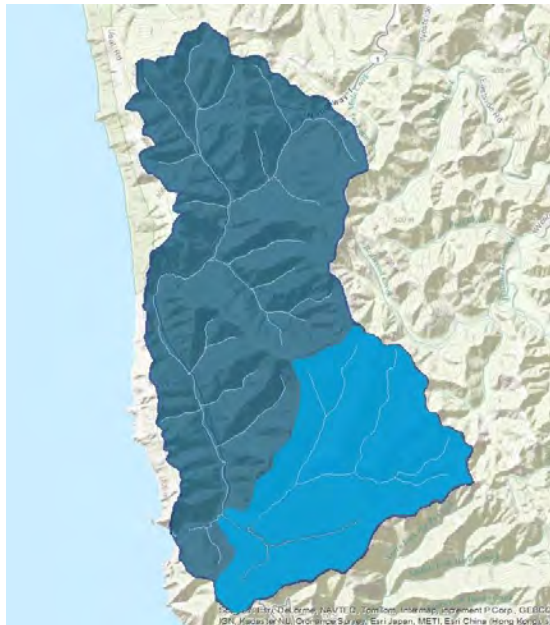
Figure 2: Watershed Boundary (SF Cottaneva in aquamarine)

South Fork Cottaneva Creek is located in coastal Mendocino County, California (Figure 1). It is a tributary to Cottaneva Creek, and drains approximately 5.4 square miles to the Pacific Ocean. South Fork Cottaneva Creek has approximately 5.6 miles of blue line stream, which supports both coho salmon and steelhead trout. The entire watershed is owned and
