A Decade of Changes in the Wildcat Creek Flood Control Channel, North Richmond

Landscape Architecture and Environmental Planning 222: Hydrology for Planners

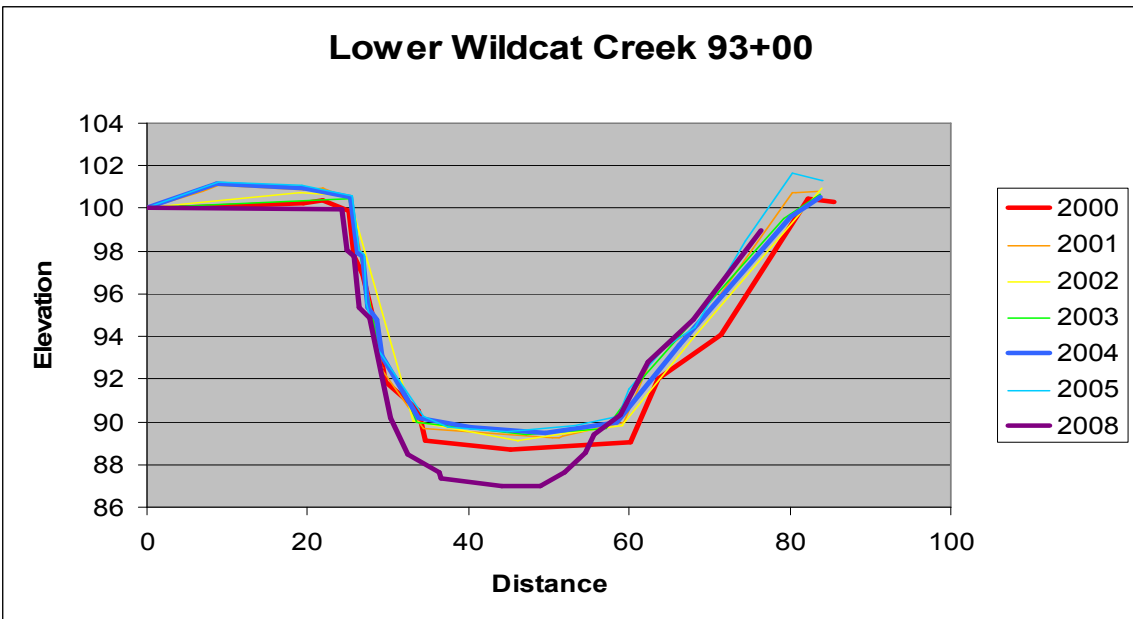
Figure 6: Cross section 9300 feet above San Pablo Bay. Looking upstream with distance zero on the right bank of the channel.

As with the first two cross-sections the level of the 93+00 cross-section was raised slightly during the year of construction. From 2001 to 2005 the level and dimensions of the channel remained static. However from 2005 to 2008 the channel degraded almost two and a half feet while the banks remained static.(figure 6 & 12)

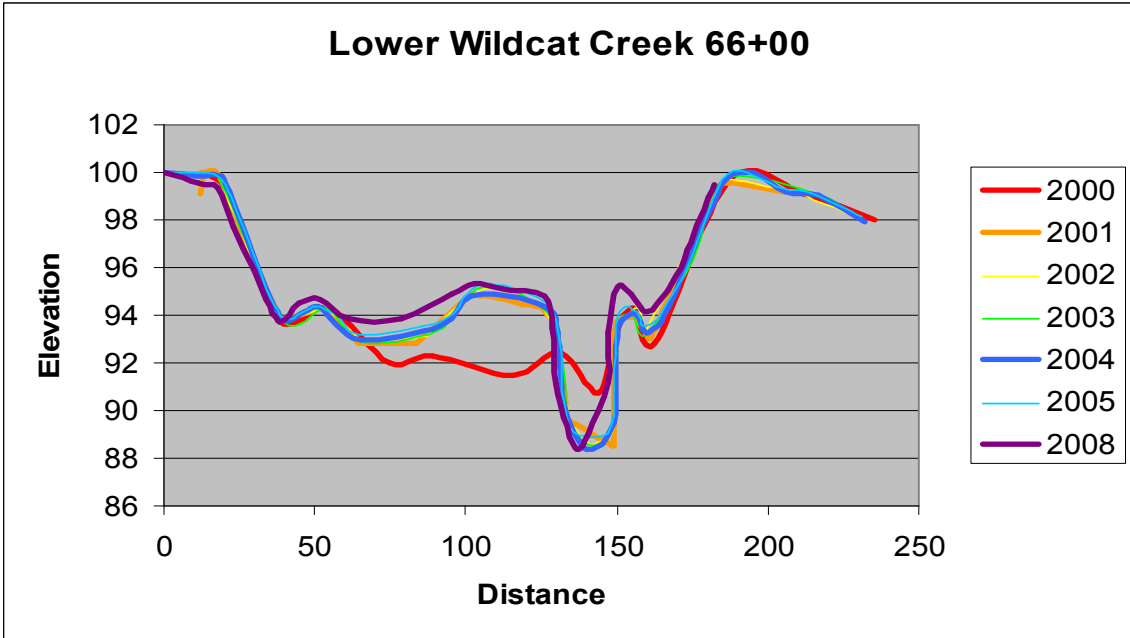
Figure 9: Cross section 6600 feet above San Pablo Bay. Looking upstream with distance zero on the right bank of the channel.

The channel below Giaramita Avenue can be characterized as consisting of two channels; one of which is a wide floodplain and the other is the deep, narrow low flow channel that meanders through the riparian corridor on the south side of the profile. The same morphological changes have occurred at all three of the lower cross-sections over the years. From 2000 to 2001, during which time the project was reworked, the thalweg of the low flow channel was lowered from two to three and a third feet. During the same year the level of the floodplain was raised 1.3 ft at the 66+00 profile but staid relatively the same at the 83+00 and 88+00 cross-sections. Since the project was created the level of the floodplains at all three cross-sections have slowly but steadily aggraded with thalwegs raising an average of 0.89 ft for the three cross-sections. The thalwegs for the low flow channel migrated slightly but hovered around the same elevation up until 2005. However, from 2005-2008 the low flow channel has entrenched.(figures 7,8,9,13,14 & 15)

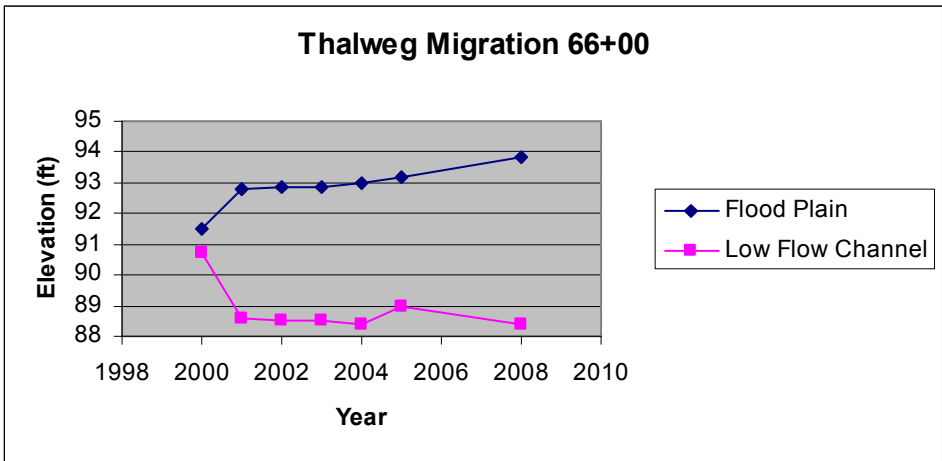
Figure 15: Vertical Thalweg migration of the flood plain and low flow channel 6600 feet above San Pablo Bay.

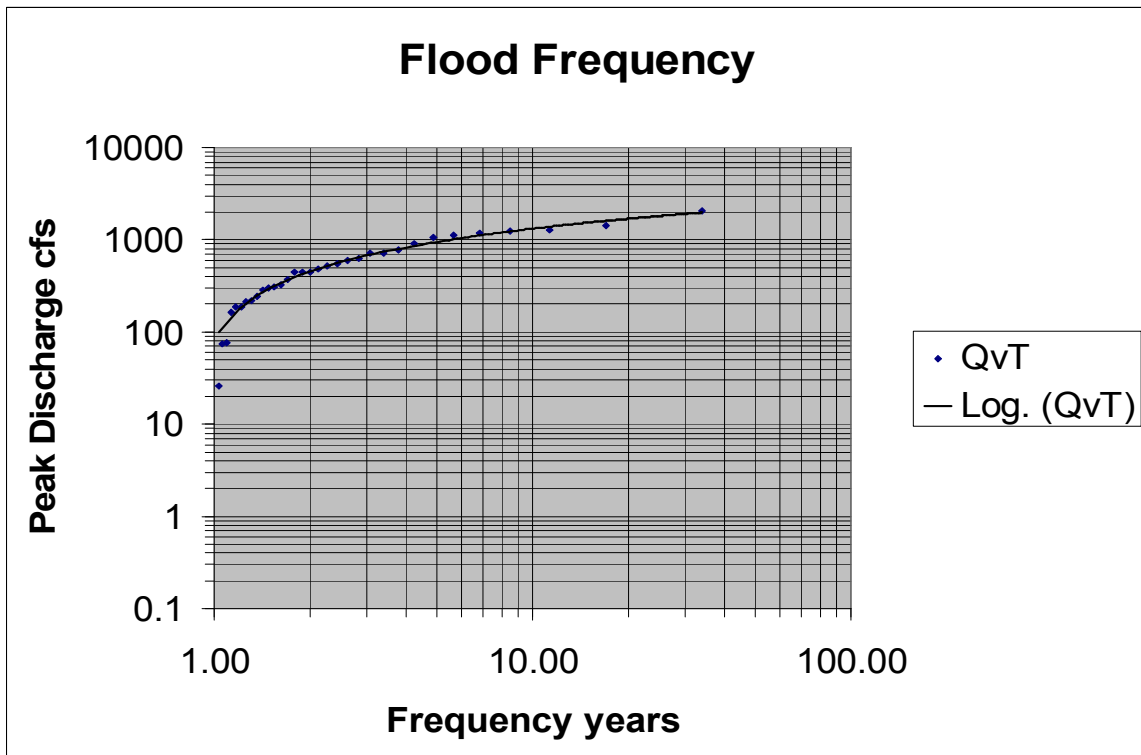
Figure 16: Flood Frequency Curve for Wildcat Creek based on USGS gauge data from 1965-1997

Upon returning from the field the data was synthesized and put into a Microsoft Excel spread sheets. Data from the surveys conducted from 2000-2005 (obtained from PHD student Hsiao-Wen Wang) was also put into these spread sheets. The cross-sections were graphed, overlaid, and lined up so that all seven years of data for one cross-section were seen on one plot.(figures 4-9) This way it was possible to see the morphological changes over time. From the data sets the thalweg for the low flow channel and the flood plain for 88+00, 83+00 and 66+00, or just the channel in general for 96+26, 95+55 and 93+00, were graphed over time.(figures 10-15) Furthermore a gauge records from the USGS gauge on Wildcat Creek at Vail Road were used to construct a flood frequency curve for the creek.(figure 16)

Using the flood frequency curve (figure 16) and the graph of annual peak flows on Wildcat Creek (figure 19) it is possible to determine the return intervals and the magnitudes of the flows during the time of monitoring. The two largest flows occurred in 2003 and 2006. The 2003 peak flow had a discharge of 1685 cubic feet per second (cfs) and a return interval of 20 year. The 2006 peak flow had a return interval of 35 years and a discharge of 1994 cfs.

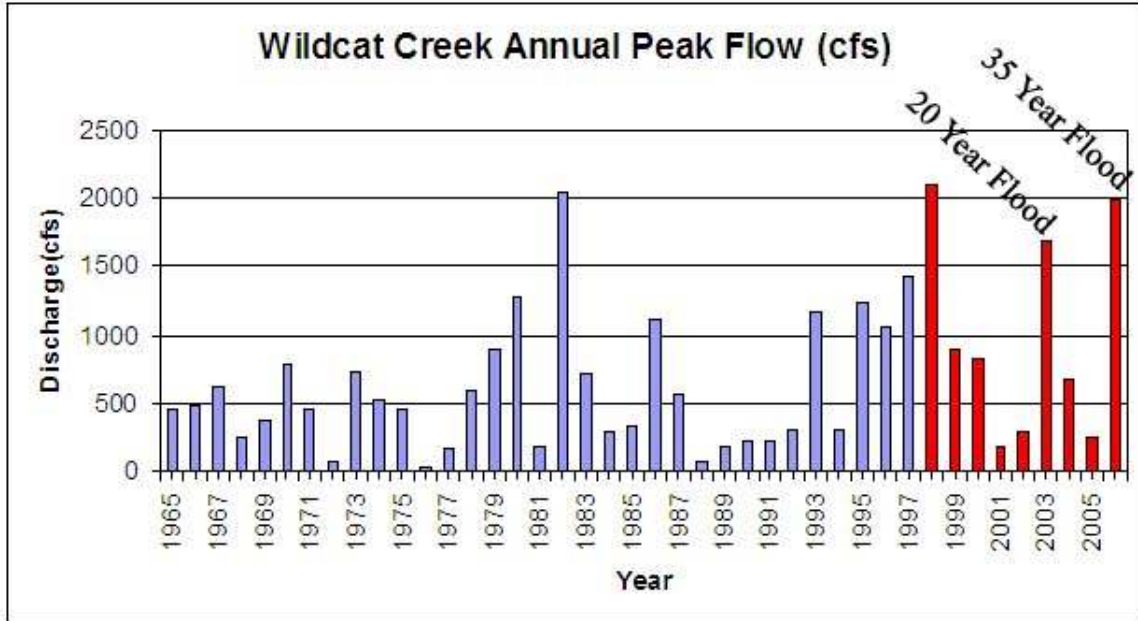
Figure 19: Wildcat Creek Annual Peak Flows 1965-2006 based on USGS gauge data and interpolation from San Ramon Creek USGS gauge data using the linear regression equation from the double mass curve (figure 18)

Finally, a graph of annual peak flow was created for Wildcat Creek from 1965-2006.(figure 19) This was done by first inputting data from the USGS gauge which ran up until 1997.(figure 17) Then to extrapolate for the next ten years the peak flows for Wildcat Creek were

plotted against the peak flows for near by San Ramon Creek creating a double mass curve.(figure 18) A linear regression was done on the scatter plot to come up with an equation which related the peak flows of Wildcat Creek to those of San Ramon Creek year to year. Using this equation and the gauge data from San Ramon Creek from 1998-2006 the approximate peak flows on Wildcat Creek, for those years, were calculated. Putting all this data together an annual peak flow graph was constructed for Wildcat Creek.
