## Restoration of Rivers and Streams (LA 227)

Post-Project Appraisal of Crocker Creek Dam Removal Project, Sonoma Co., California

December 13, 2005

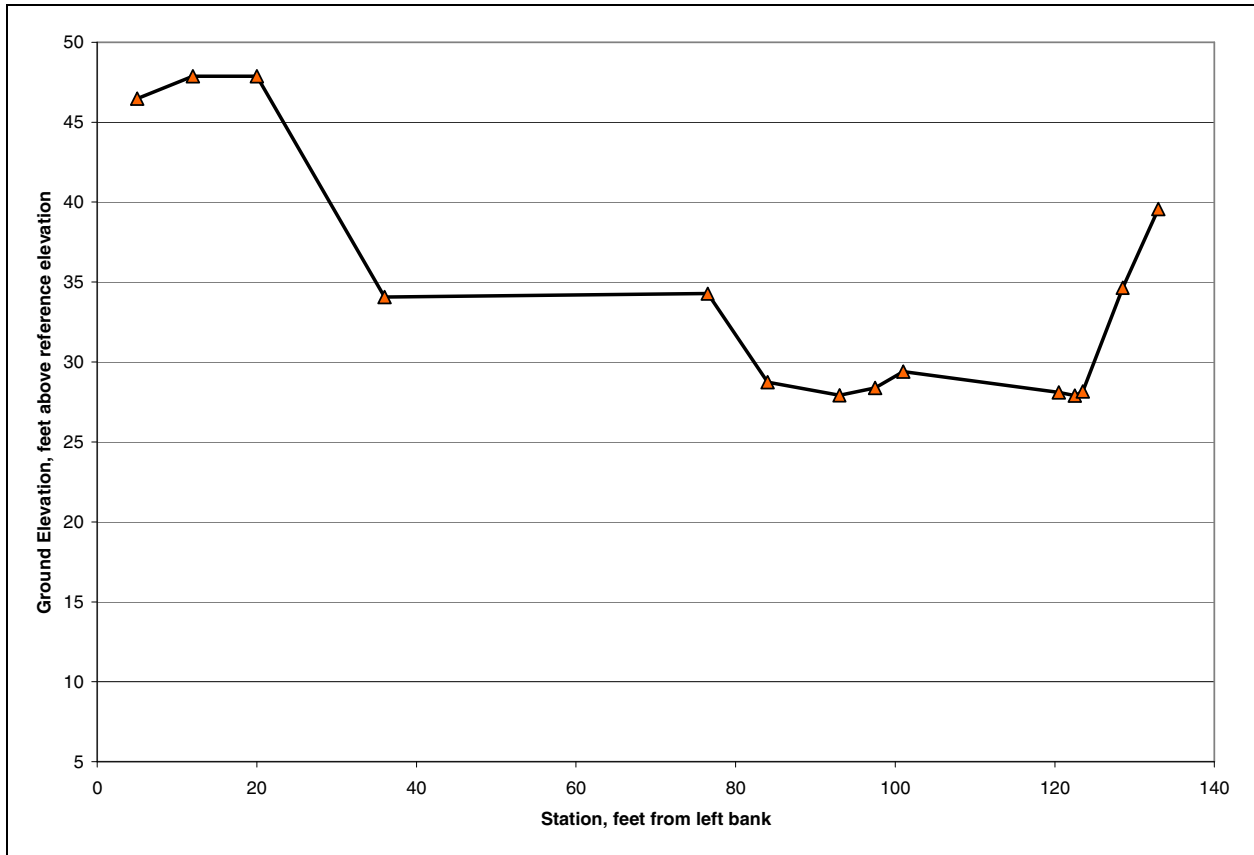
**FIGURE 11.** Cross-section 2 (CS2) located at Station 217 on longitudinal profile. Cross-section intersects longitudinal profile at thalweg (CS2 Station 82). Ground elevation, in feet above reference elevation (0 ft at Station 1242), is plotted vs. Station, as feet from left bank.

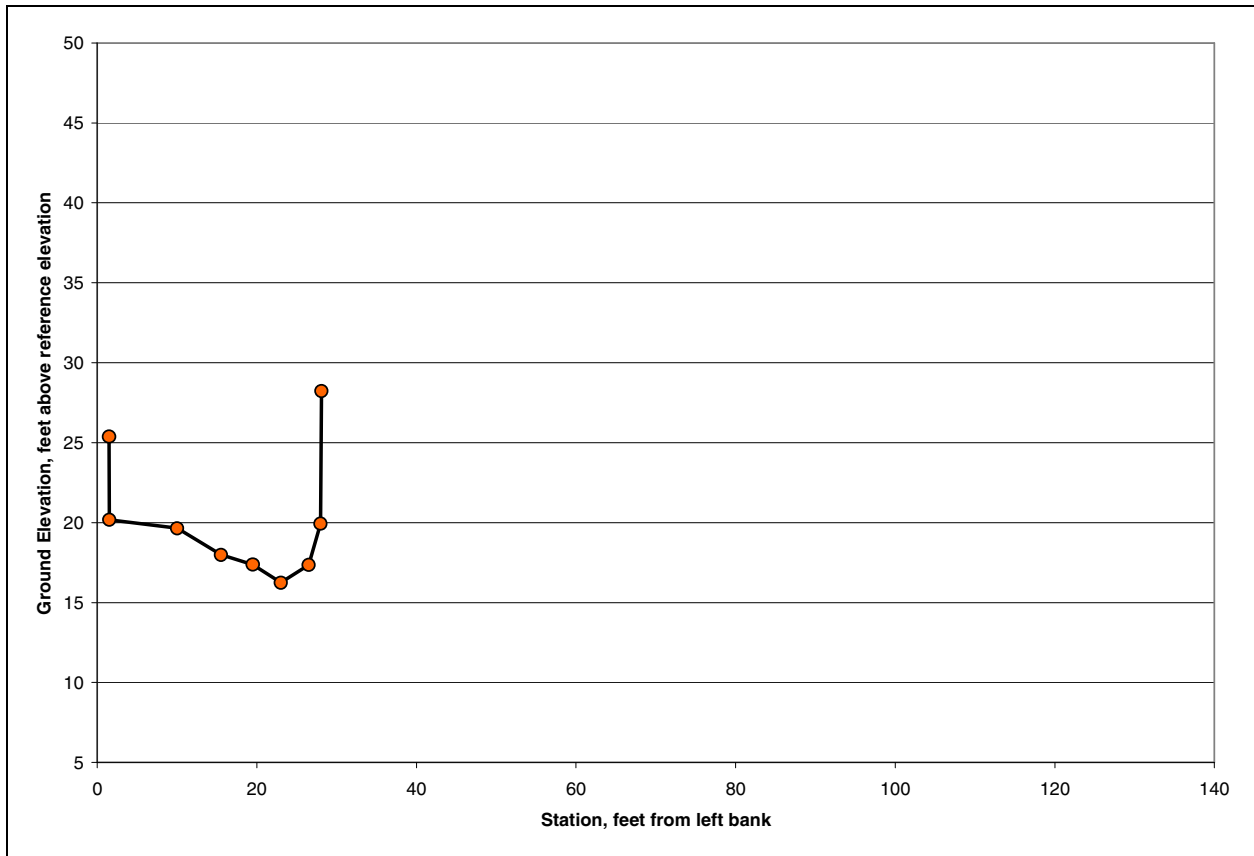
active erosion. Erosion of the left bank is occurring just downstream from the above-mentioned right bank location, suggesting that the flow is possibly being deflected from the right bank into the left bank. The cross section of this area, Figure 12, exhibits the vertical banks at this location. Due to the vertical nature and height of the right bank, undercutting would cause a large section of the bank to collapse, thus depositing large amounts of sediment into the channel.

**FIGURE 12.** Cross-section 3 (CS3) located at Station 311 on longitudinal profile. Cross-section intersects longitudinal profile at thalweg (CS3 Station 93). Ground elevation, in feet above reference elevation (0 ft at Station 1242), is plotted vs. Station, as feet from left bank.

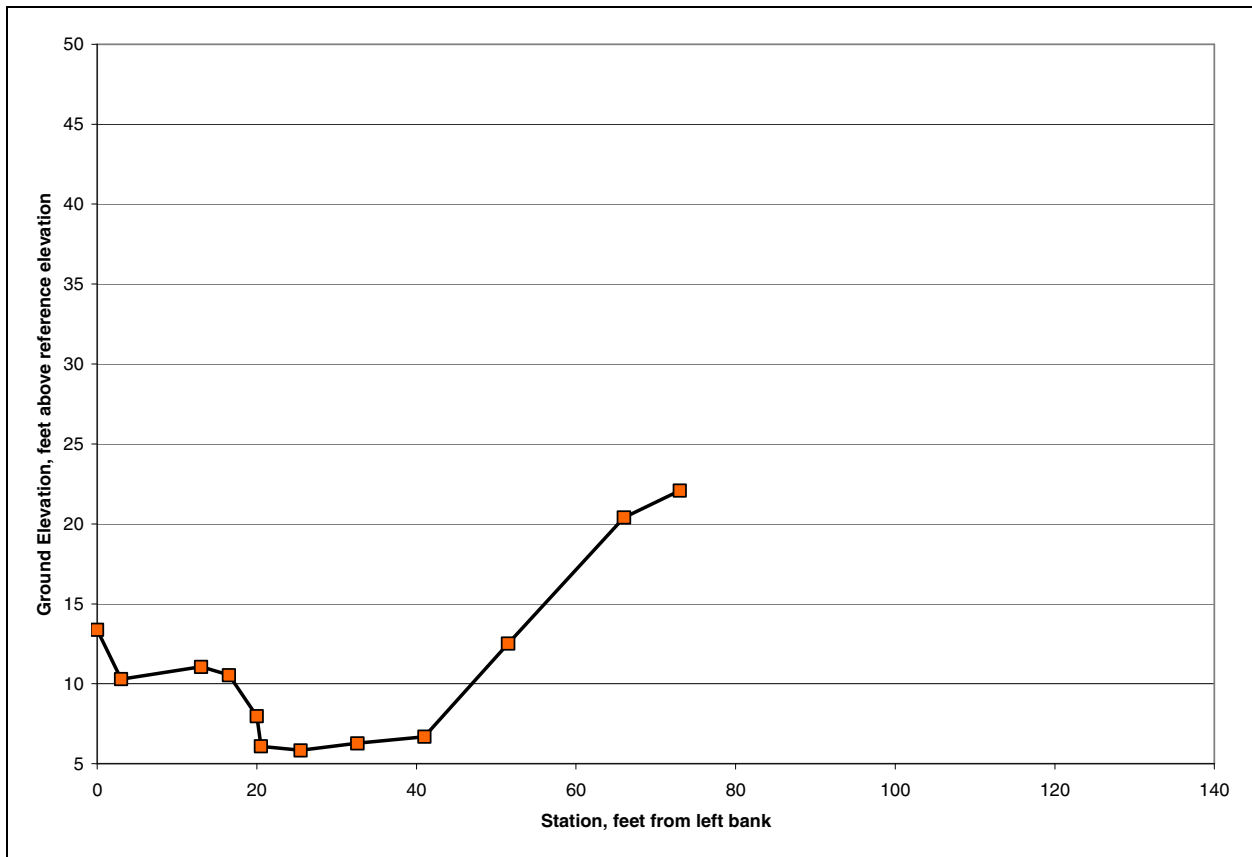
**FIGURE 13.** Cross-section 4 (CS4) located at Station 835 on longitudinal profile. Cross-section intersects longitudinal profile at thalweg (CS4 Station 23). Ground elevation, in feet above reference elevation (0 ft at Station 1242), is plotted vs. Station, as feet from left bank.
