Post-project appraisal of Martin Canyon Creek restoration

Post-Project Appraisal of Martin Canyon Creek Restoration

Final Project
LAEP 227
Fall 2006
Wayne Wagner
Jesse Roseman

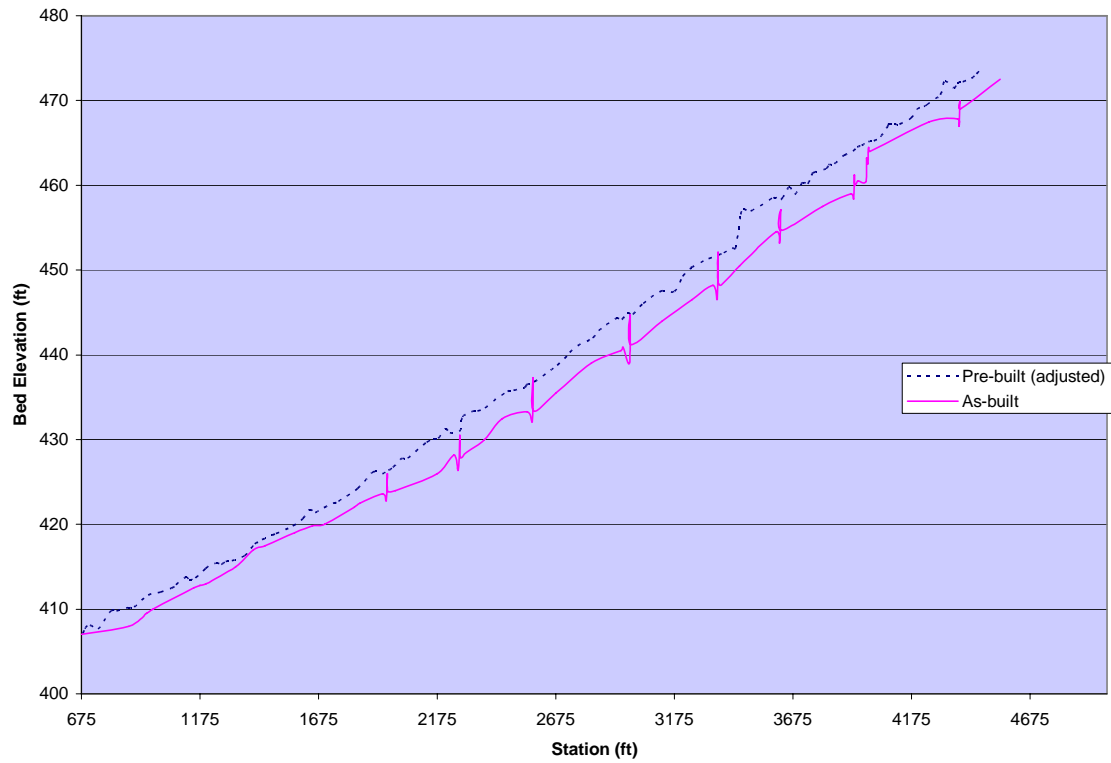
Figure 4: Pre-built (adjusted) vs. As-built long profile

The benchmark for our long profile was the upstream end of the culvert which goes below Silvergate Drive, at the lower end of the project reach. The elevation at this point was given as 407 feet in the project documentation.¹⁰ The pre-built survey however used this elevation at station 0, which was 675 feet downstream of the culvert (Figure 3). Both the pre-built and as-built surveys place GC1 in the same equivalent location, near station 1970, showing that the stationing appears consistent between the two. For comparative purposes, we therefore adjusted the pre-built survey using 407 feet for the elevation at its station 675, with the remaining upstream values adjusted accordingly. Despite the adjustments, the pre-built survey was still higher than the as-built (Figure 4). While this difference could be due to erosion during

the high flows in 1998 between the two surveys, it could also be some undetermined difference in surveying techniques.

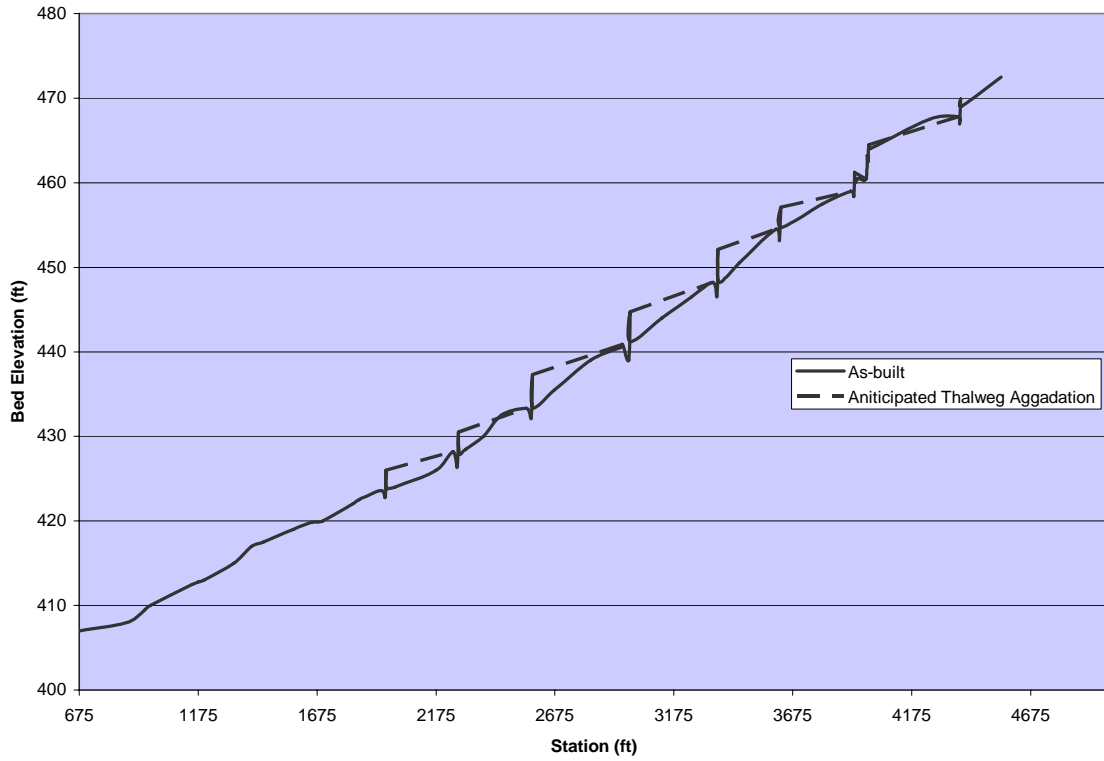
Figure 6: Expected post construction long profile

Directly upstream of the grade control structures, the stream bed is aggrading, with fine sediments collecting and visible (Figure 5). The long profile matches that expected by the project designers (Figure 6). Directly below grade control structures however the opposite trend is occurring with localized degradation. This could just be the effect of the plunge pools, but the results are more extensive than just these small areas (Figure 7).
