Post Project Appraisal of Village Creek Restoration, Albany, CA

# **Post Project Appraisal of Village Creek Restoration, Albany, CA**

**LA 227 Restoration of Rivers and Streams**

*December 12, 2005*

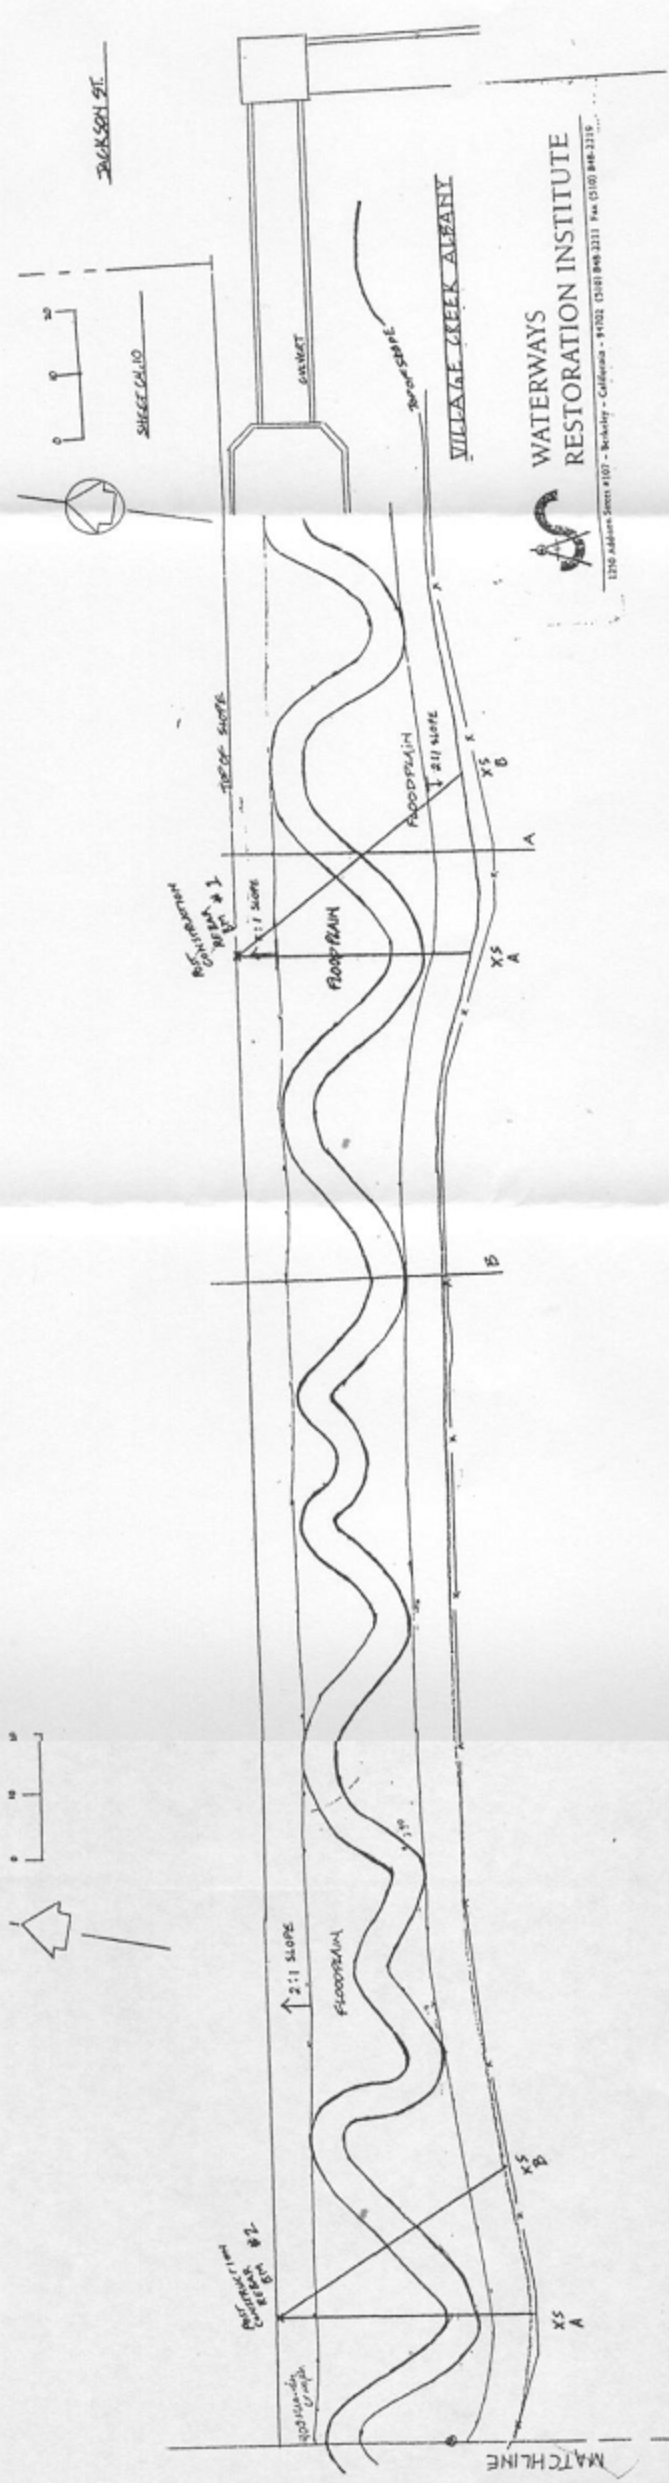
Figure B.1: As-built facies map of Village Creek - Section 1

The channel map shows the evolution of the channel bed since 1998. The general shape of the channel has not significantly changed except for slight movement in some meanders (Figures A.1-3 and B.1-3). One significant difference is that the current channel bed changes directions 41 times during the 740 feet between the two culverts, while the as-built channel shape included 42 changes. The bend located at approximately 250 feet from the upstream culvert (04+90) has straightened since the restoration. We found that there is 860 feet of meander for the 740 linear foot reach. This results in approximately 116 feet of meander per 100 linear feet. Although we do not know the as-built meander length, the design called for 160 feet of meander per 100 linear feet. Therefore, the current channel contains about 324 feet less meander than the original design. Considering the channel shape has not changed significantly, except for the loss of one meander bend, the as-built meander length could not have been the design length of 160 feet per 100 linear feet. It would have been slightly larger than the current ratio of 116 feet of meander to 100 linear feet.

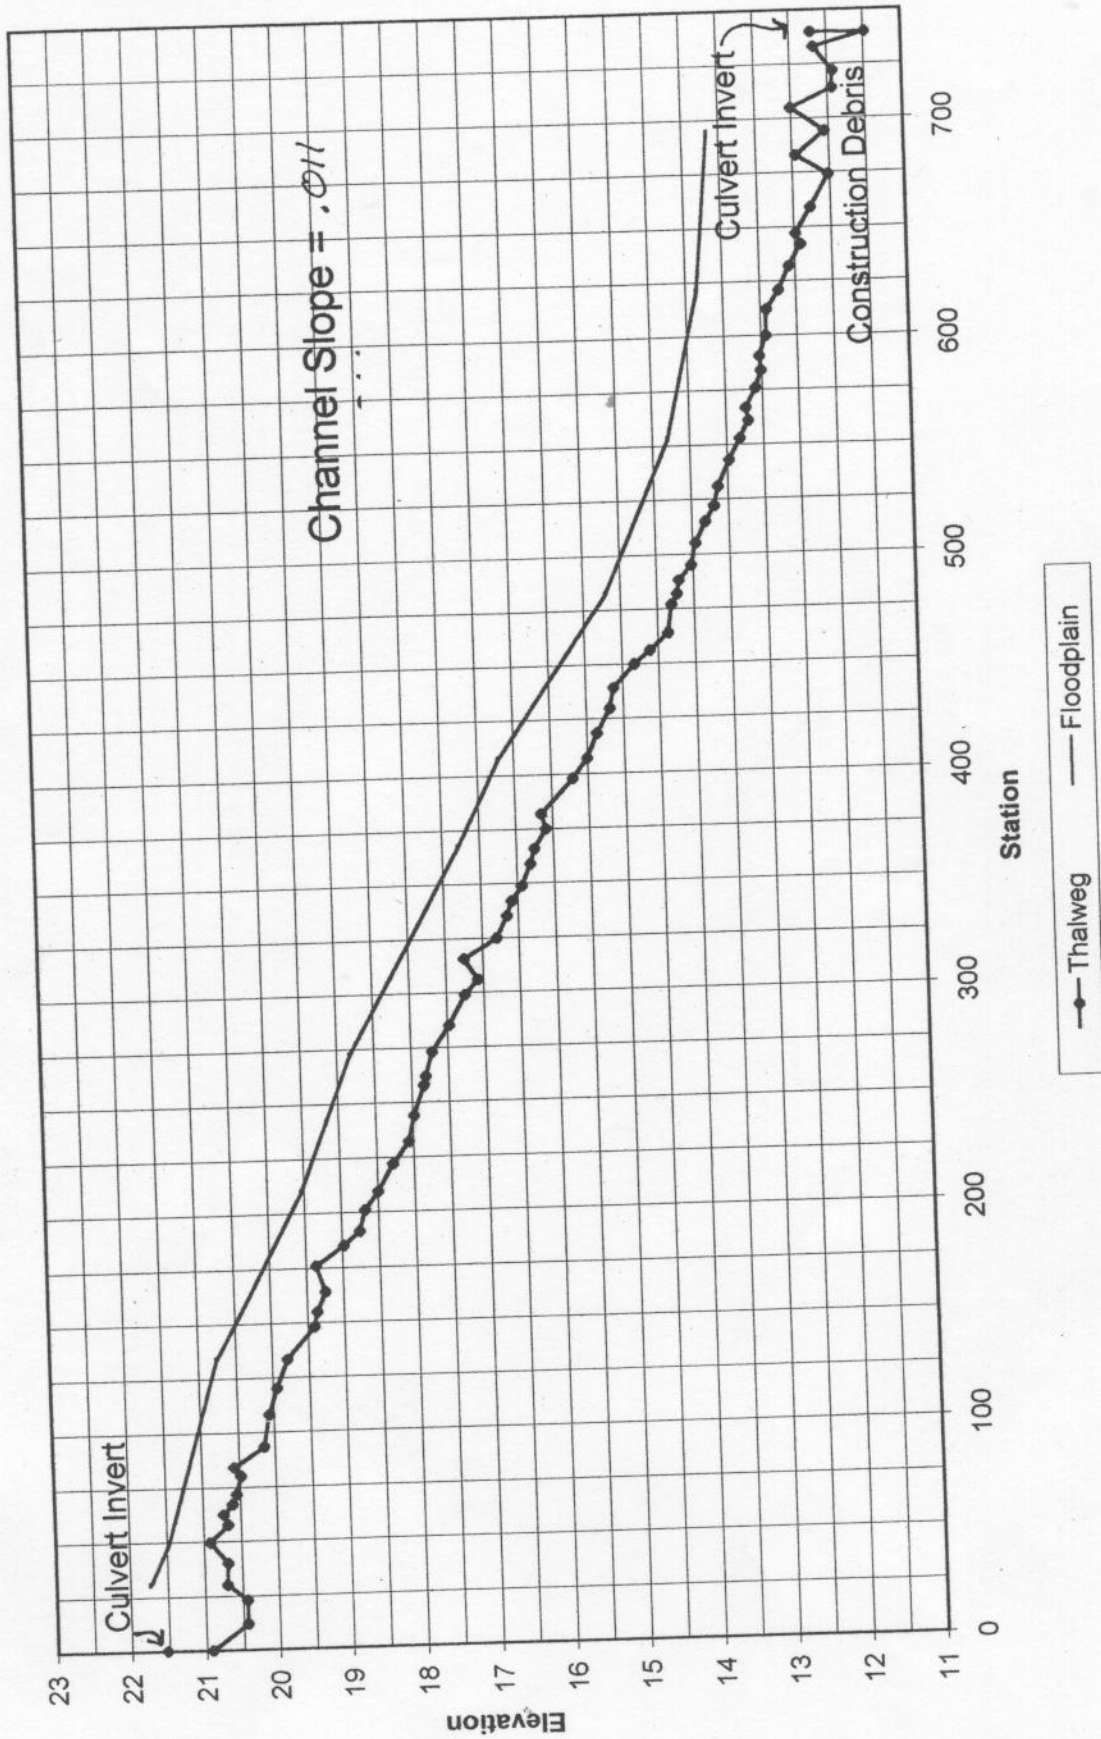
Figure B.9: As-built longitudinal profile (along linear distance from upstream to downstream culvert) - Village Creek

1) We have found that the as built longitudinal profile was conducted along the linear distance from the upstream to downstream culvert and not along the thalweg/channel. We understand that you may not have directly been involved in the as built study but do you have any ideas as to why they conducted the profile this way?
