Gully incision in Gerbode Creek, Rodeo Lagoon watershed

Title: Gully Incision in Gerbode Creek, Rodeo Lagoon Watershed

Raymond L. Costantino
Dept. City and Regional Planning
University of California, Berkeley
Final Paper
December 17, 2003

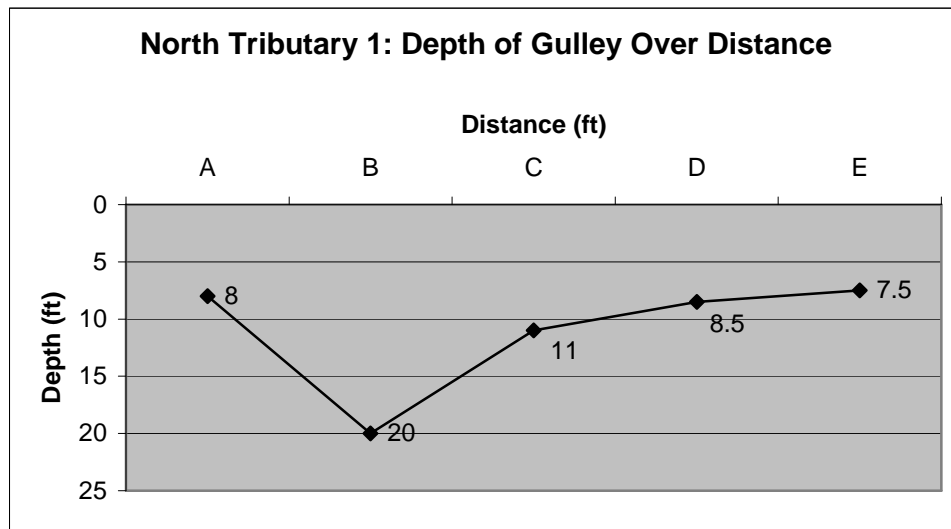
Graph 1.

Depth of North Tributary #1: Point A is the source of the tributary and point E is closer to the confluence. Willows stop growing at point B, and give way to Coyote Bush and grasses. By point D they reappear. To see the cross section of each point refer to Appendix I.

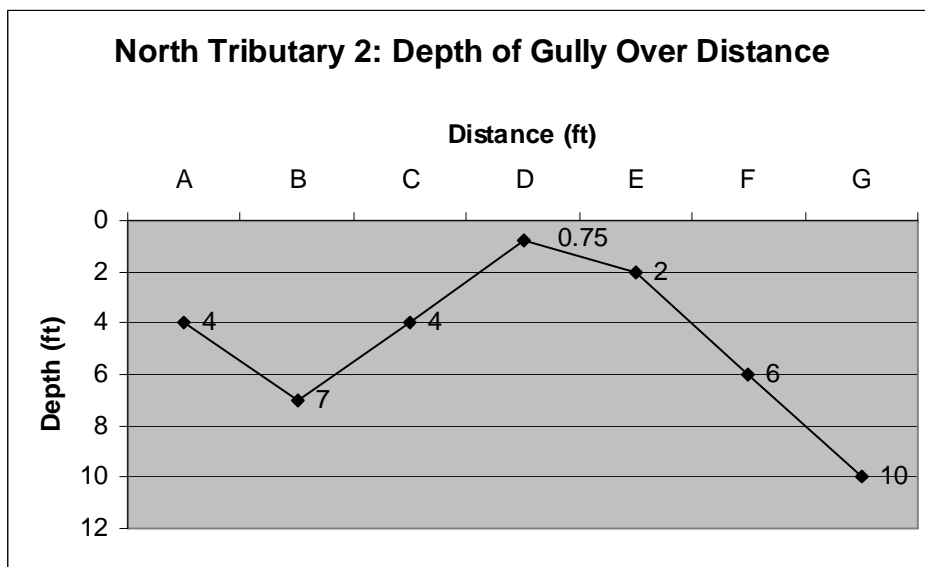
Graph 2.

Depth of the North Tributary #2: Point A is the source of the tributary and point G is towards the main stem. The tributary at point A starts at a depth of 4 feet, then lowers to 7 feet before it rises close to grade at 0.75 feet. It then lowers to a depth of 10 feet. To see the cross section of each point refer to Appendix I.

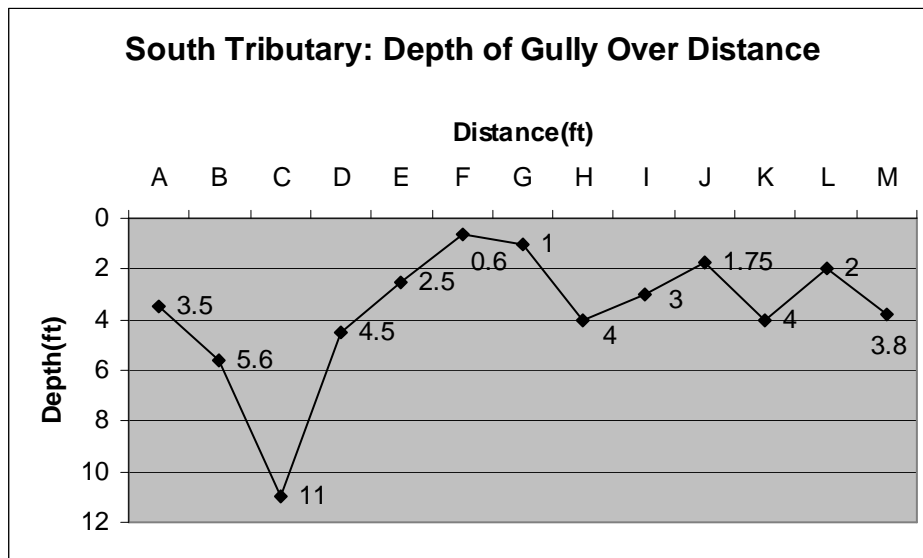
Graph 3.

Depth of the South Tributary: Point A is close to the source the tributary, before the Bobcat Trail Culvert. Point M is closest to the main stem. Notice that the bottom of the tributary begins at 3.5 feet and decreases to 11 feet and then it increases to 0.6 feet, which is almost grade level. Then the bottom lowers and rises between 2 and 4 feet (approximately, refer to line graph) before it finally lowers to meet the main stem. To see the cross section of each point refer to Appendix I.

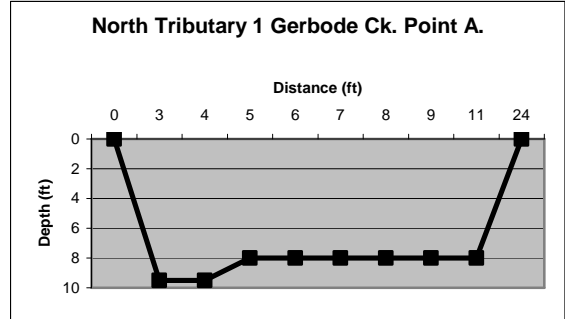
Cross Section A.

The bank full width is 24 feet and the depth is 9.5 feet. There is a deeper channel on the left side. The banks are covered with a combination of Willows, Coyote Bush and grasses.

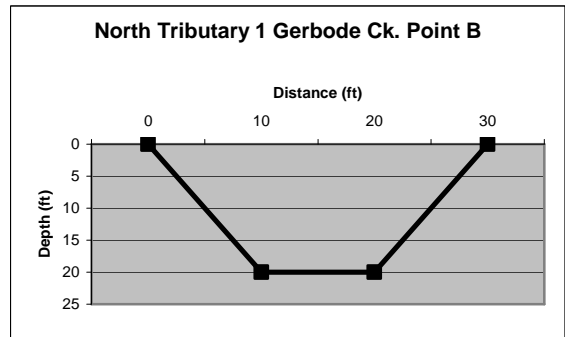
Cross Section B.

Point B is a trapezoidal channel. The bank full width is 30 feet and the depth is 20 feet. Willows cover the banks.

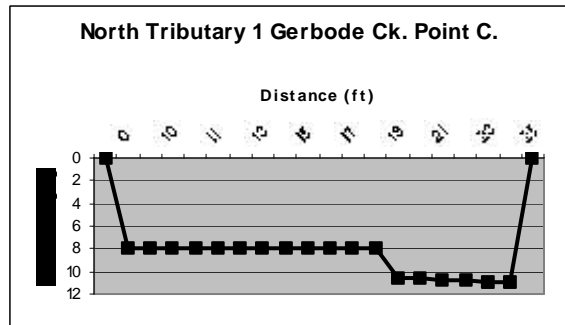
Cross Section C

Point C is basically a trapezoidal channel, with a deeper channel on the right side. The bank full width is 35 feet and the depth is 11 feet. Coyote Bush and grasses are growing on the bank. Died horsetail was found on the banks of the creek.

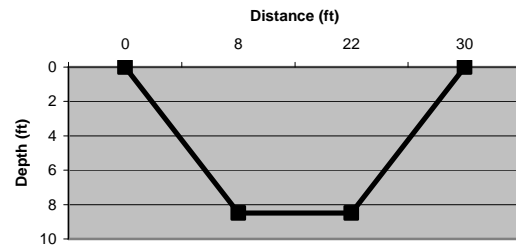
North Tributary 1 Gerbode Ck. Point D

There is a trapezoidal shaped channel at Point B. The bank full width is 30 feet, the bottom bank width is 14 feet, and the depth is 8.5 feet. Willows stop growing at this point and Coyote Bush and grasses begin.

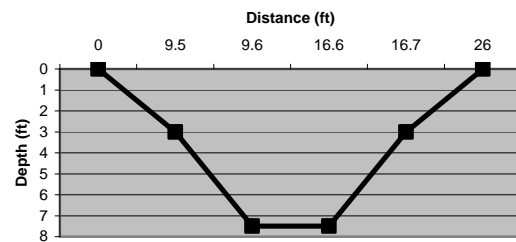
North Tributary 1 Gerbode Ck. Point E.

The banks at Point E are covered with willows. The bank full width is 26 feet and the depth is 7.5 feet. There is a 3.5 wide shelf on the right bank.

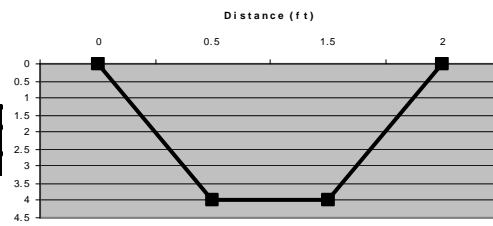
North Tributary 2 Gerbode Ck. Point A.

At point A the shape of the gully is an inversed triangle. The top width is 2 feet and the depth is 4 feet.

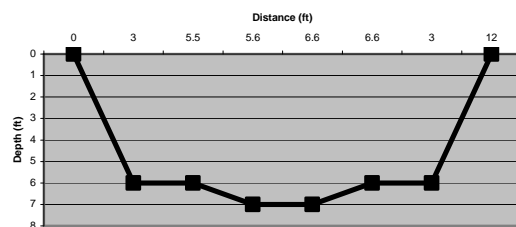
North Tributary 2 Gerbode Ck. Point B.

At point B there is trapezoid shaped channel with a smaller incision at the bottom of the channel. The top width of the channel is 12 feet and the depth is 7 feet. This shape is uniform for about 150 feet downstream.

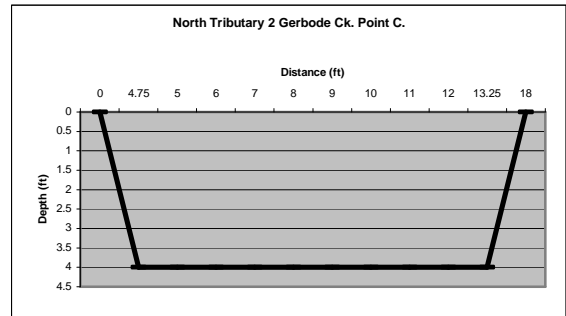
Cross-Section C.

At point C the channel is in the shape of a trapezoid. The top width is 18 feet, the bottom width is 8.5 feet and the depth is 4 feet.

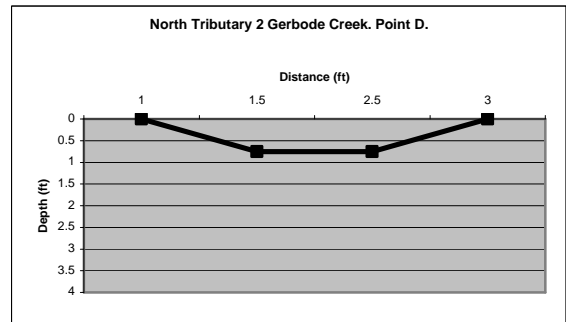
Cross-Section D. At point D the channel is the shape of an inversed triangle. The top width is 3 feet and the depth is .75 feet.

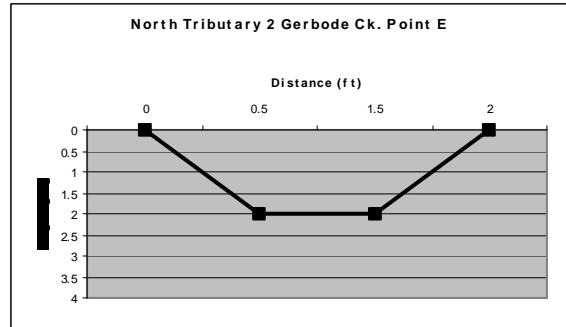
Cross-Section E.

At point E the channel is the shape of an inversed triangle. The top width is 2 feet and the depth is 2 feet.

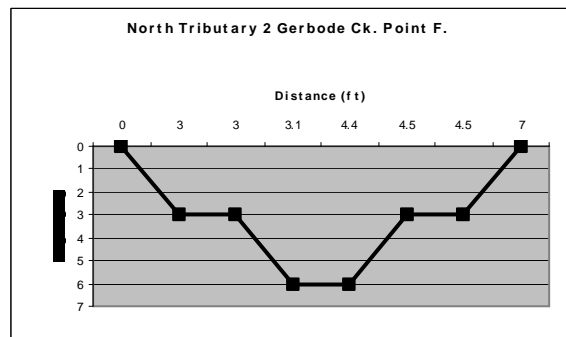
Cross-Section F.

At point F there is trapezoid shaped channel with a smaller incision at the bottom of the channel. The top width of the channel is 7.5 feet and the depth is 6 feet. The width of the small gully at the bottom is 1.5 feet.

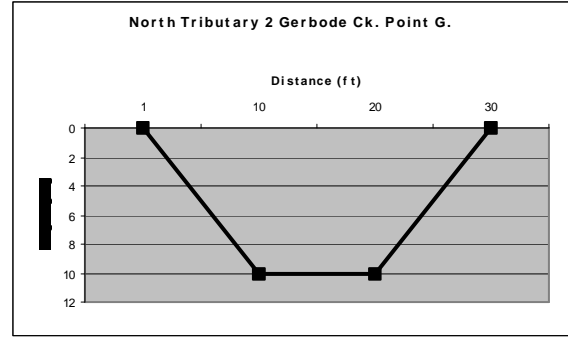
Cross-Section G.

At point G the channel is the shape of an inversed triangle. The top width of the channel is 30 feet and the depth is 10 feet.

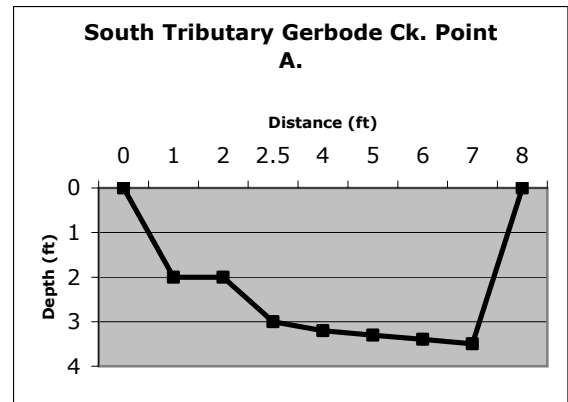
Cross-Section A. This is a cross section of the creek at point A. before it passes through the culvert under the Bobcat Trail/Road. The banks are full of vegetation, mostly Coyote Bush. There is no running water but the soil at the bottom of the creek is moist. As the cross section shows the top width is 8 feet and the deepest part is 3.5 feet. The shape of the cross-section is a trapezoid with a 2foot wide terrace.

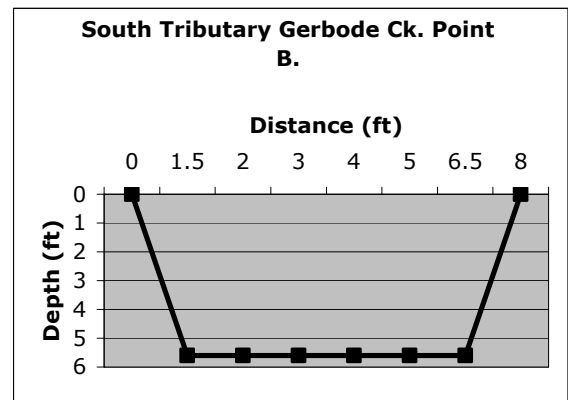
Cross-Section B. This is a cross section of the creek at point B, after it passes through the culvert under the Bobcat Trail/Road. Here the banks are full of vegetation. There is no running water, but the soil at the bottom of the creek is wet. The cross section of the channel is trapezoidal. The top width is 8 feet, the bottom width is 5 feet and the depth of the channel is 5.5 feet

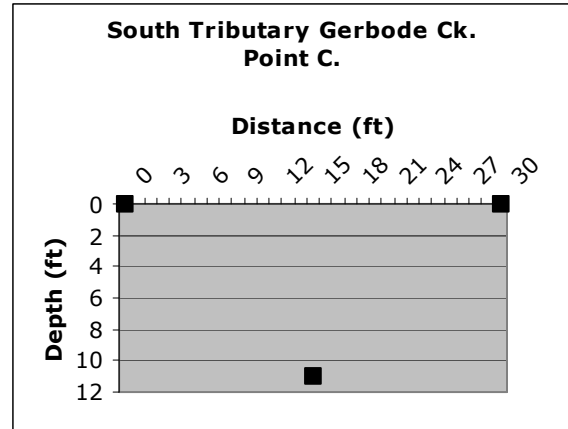
Cross-Section C. At point C, the riparian vegetation dies out and the channel is mostly barren. The shape of the channel is an upside down triangle. The top width of the channel is 30 feet and the depth of the channel is 11 feet. As mentioned above, the vegetation changes at this point. Here the willows give way to wetland type grasses and Coyote Bush and the channel is dry.

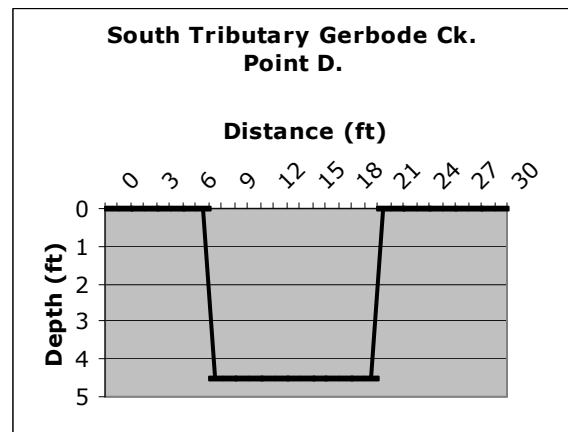
Cross-Section D. At point D, the cross section is trapezoidal. It has a top width of 28 feet, a bottom width of 12 feet and a depth of 4.5 feet. The banks are covered in low growing Coyote Bush. In this section the sediment deposition from up stream is apparent.

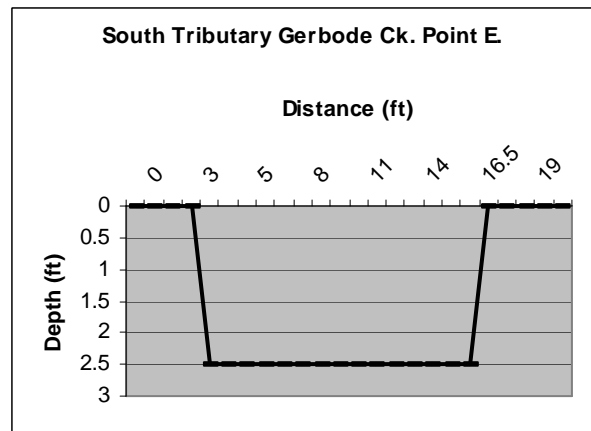
Cross-Section E. At point E, the cross section is trapezoidal. It has the top width of 21 feet, a bottom width of 12 feet and a depth of 2.5 feet. The surface is covered in wetland type grasses. In this section there is increased sediment deposition from up stream.

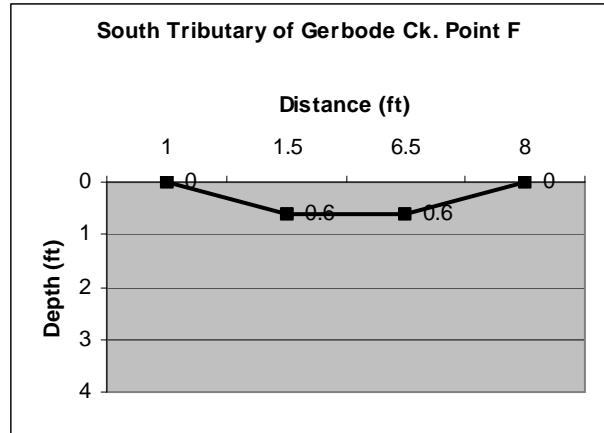
Cross-Section F.

At point F, the cross section is trapezoidal. It has the top width of 8 feet and a depth of 0.6 inches.

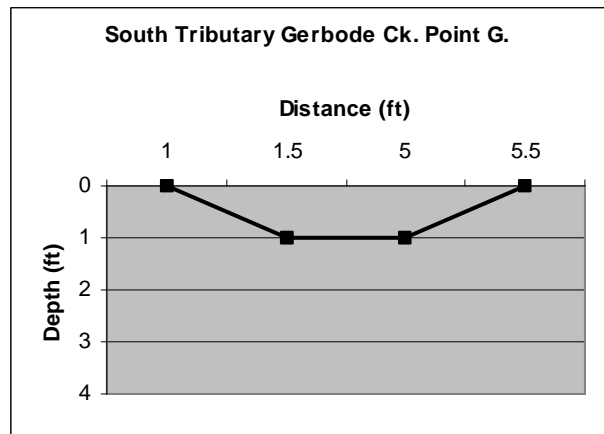
Cross-Section G.

At point G, the cross section is trapezoidal. It has the top width of 5.5 feet and a depth of 1 foot.

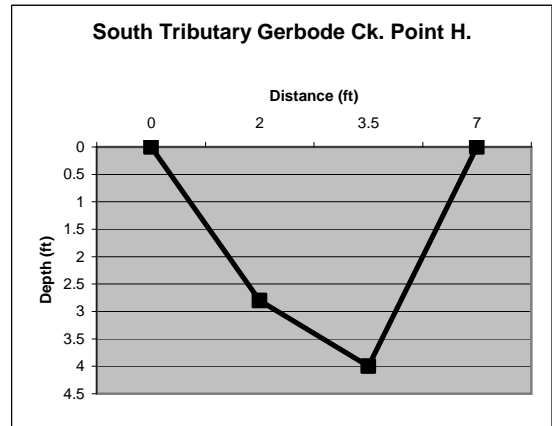
Cross-Section H.

At point G, the cross section is triangular. It has the top width of 4 feet and a depth of 3.5 foot.

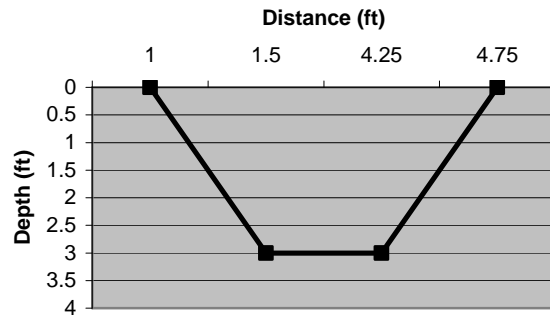
South Tributary Gerbode Ck. Point I.

At point I, the cross section is trapezoidal. It has the top width of 4.75 feet and a depth of 3 foot.

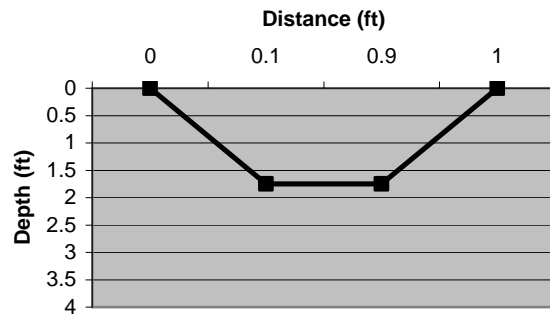
South Tributary Gerbode Ck. Point J.

At point J, the cross section is trapezoidal. It has the top width of 1 foot and a depth of 1.75 feet.

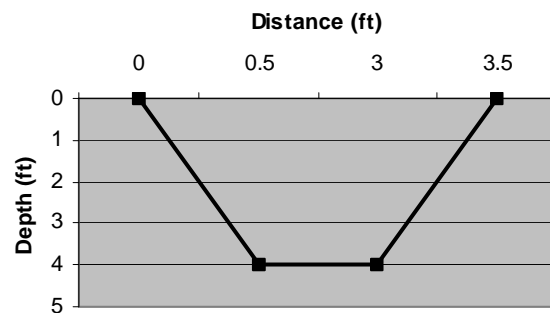
South Tributary Gerbode Ck. Point K.

At point K, the cross section is trapezoidal. It has the top width of 3.5 feet and a depth of 4 feet.

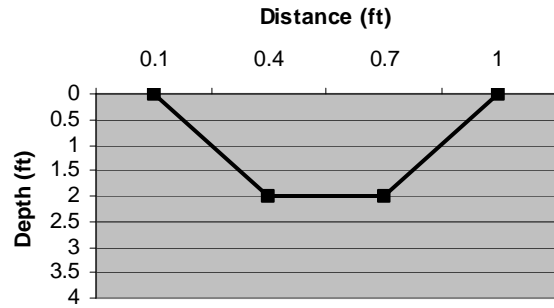
South Tributary Gerbode Ck. Point L.

At point L, the cross section is trapezoidal. It has the top width of 1 foot and a depth of 2 feet.

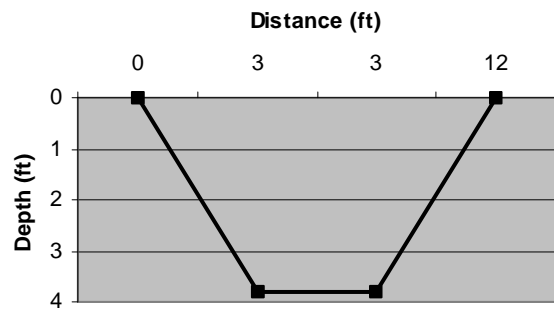
Southern Tributary Gerbode Ck. Point M.

At point M, the cross section is trapezoidal. It has the top width of 12 feet and a depth of 3.8 feet. Willows grow in the center of the channel.

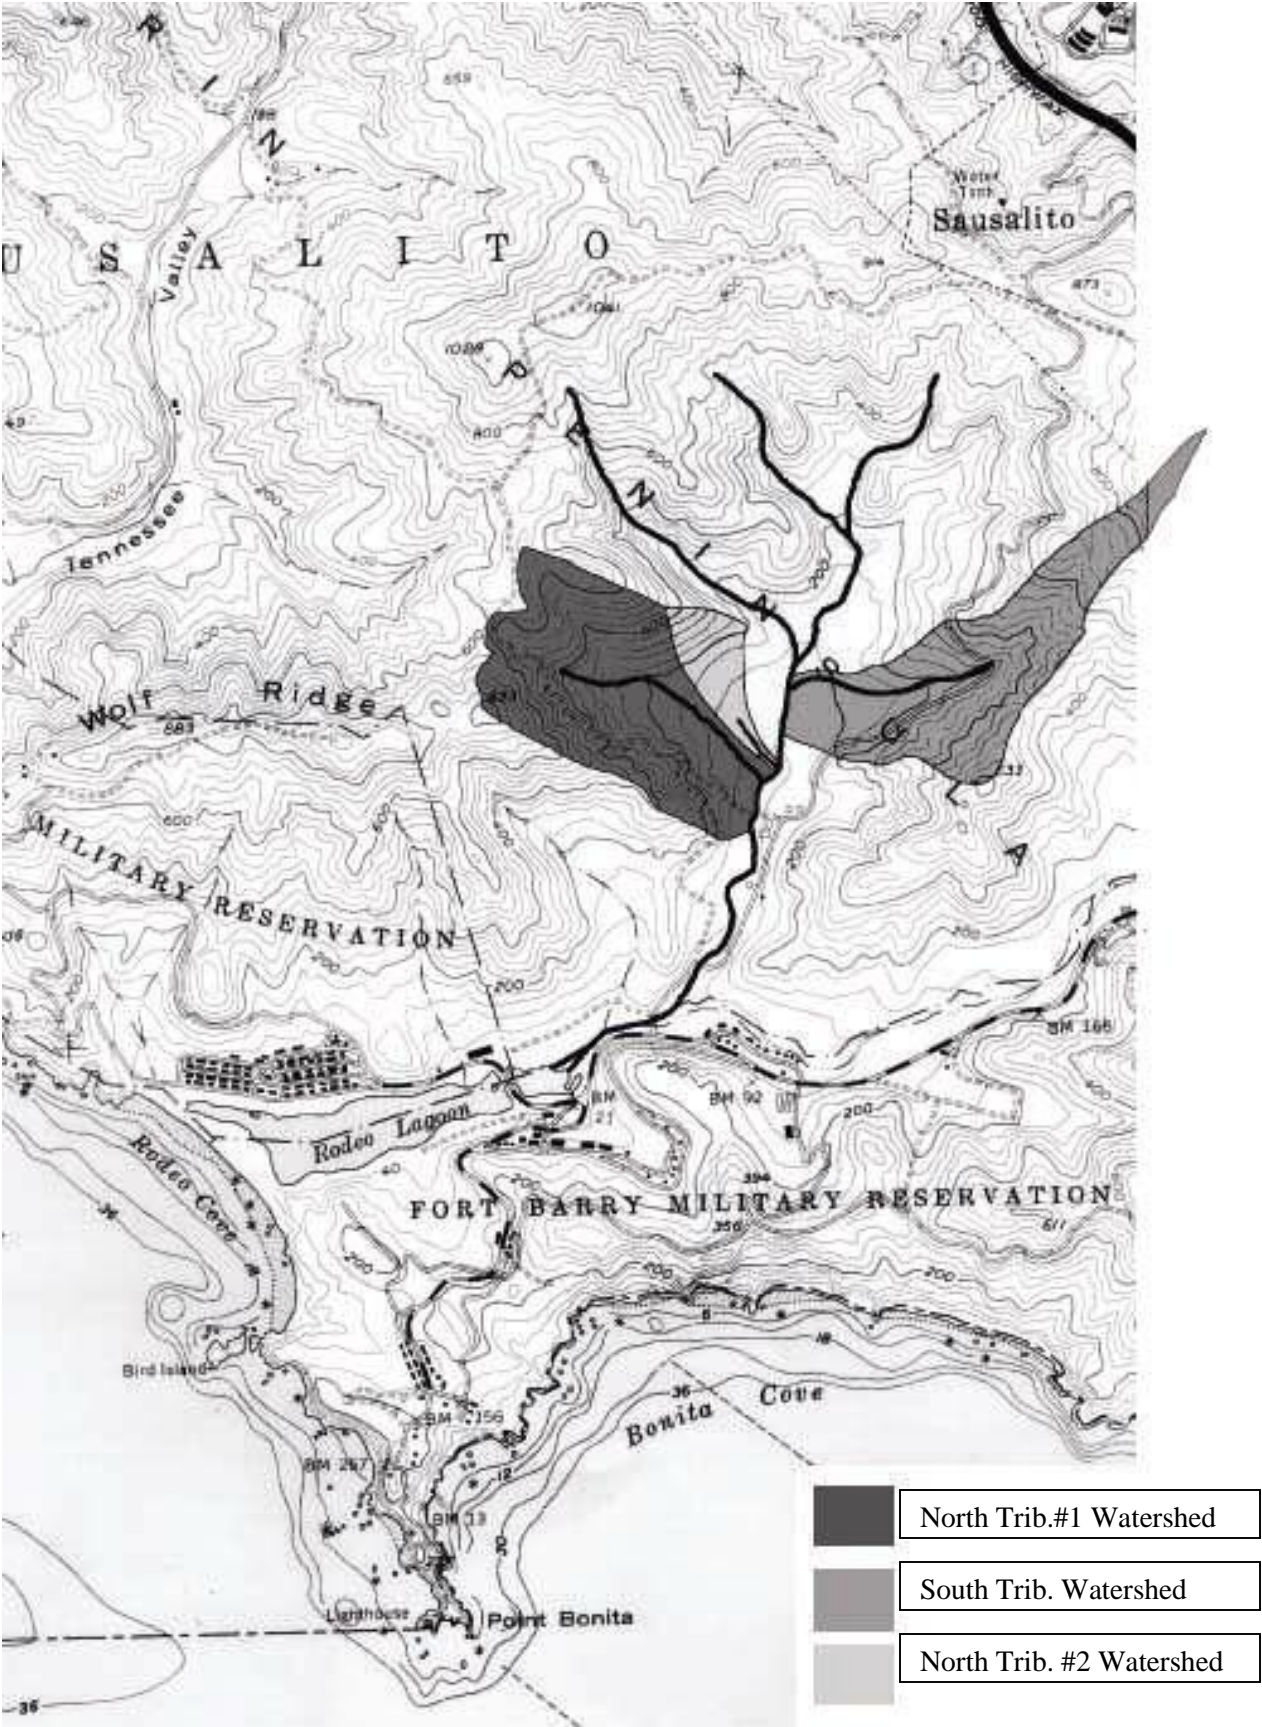
Figure 1. Map of Gerbode Creek with three sub-watersheds outlined.

On the USGS map I identified the landmarks that might have caused increased erosion, such as old roads and culverts, and their proximity to the gullies. (See figure 1. and photographs 2-4).
