A post project appraisal of the restoration/rehabilitation of Alamo Creek

A Post Project Appraisal of the Restoration/Rehabilitation of Alamo Creek

UC Berkeley Department of Landscape Architecture 227 River Restoration

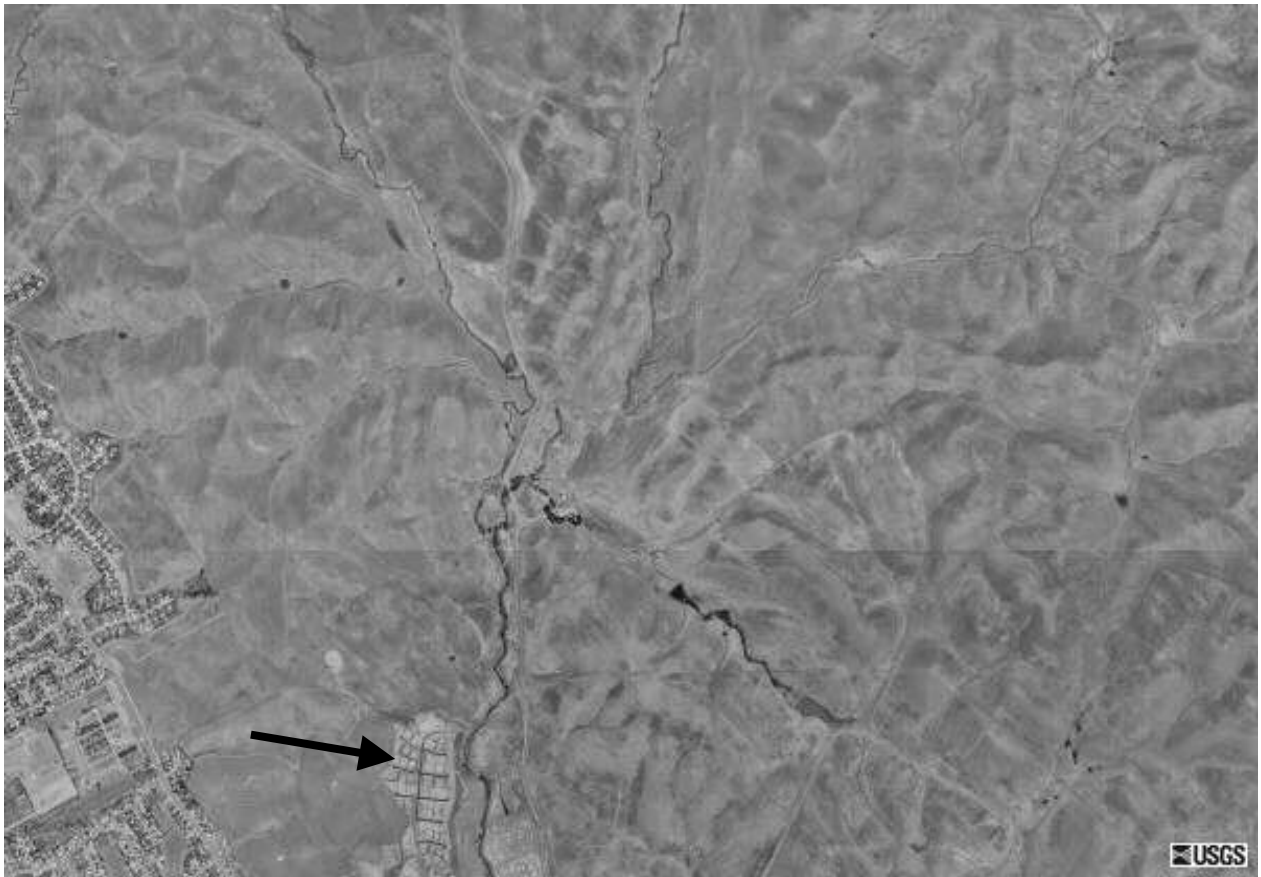
Figure 1

Alamo Creek is located just east of Danville California in Contra Costa County. The creek's three dominant branches (West, East, and Main) converge one mile east of Danville proper near Bolinger Canyon Road (Figure 1). The main branch then flows south along the Windemere housing development for 11,600 linear feet. Alamo creek drains 7.28 square miles of rolling grassland, on which cattle grazing began in the late 1880's and has persisted to the present day. The removal of the Valley Oak in conjunction with heavy grazing has increased the velocity of flow resulting in channel incision and preventing normal floodplain inundation. As incisions increases channel capacity increases which greatly increases floodstage discharge. This process has jeopardized the riparian zone and created bank instability.

The West Branch flows into the Main Branch from the northwest (upper left side of image) while the East Branch, which cannot be seen in this image, flows parallel to the road (centrally bisecting image) into the Main Branch. The construction of the Windemere Housing Development can be seen in the upper right corner. In this image the development extends to the riparian corridor on the Main Branch.

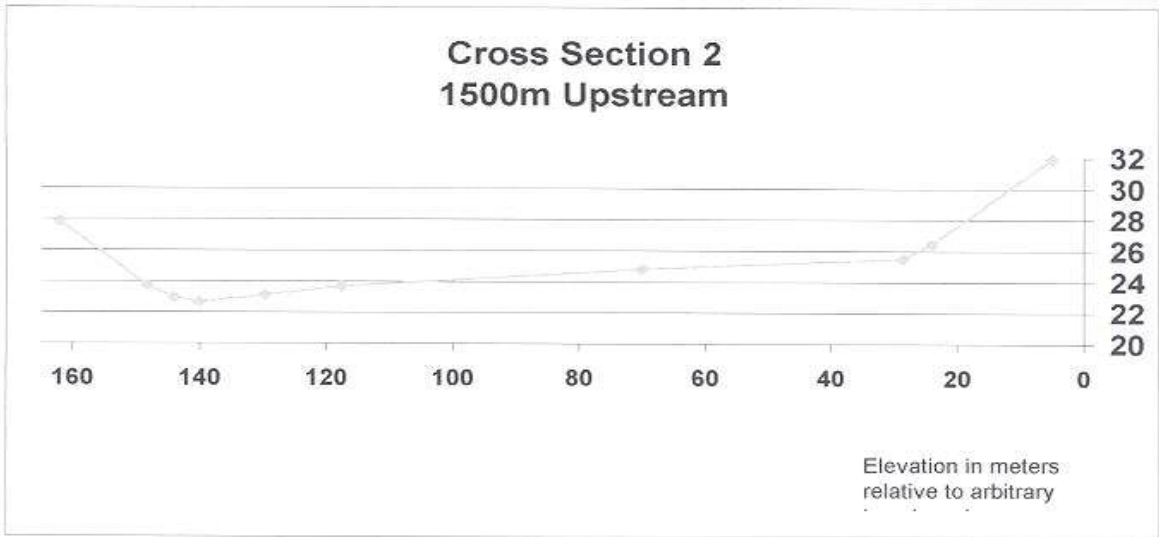
Figure 6

Although bank stability was not a major objective it was recognized by PWA as an important factor in maintaining a healthy riparian zone and was part of treatment 1 and 7. By comparing treatment 2 & 3 design cross sections to the three post-project cross sections (Figure 6, 7a, 7b) and current site photographs it can easily be seen that the left bank down the entire cross section is stable and supports a healthy riparian zone. The design plans proposed a 3: 1 slope on the left bank that has been maintained and the bank shows no signs of landslides, undercutting, or undermining. PWA chose to grade a floodplain and a 3: 1 slope on the left side of the channel but avoided planting riparian vegetation or grading a 3: 1 on the right side of the channel. It was not clear why this discrepancy was created as there may have been complications with the property owner on the right-bank however, the Windemere property only exists on the left side of the creek.
