Post-Project Appraisal of Baxter Creek at Booker T. Anderson Park : Shopping Carts - The New Boulders

Post-Project Appraisal of Baxter Creek at Booker T. Anderson Park
Shopping Carts: The New Boulders

December 2005

By:
Colleen Bronner
Maggie McKeon
Janel Weston

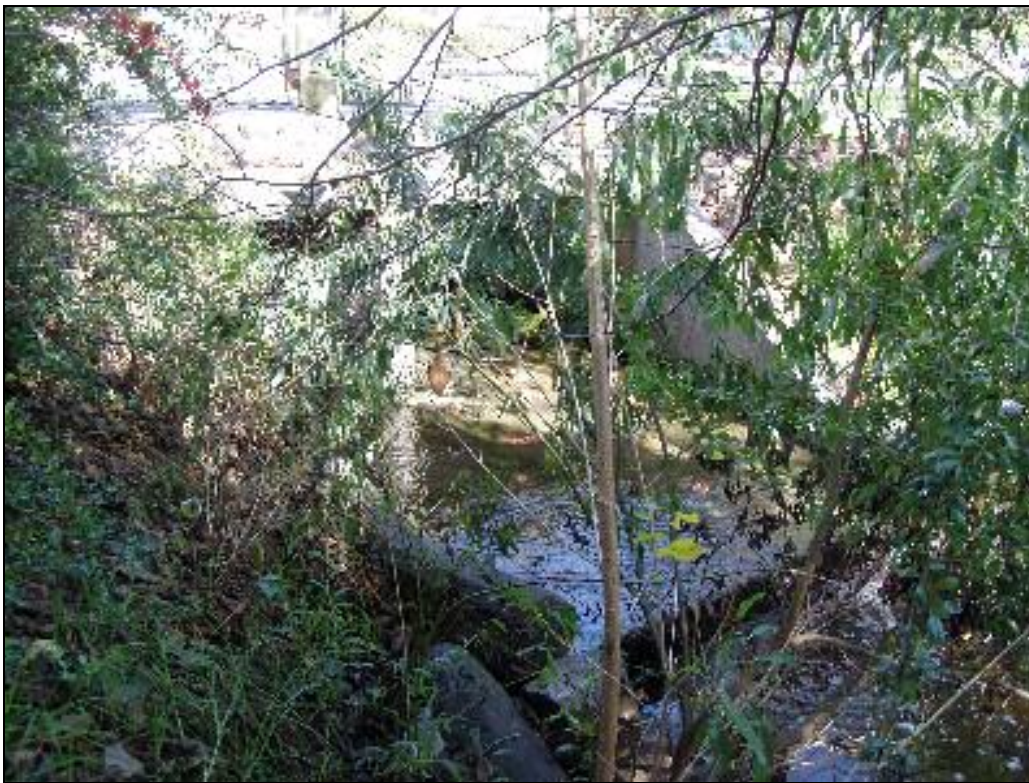
Figure 14: Beginning of project reach

The complete site map is located in Appendix A. We noted important features throughout the site mapping process including: steep banks in the upstream half of the reach, significant amounts of trash collected on bars or floating in pools, grassy vegetation/weeds dominating bars and growing in the creek. Although we did not complete any pebble counts, we estimated the bars to be dominantly silt/sand as noted on the site map. Riffles and pools were observed throughout the reach. Figures 14 – 20 show significant sites of the site mapping.
