Cattle grazing has varying impacts on stream-channel erosion in oak woodlands

California Agriculture, 58(3)

Melvin R. George  
Royce E. Larsen  
Neil K. McDougald  
Kenneth W. Tate  
John D. Gerlach, Jr.  
Kenneth O. Fulgham

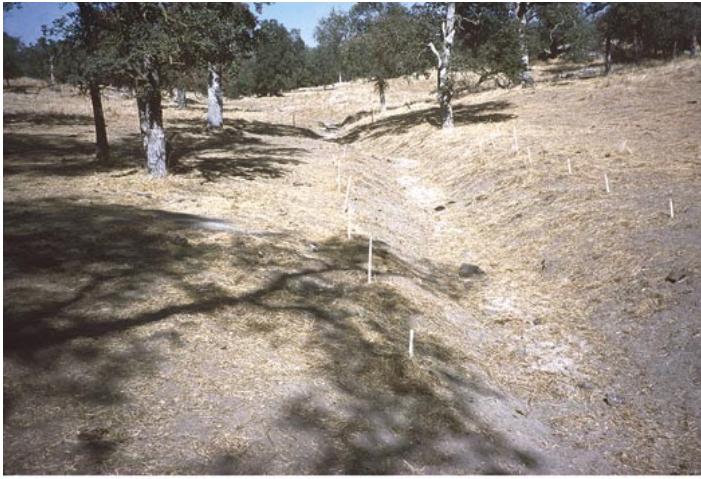
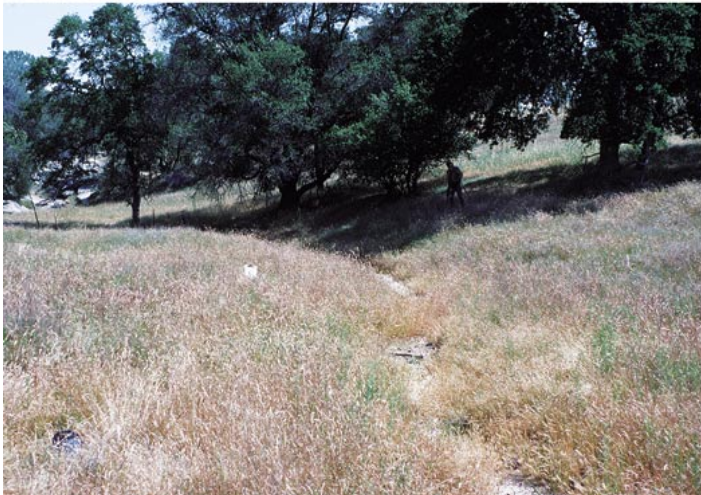
Fall comparison of stream channel in concentrated grazing treatment, *upper*, and no grazing, *lower*.

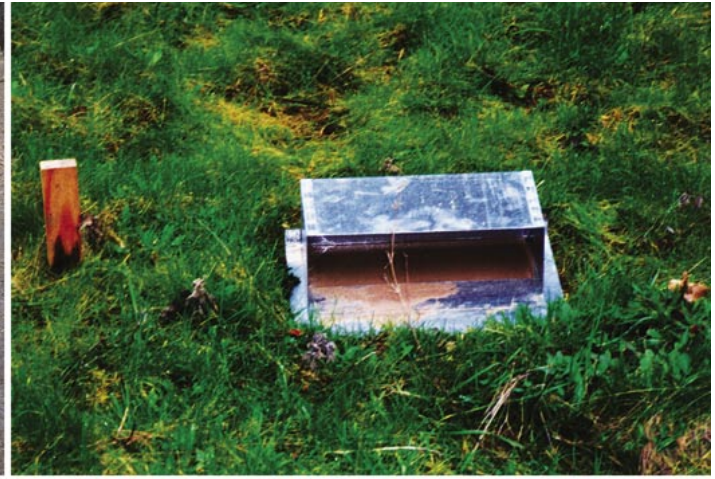
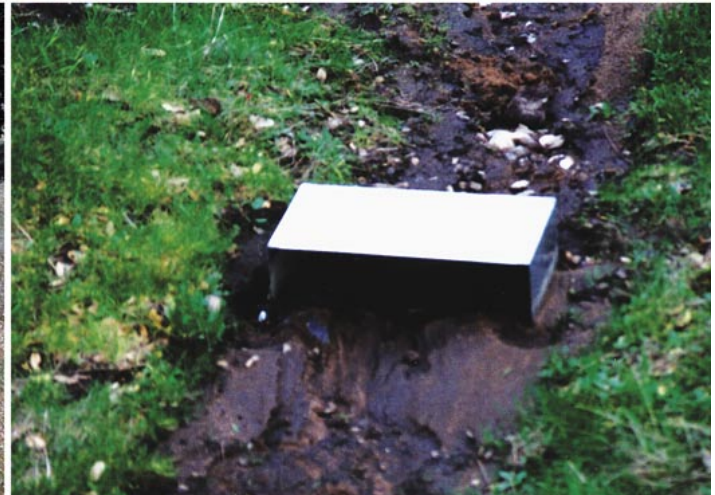
Comparison of sediment trap in a vegetated area, *upper*, and sediment trap in an adjacent trail, *lower*.

During the 1997, 1998 and 1999 water years, sediment traps (Wells and Wohl-gemuth 1987) were placed in pairs at several locations along stream channel 2 (fig. 1) that drains the research watershed at the San Joaquin Experimental Range. Traps were sheet-metal boxes open on one side to catch sediment. One of each pair of traps was placed in

a cattle trail near the point where the trail crosses the stream channel. The second sediment trap of each pair was placed in well-vegetated areas of similar slope and slope-length adjacent to the trap in the trail. Throughout the rainy season the sediment traps were emptied as needed during and following storms. Sediment samples were dried and weighed. ANOVA was used to separate treatment and year differences.

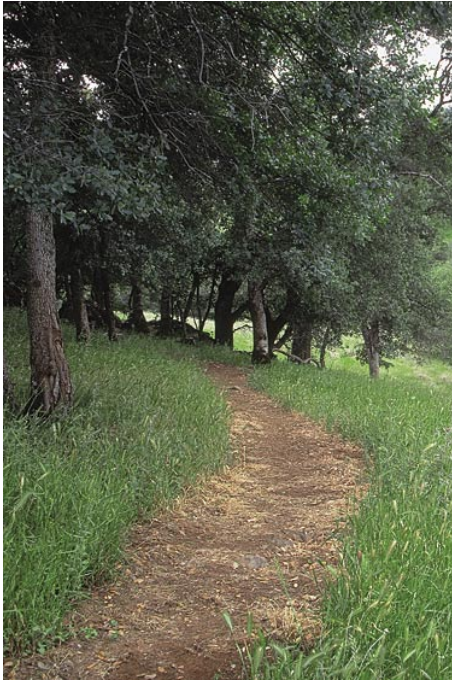
**Cattle trails can aid the flow of sediment into streams. By reducing the distance between foraging and watering sites, the formation of cattle trails can be reduced.**

several stream channels. Several trails are common in the steep terrain of foothill rangelands, resulting in many trail crossings of each stream channel. Regular trampling by livestock keeps these trails devoid of vegetation throughout the year and reduces the infiltration rate, resulting in increased surface runoff along trails, especially along the downhill approach to stream crossings. During the dry season cattle trampling loosens surface soil, providing a ready source of sediment during the rainy season. The trails become a conduit for surface runoff and a source of sediment.
